# **Volcanic Eruption of the 15th of January 2022 and induced tsunami, Hunga Tonga-hunga Ha'apai Volcano**

## **Preliminary Satellite-Derived Damage Assessment**

Kingdom of Tonga

Status: Affected structures and affected facilities observed in all island after tsunami triggered by volcanic eruption

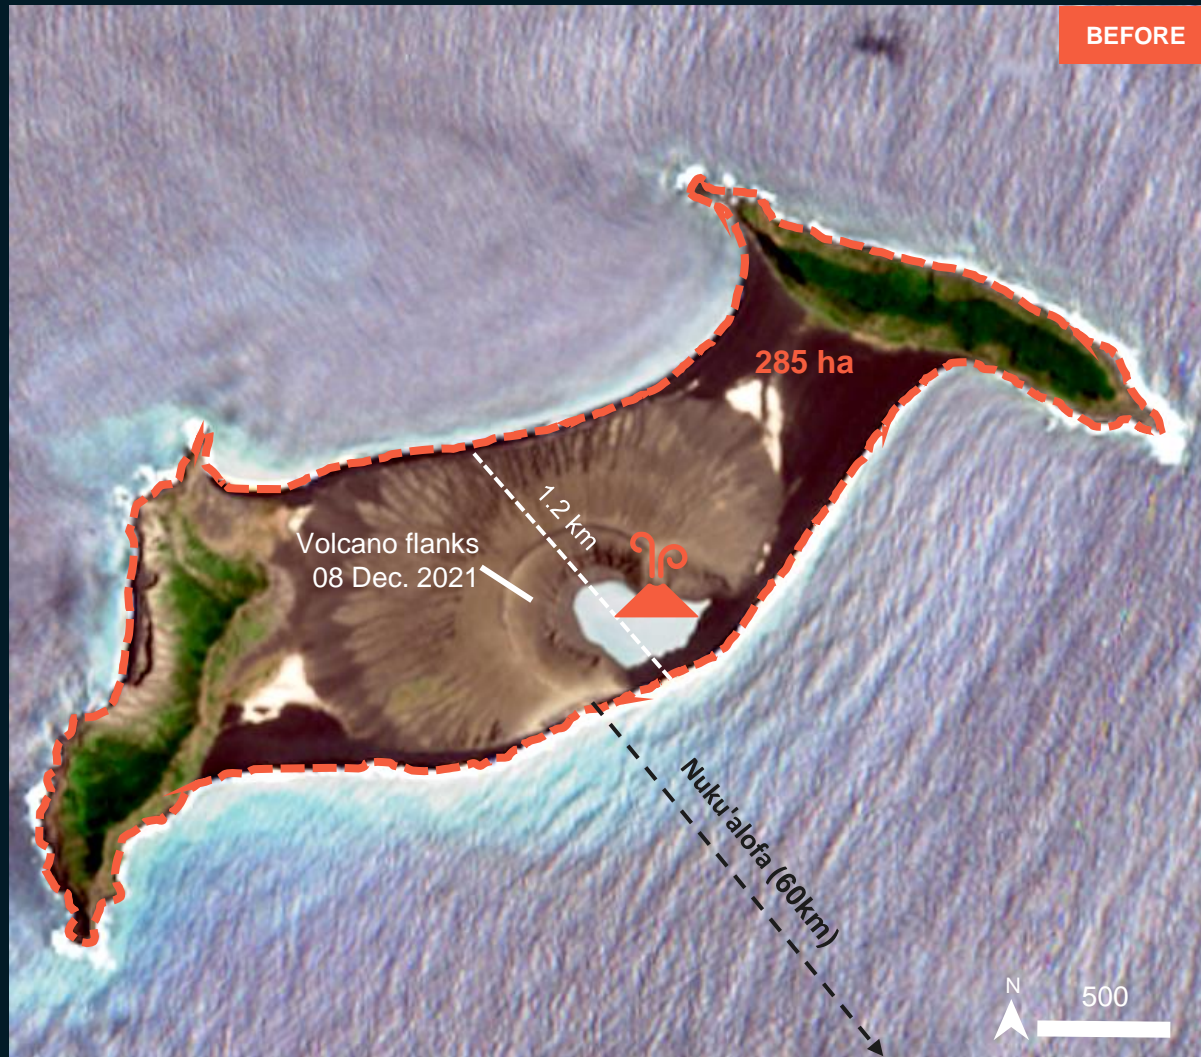
# AOI 1- HUNGA TONGA - HUNGA HA'APAI VOLCANO

## Destroyed area around the volcano / Collapse of the caldera

Sentinel-2 / 8 Dec 2021

Pléiades / 16 Jan 2022 (21:53 UTC)

- Collapse of the caldera of the Hunga Tonga - Hunga Ha'apai Volcano after the eruption of the 15 January 2022;
- Surface of the island 285 ha (08 December 2021)

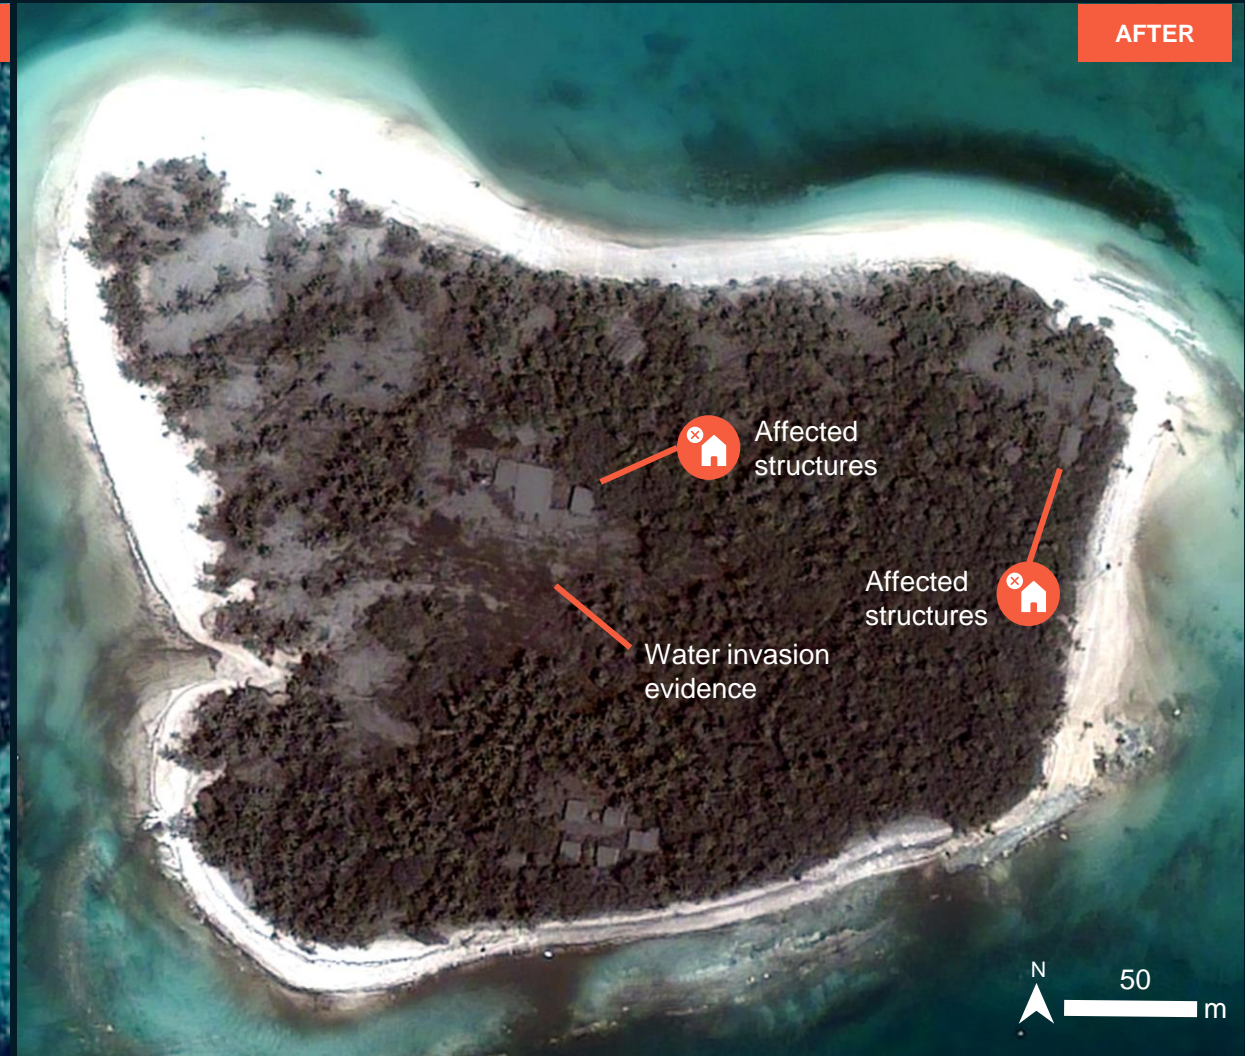
# AOI 2-1 – FAFAA VILLAGE, KOLOFO'OU DISTRICT, TONGATAPU DIVISION

## Water invasion evidence and affected structures

ESRI Basemap / Worldview-2 / 5 Nov 2020

Pléiades / 16 Jan 2022

- Ash deposits observed in Tongatapu division as of 16 Jan. 2022;
- Water invasion evidence, affected structures and inundated road observed in Tongatapu division as of 16 Jan. 2022;
- Ash deposits, inundated runway and potentially affected structures observed in Fua'amotu Airport, Tatakamotonga district, Tongatapu division as of 16 Jan 2022;

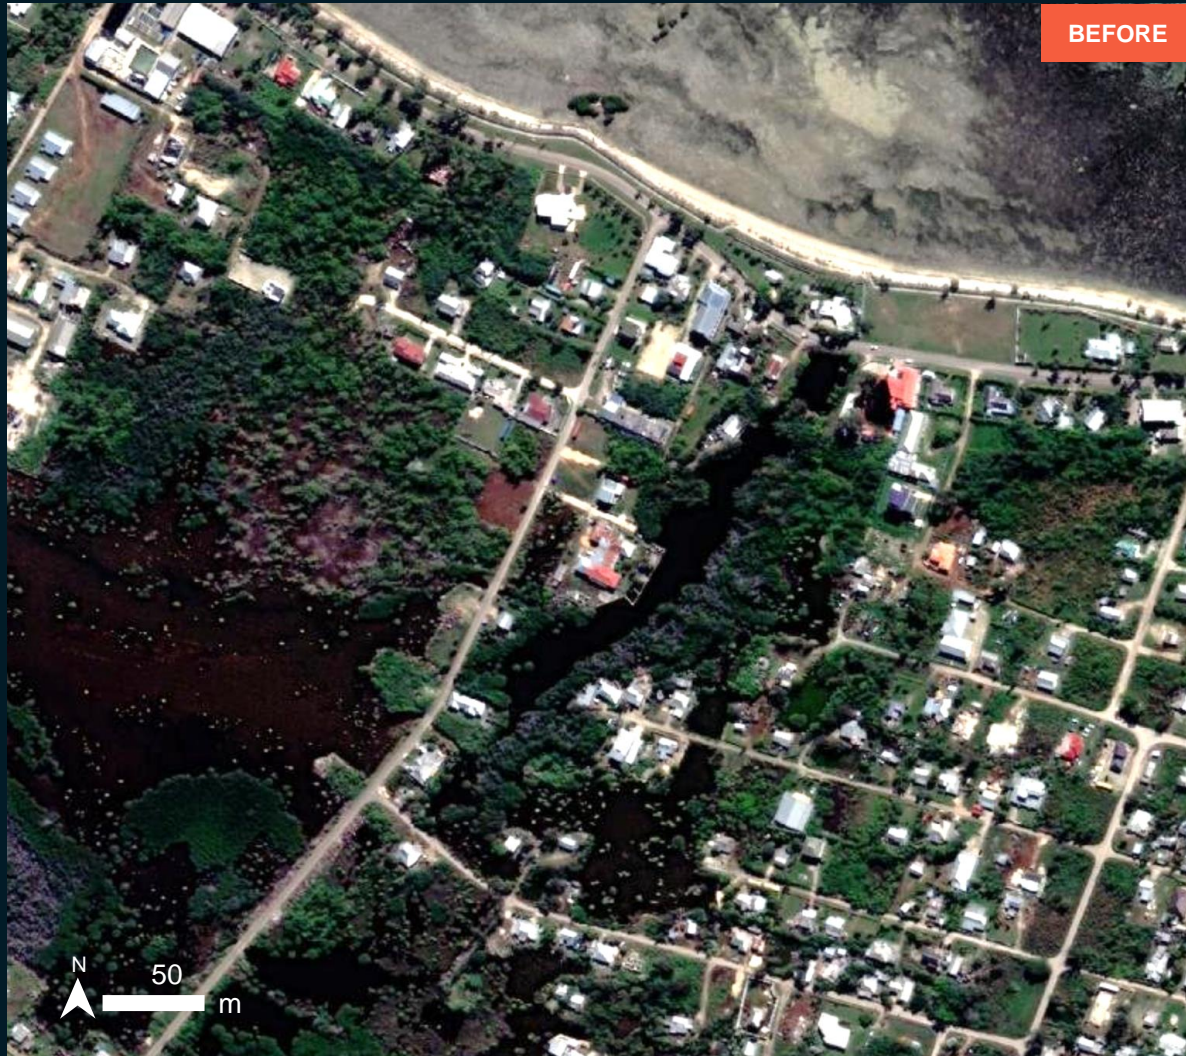
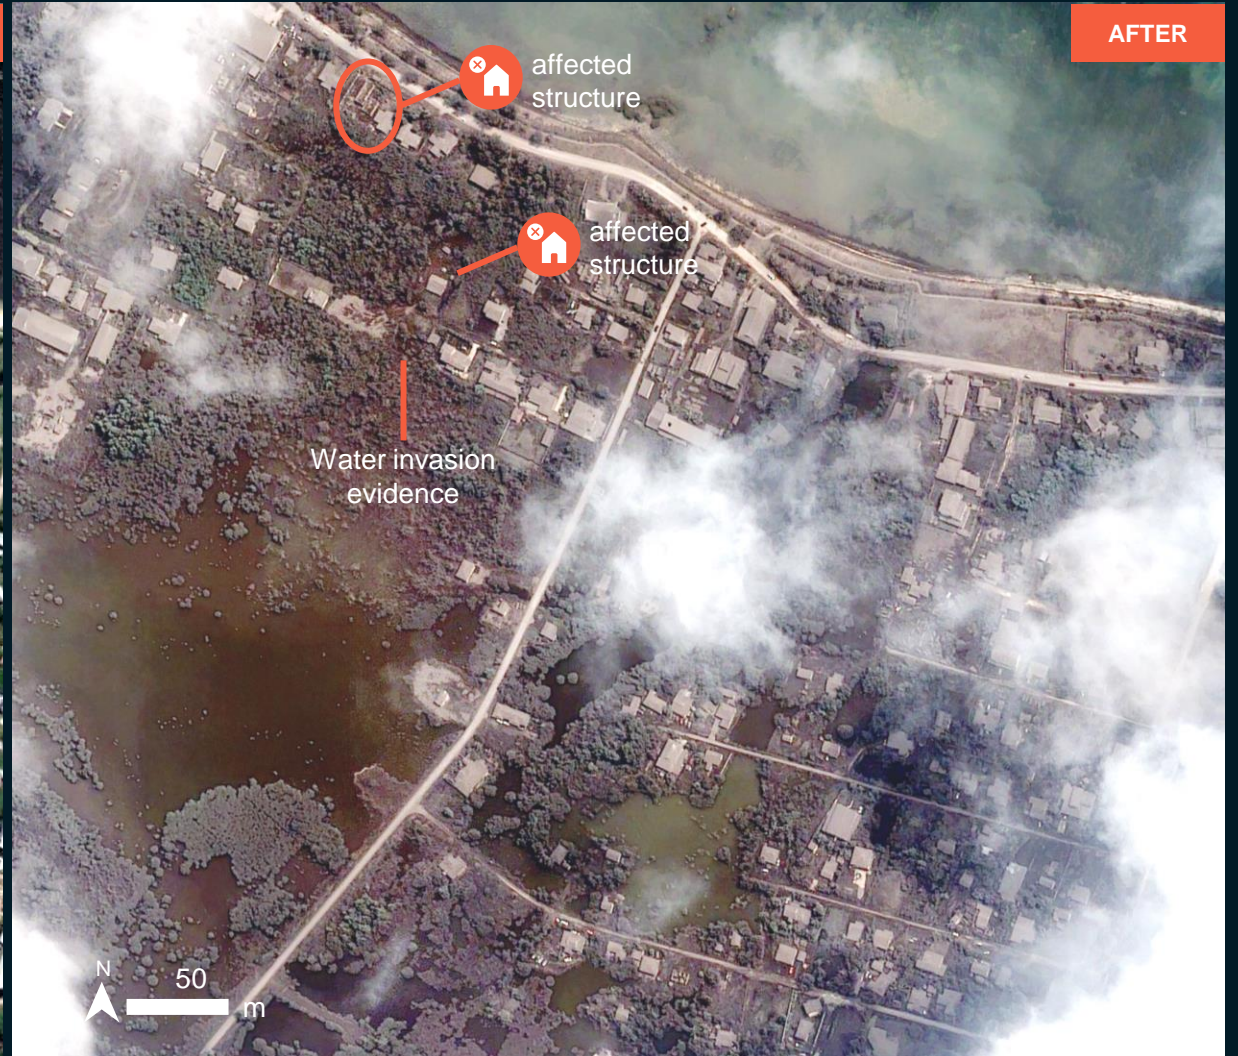
# AOI 2-2 – KOLOMOTU'A VILLAGE, KOLOMOTU'A DISTRICT, TONGATAPU DIVISION

## Water invasion evidence and potentially affected structures along the shoreline

BEFORE

AFTER

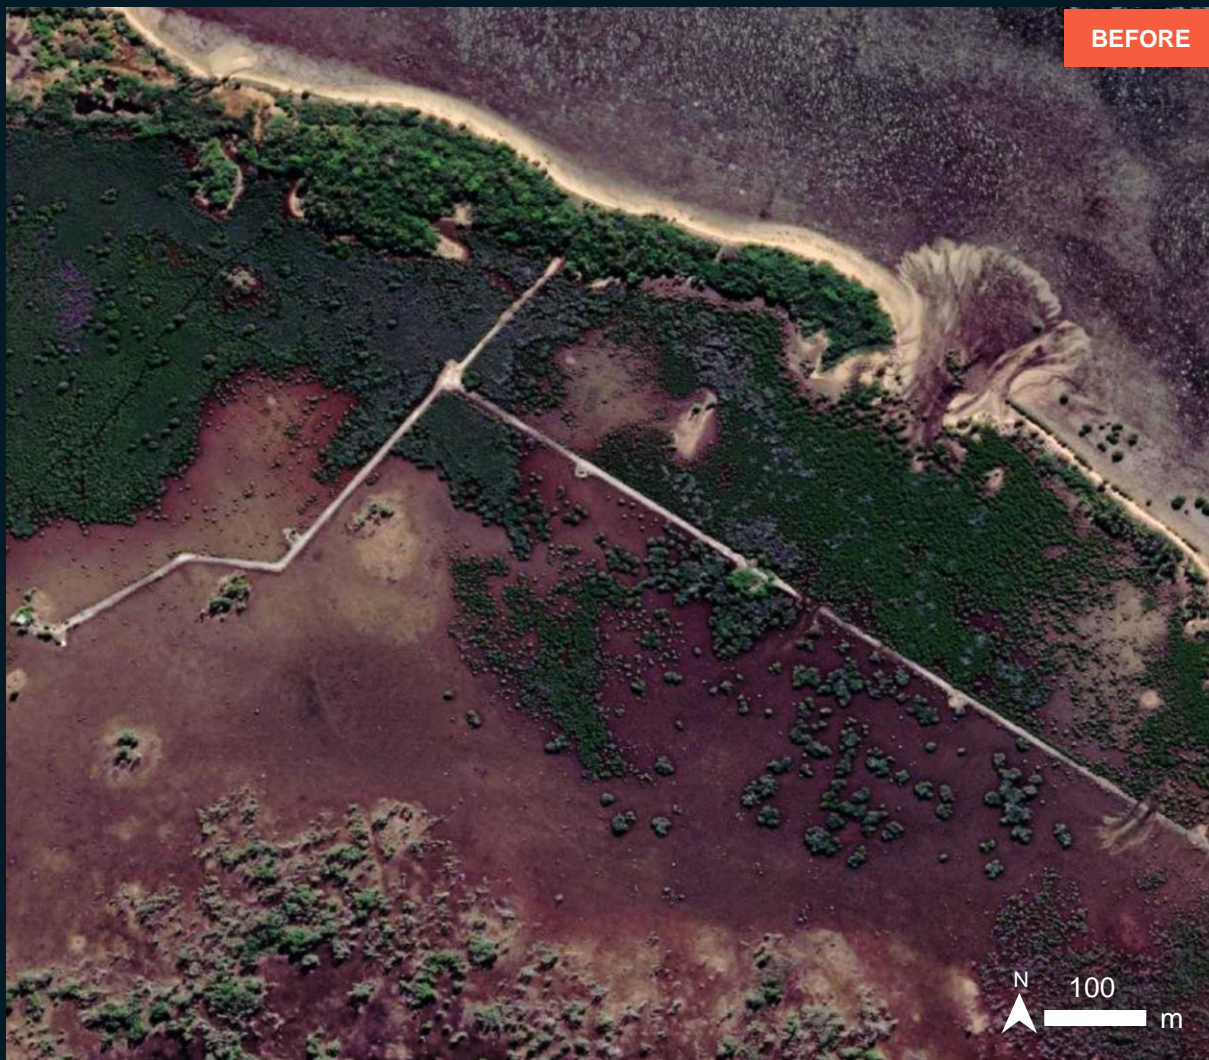
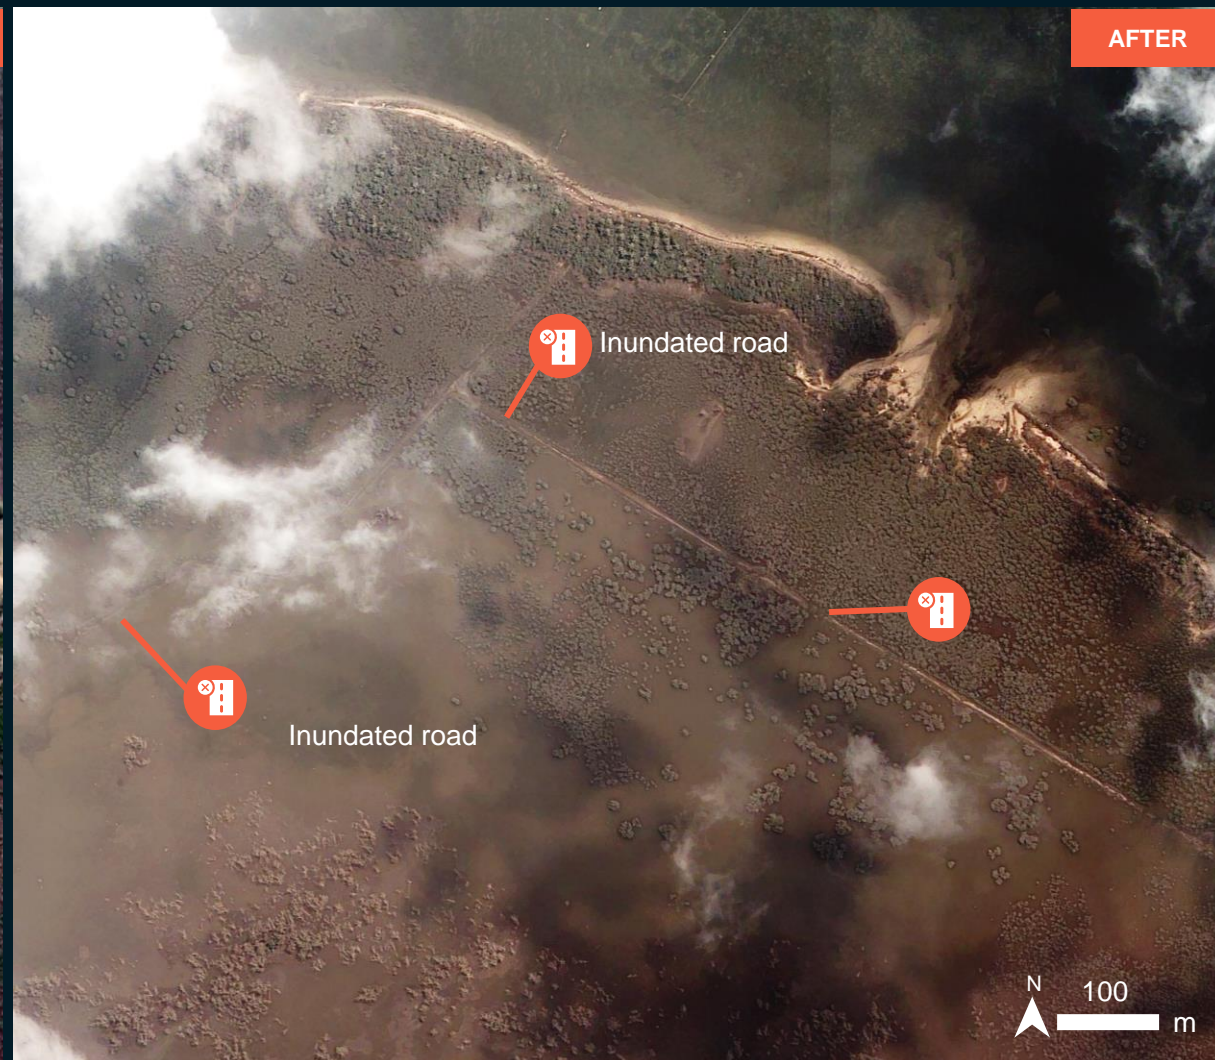
# AOI 2-3 – KOLOMOTU'A VILLAGE, KOLOMOTU'A DISTRICT, TONGATAPU DIVISION

## Inundated road along the shoreline

BEFORE

AFTER

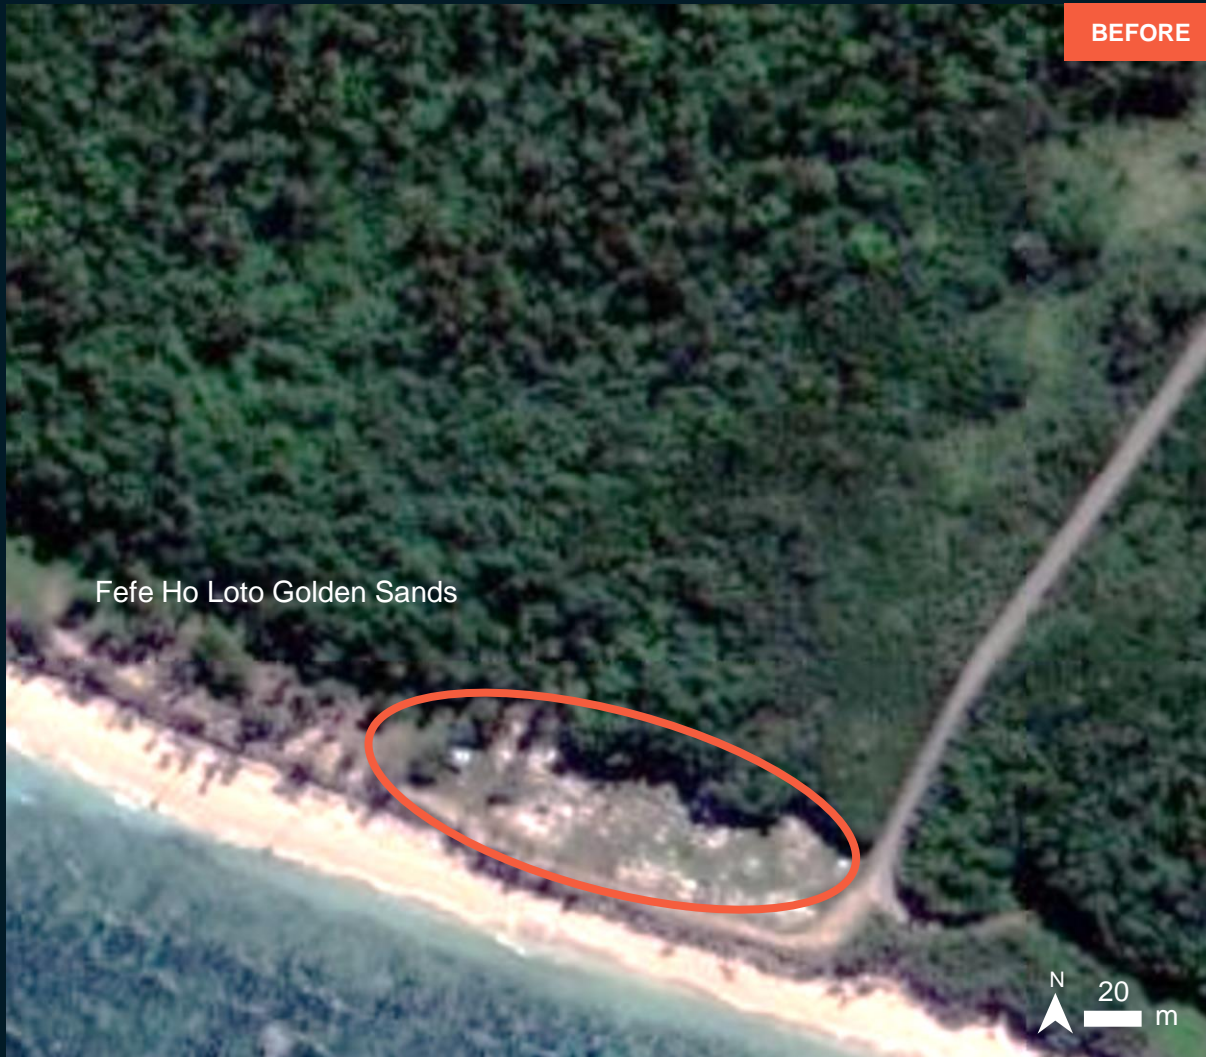
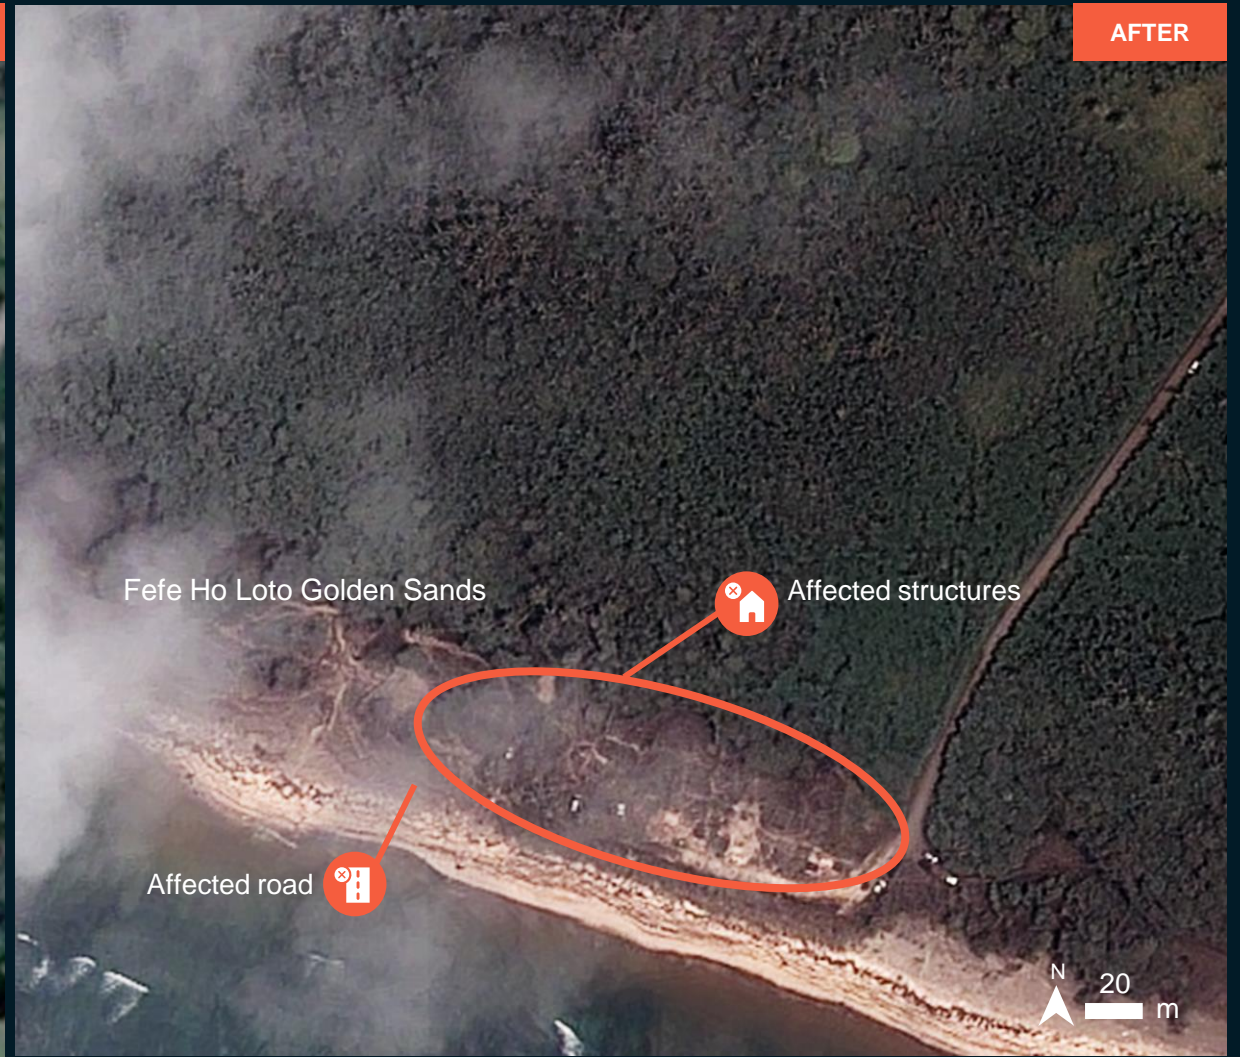
# AOI 2-4 –FEFE HO LOTO GOLDEN SANDS, TATAKAMOTONGA DISTRICT, TONGATAPU DIVISION

Affected area along the shoreline

ESRI Basemap / Worldview-2 / 5 Nov 2020

Pléiades / 16 Jan 2022

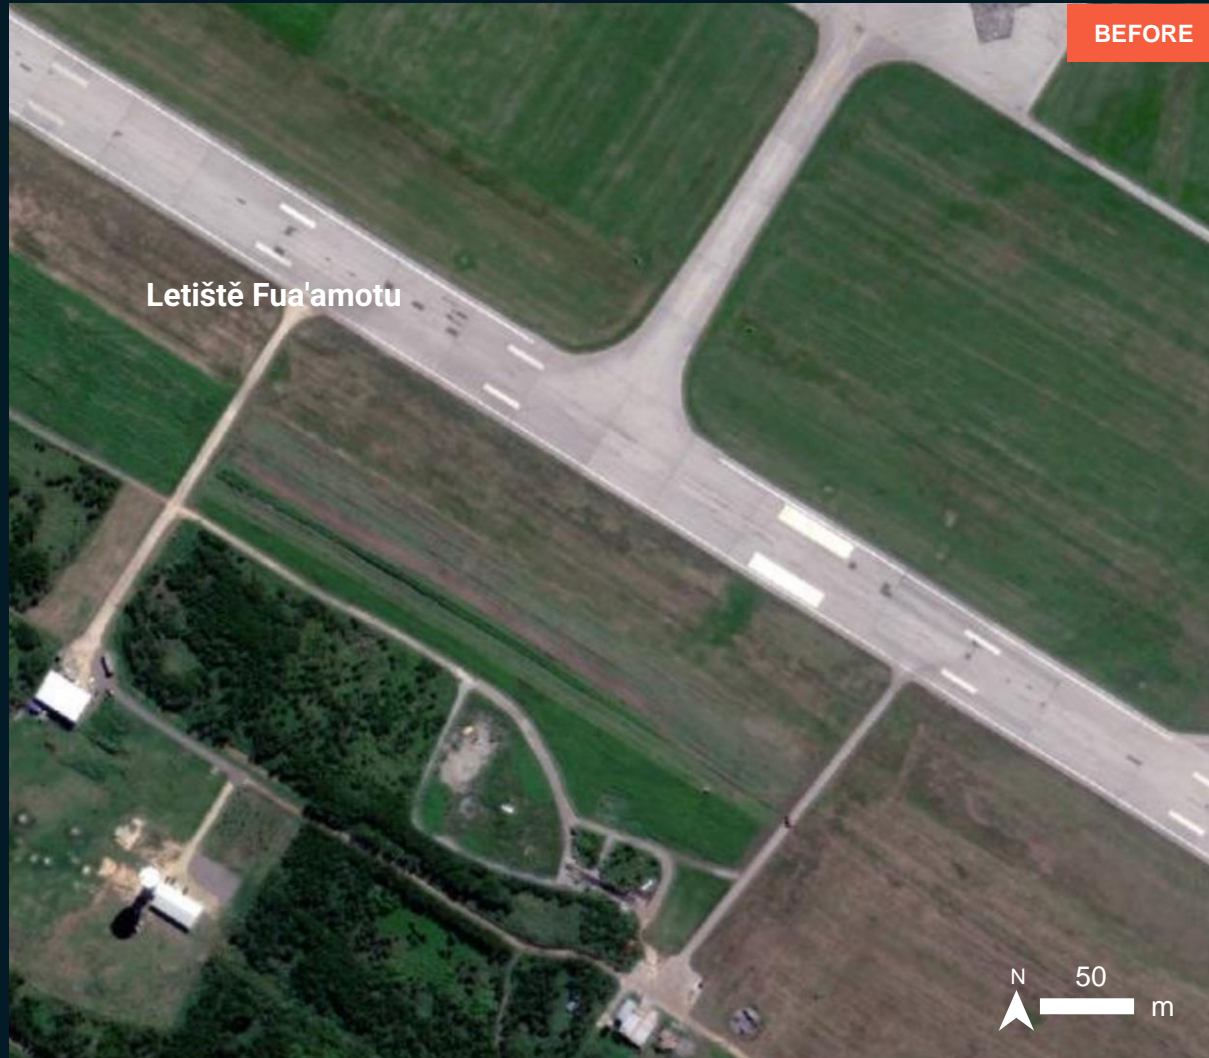
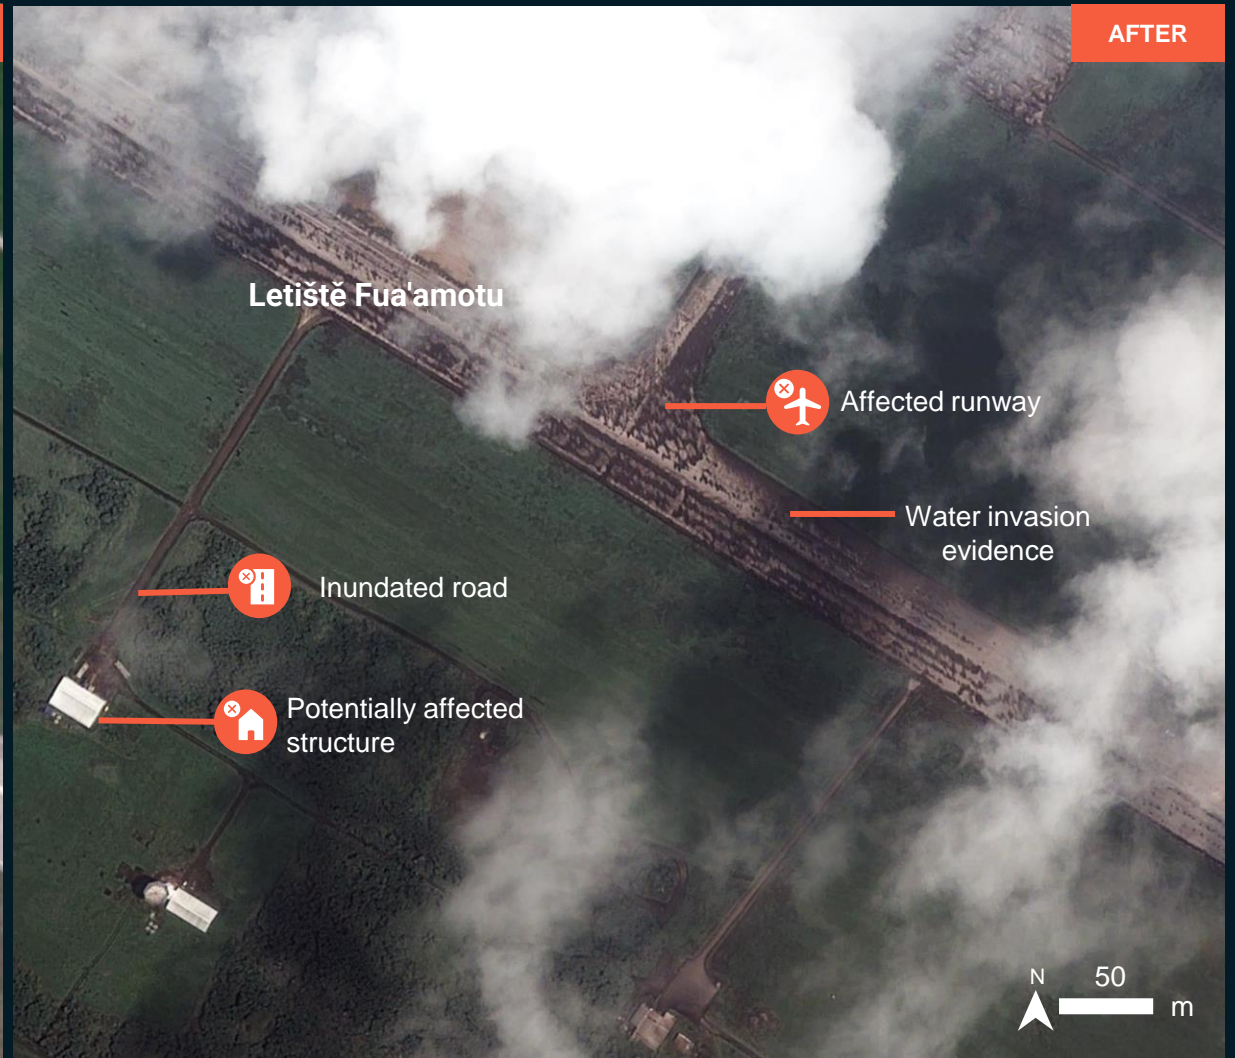
# AOI 2-5 – FUA'AMOTU AIRPORT, TATAKAMOTONGA DISTRICT, TONGATAPU DIVISION

## Inundated runway and potentially affected structures

Affected runway

Inundated road

Potentially affected structure

Water invasion evidence

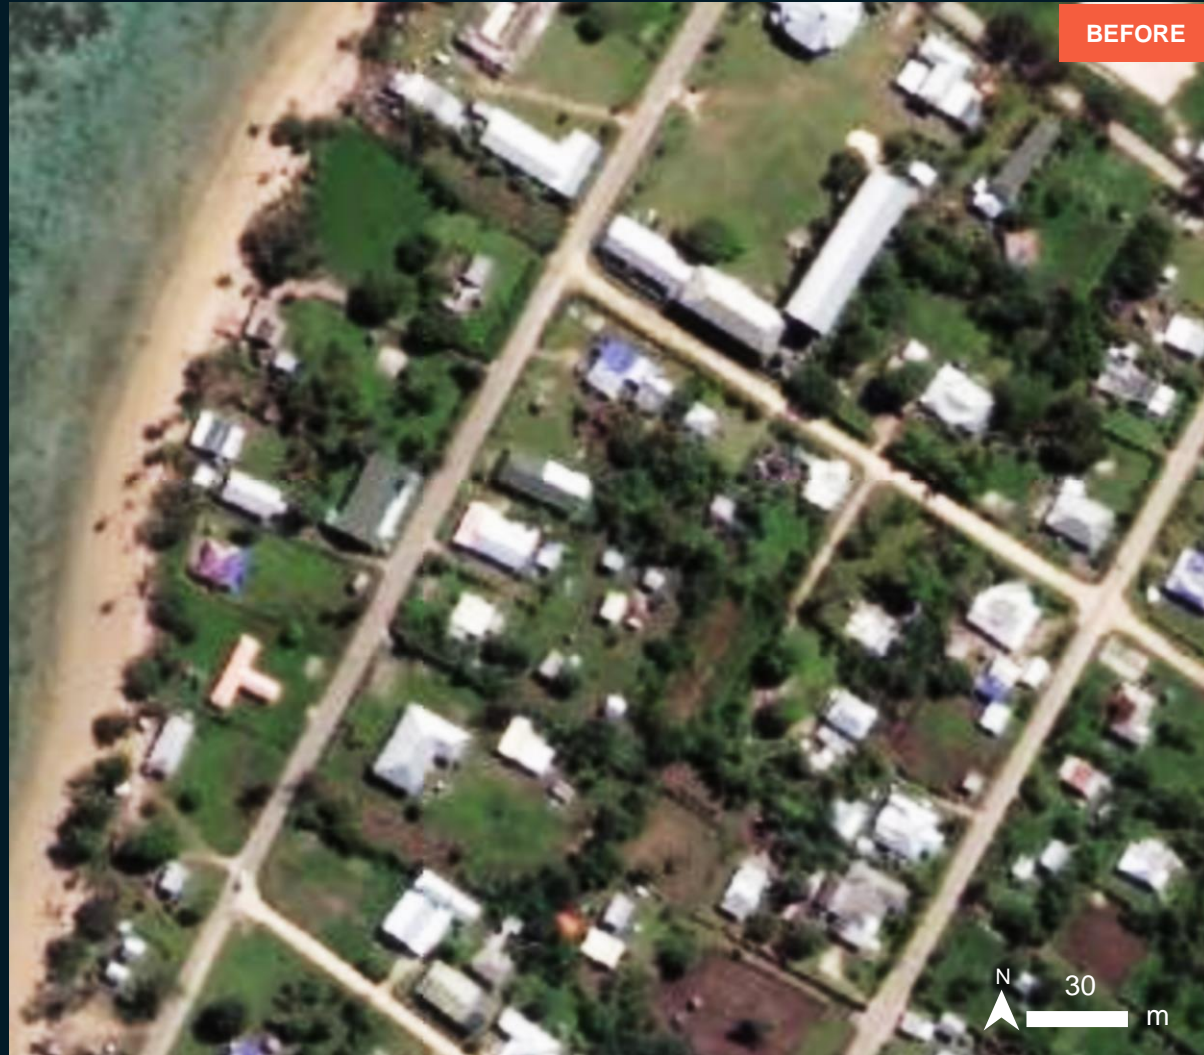
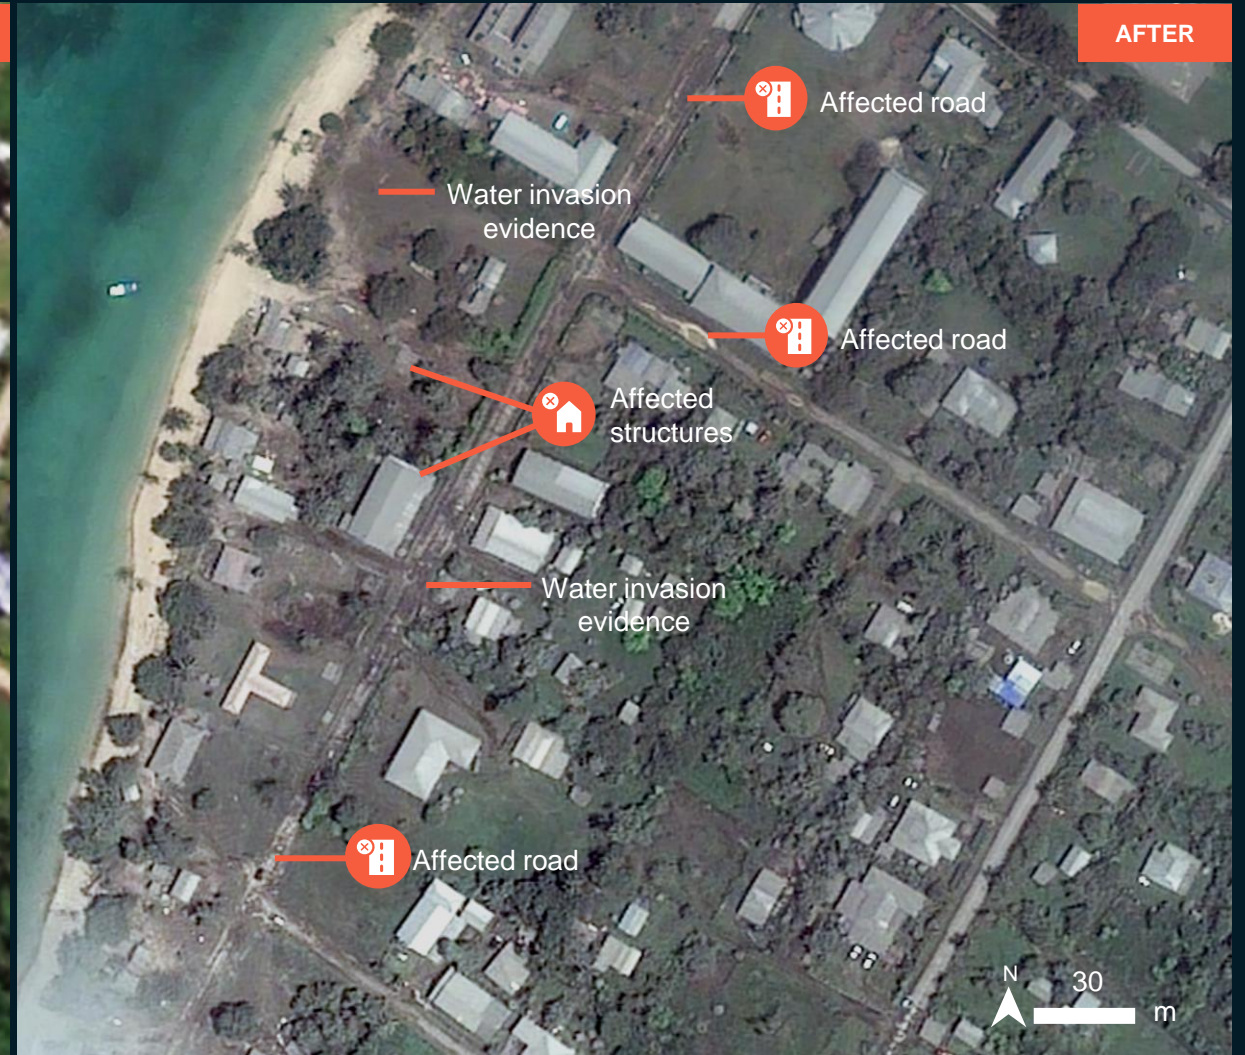
# AOI 3-1, LIFUKA VILLAGE, PANGAI DISTRICT, HA'APAI DIVISION

## Water invasion evidence, affected road, and affected structures

- Ash deposits, water invasion evidence, affected structures and inundated road observed in Lifuka village & Pangai town, Pangai district, Ha'apai division as of 16 Jan. 2022;

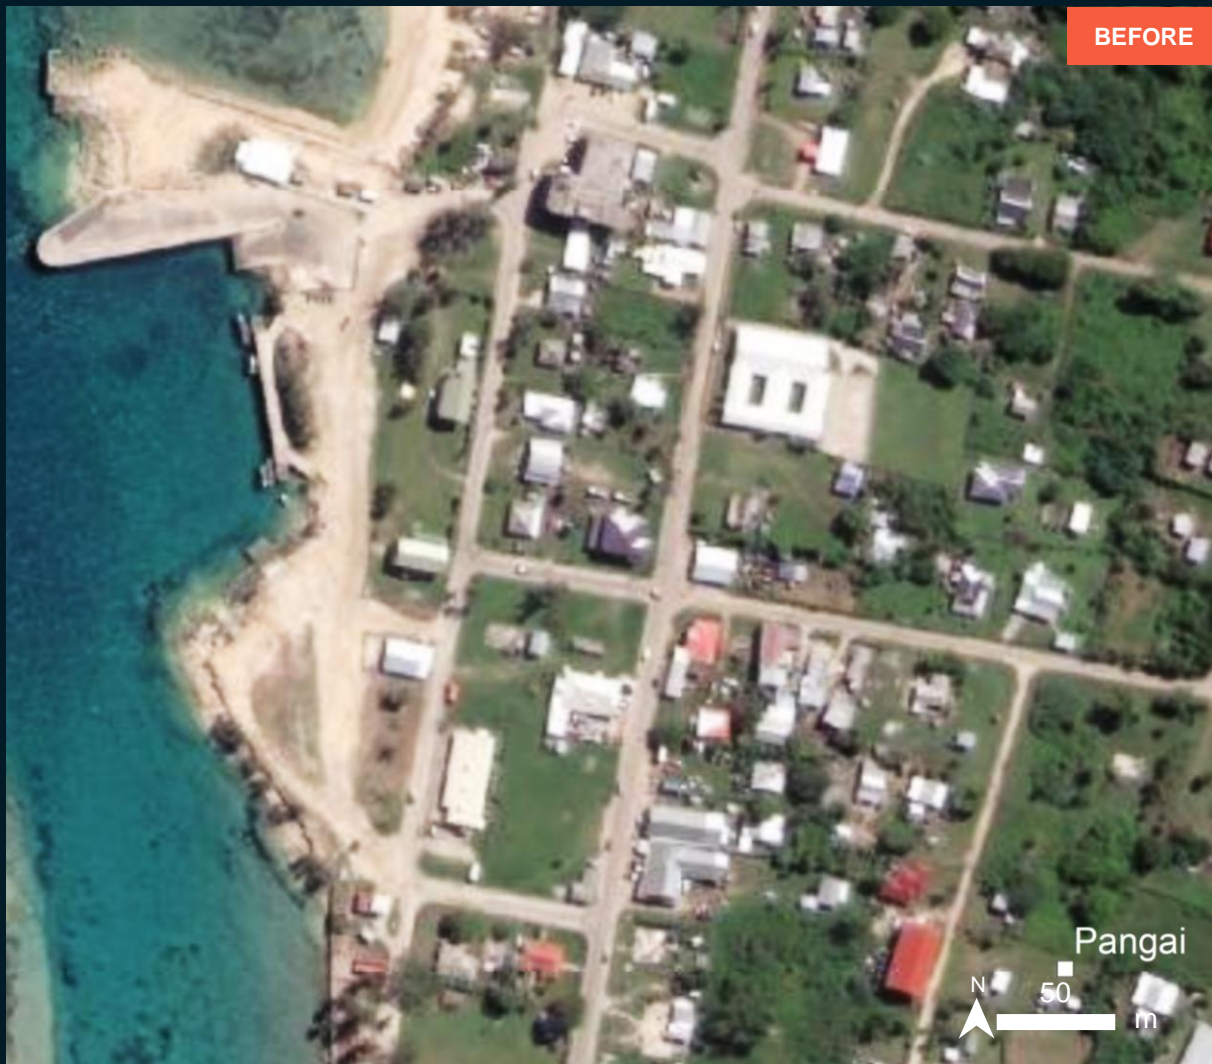
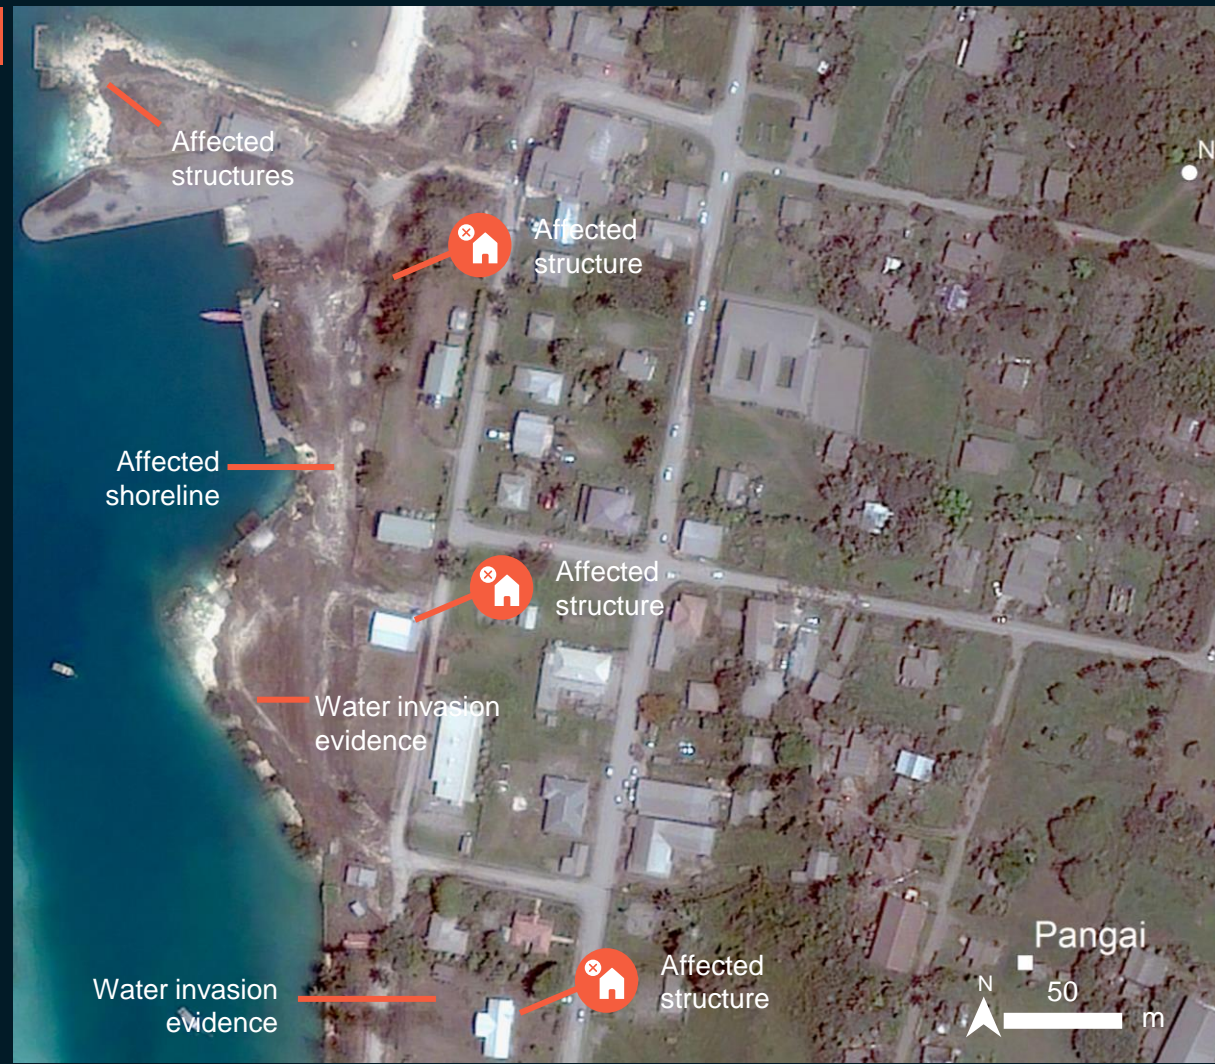
# AOI 3-2, PANGAI TOWN, PANGAI DISTRICT, HA'APAI DIVISION

## Water invasion evidence and affected structures

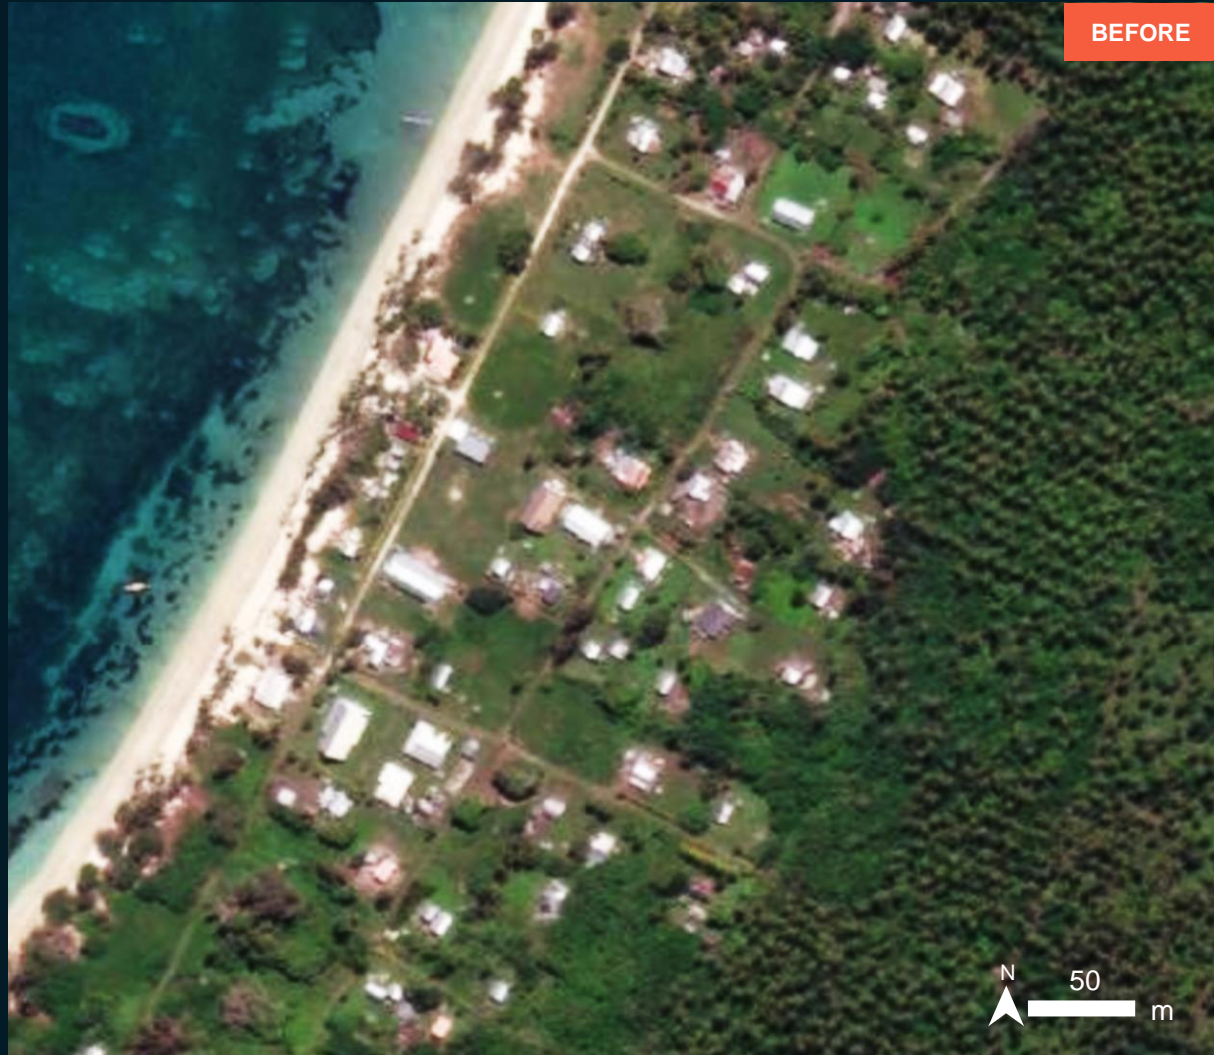
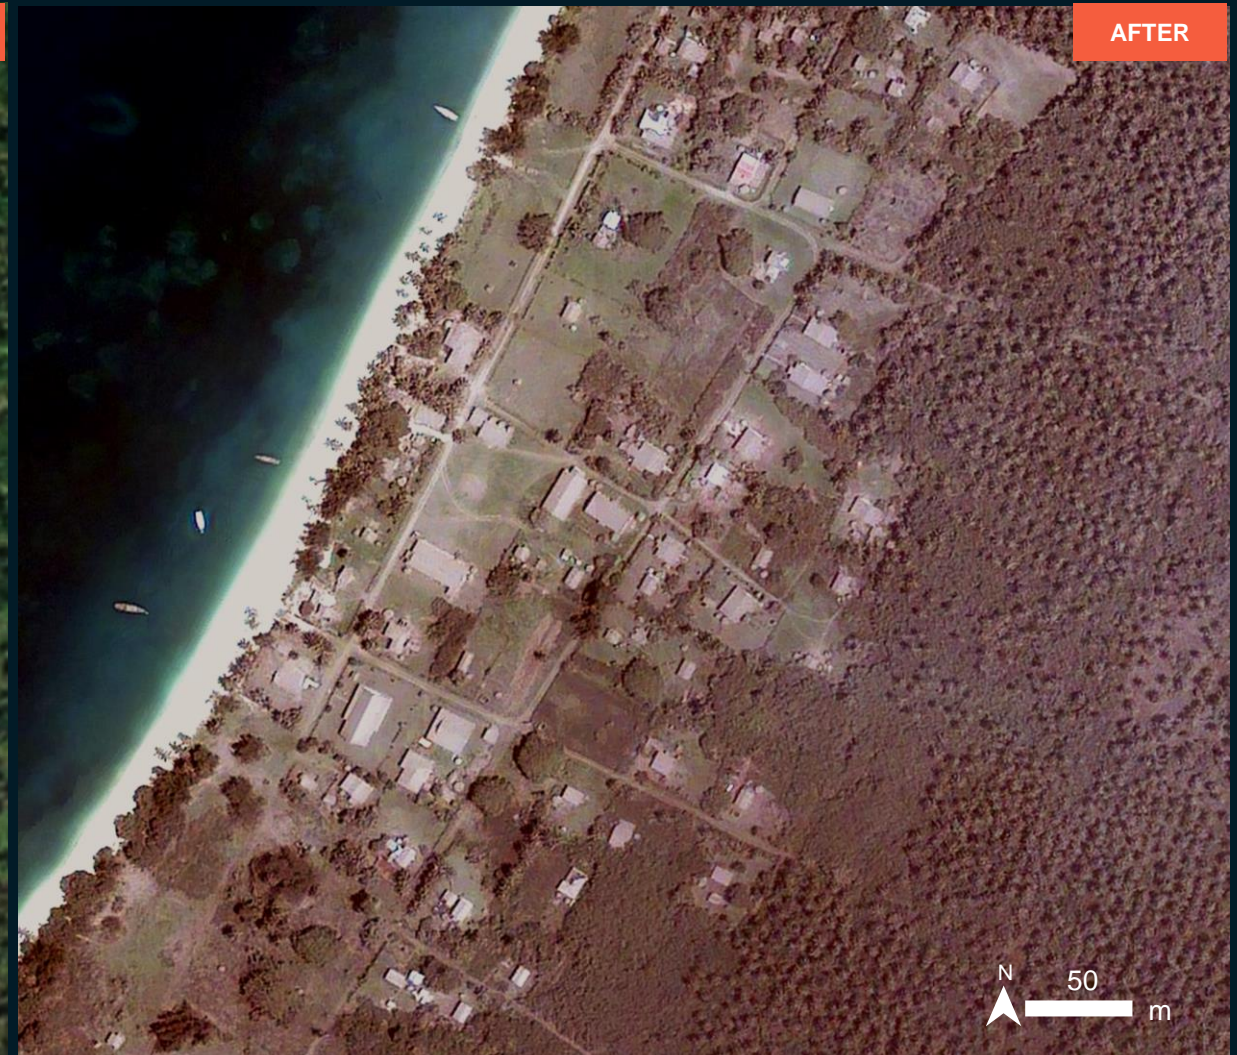
# AOI 4-1, FELEMEA VILLAGE, 'UIHA DISTRICT, HA'APAI DIVISION

No visible damage

- Ash deposits observed in Uha Island as of 16 Jan. 2022;
- Water invasion evidence, affected roads and affected structures observed in 'Uha village, 'Uha district, Ha'apai division as of 16 Jan 2022;
- No visible damage observed in Felemea Village, 'Uiha district, Ha'apai division observed as of 16 Jan 2022;
