# **Volcanic Eruption of the 15th of January 2022 and induced tsunami, Hunga Tonga-hunga Ha'apai Volcano**

## **Preliminary Satellite-Derived Damage Assessment**

Kingdom of Tonga

Status: Affected structures and affected facilities observed in all island after tsunami triggered by volcanic eruption

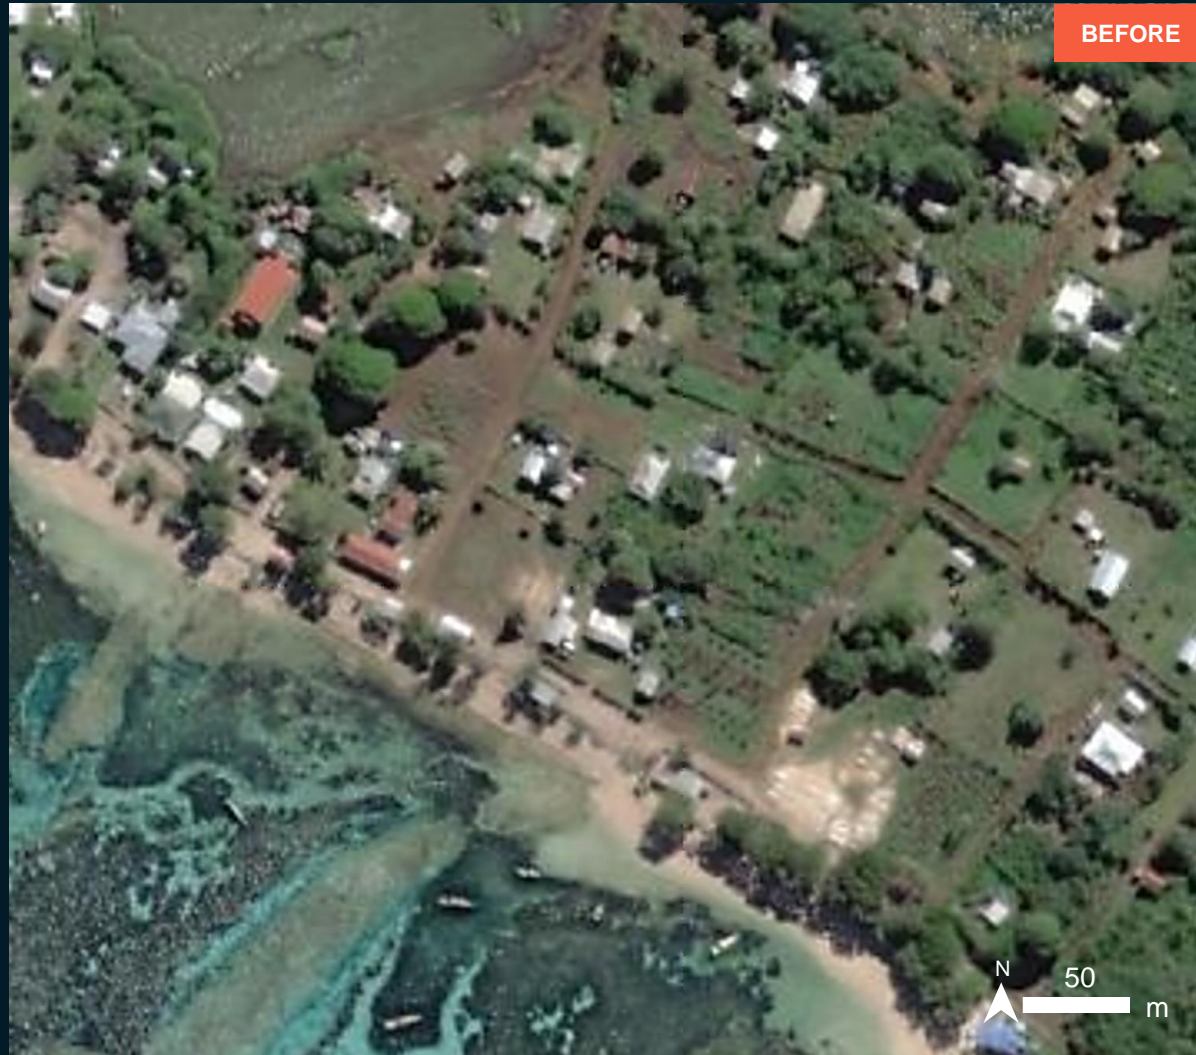
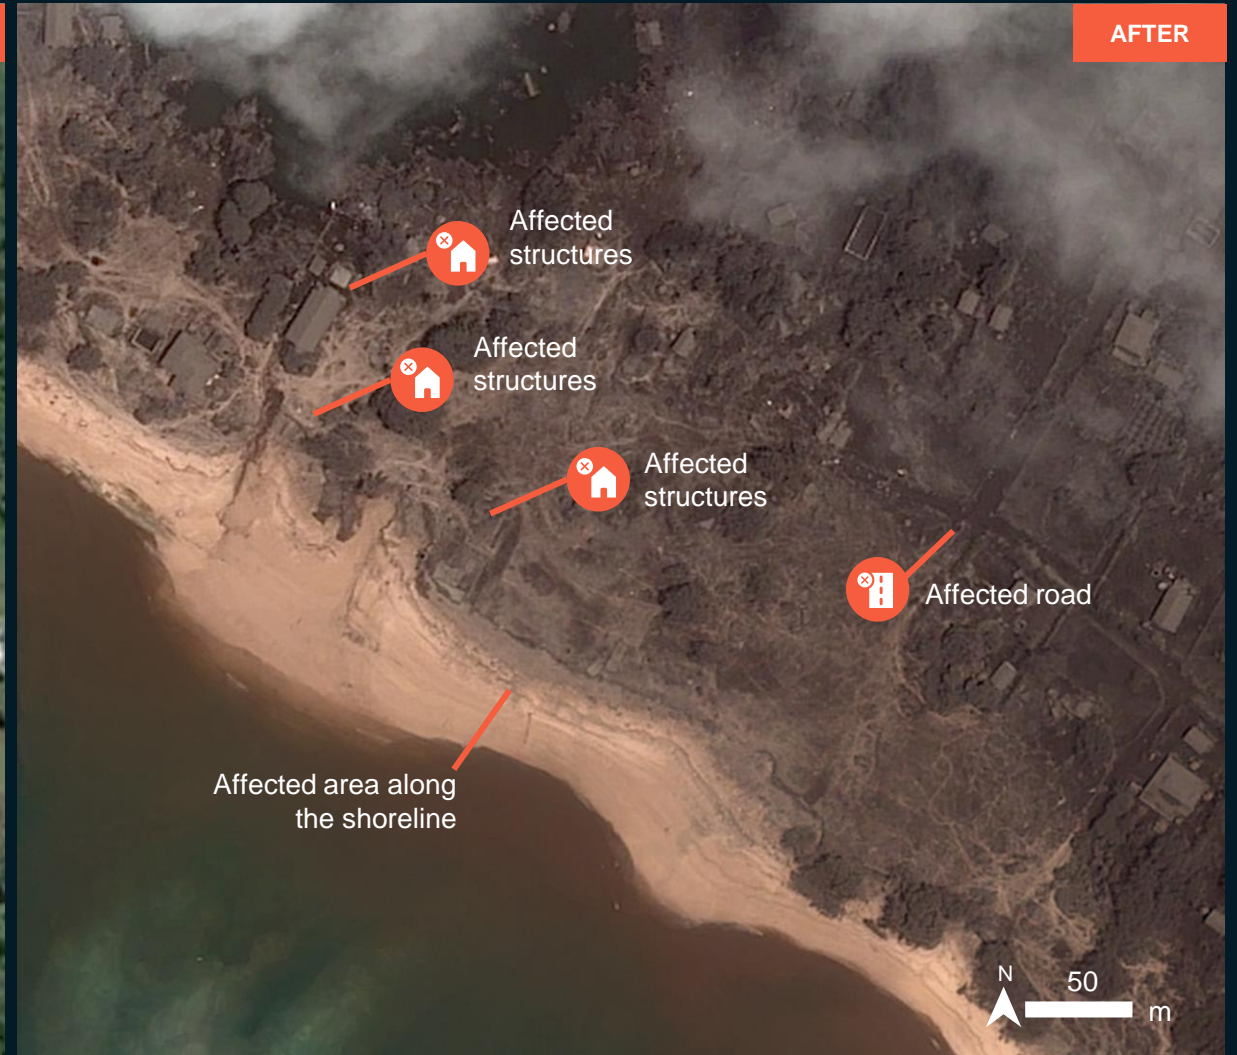
# AOI 5-1, NOMUKA VILLAGE, MU'OMU'A DISTRICT, HA'APAI DIVISION

## Affected shoreline, structures and road

- Ash deposits, observed along the shoreline, affected structures and affected road observed in Nomuka Village, Mu'omu'a District, Ha'apai Division as of 16 Jan 2022.
