6 February 2023 M 7.8 Marash/Antep (Kehramanmarash) Earthquake, Preliminary Satellite-Based Comprehensive Damage Assessment Report

Latakia, Aleppo, and Idleb Governorates
Syrian Arab Republic

16 March 2023

Prepared By
United Nations Satellite Centre (UNOSAT)

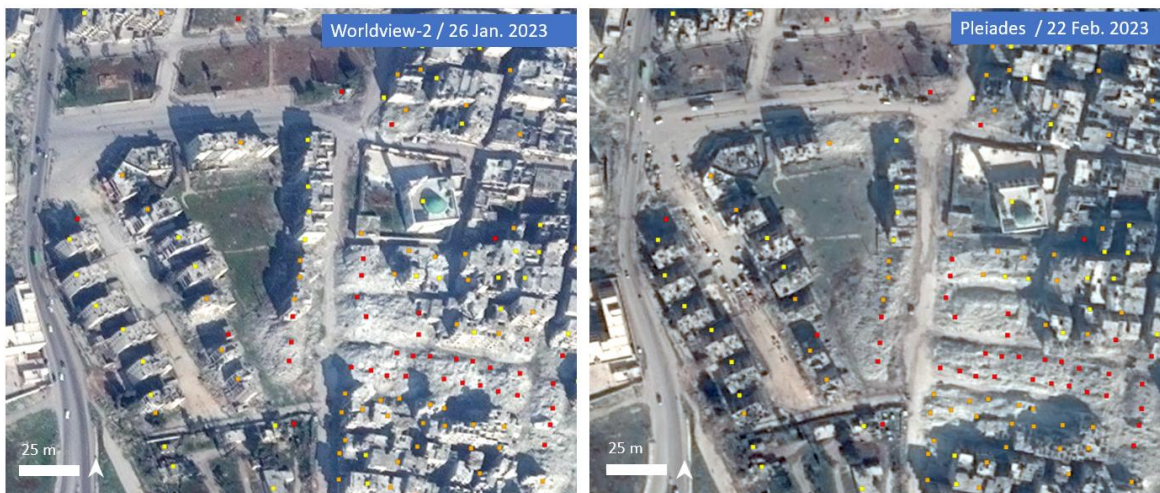
Figure 12. This image shows inset 1 with destroyed, damaged and potentially damaged buildings in southwestern part of the city Aleppo before and after the earthquake of 6th of February 2023. The pre imagery from the Worldview-2 satellite acquired on the 26th of January 2023, and the Pleiades satellite acquired on the 22nd of February 2023 visualise that damage was already existent prior to the earthquake.

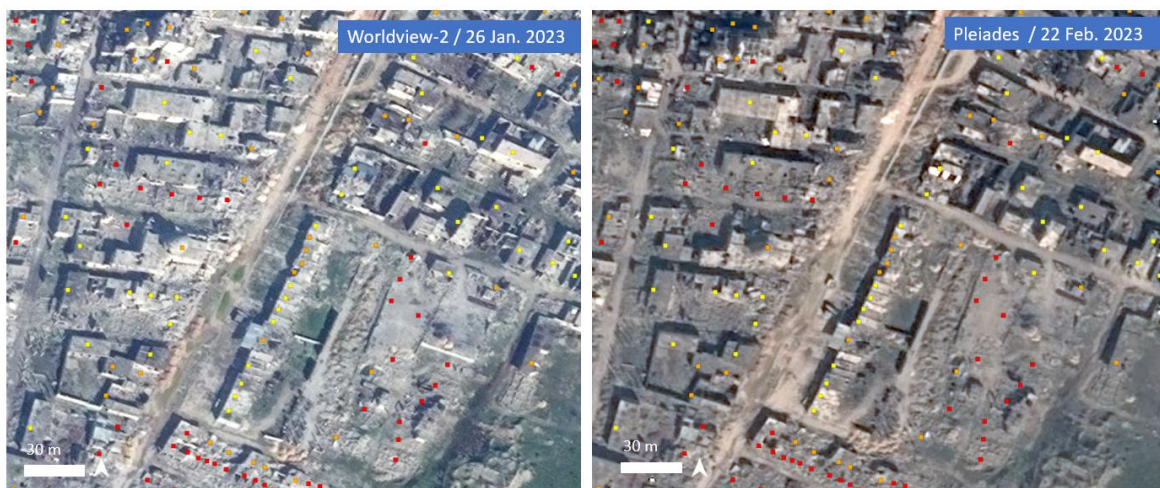
Figure 13. This image shows inset 2 with destroyed, damaged and potentially damaged buildings in southwestern part of the city Aleppo before and after the earthquake of 6th of February 2023. The pre imagery from the Worldview-2 satellite acquired on the 26th of January 2023, and the Pleiades satellite acquired on the 22nd of February 2023 visualise that damage was already existent prior to the earthquake

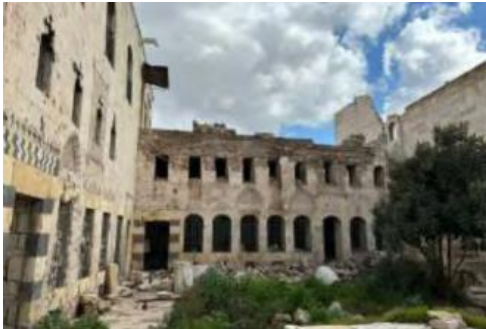
Figure 15. This field photo illustrates damaged building over the cultural site Bayt Ghazale by the Syrian Directorate-General of Antiquities & Museums (DGAM)

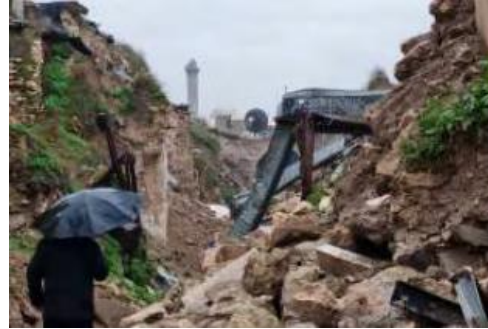
Figure 16. This field photo illustrates damaged building in area between Suq al-Attarin and Suq al-Ebi, Ancient City of Aleppo by the Syrian Directorate-General of Antiquities & Museums (DGAM)

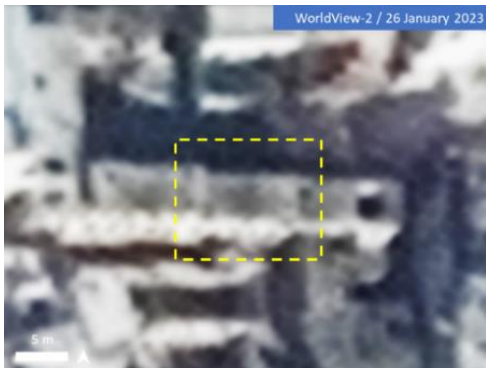
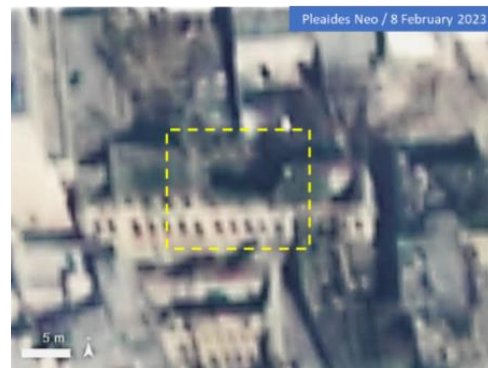
Figure 17. These images illustrate severe damage in cultural site Bayt Ghazale Ancient City of Aleppo

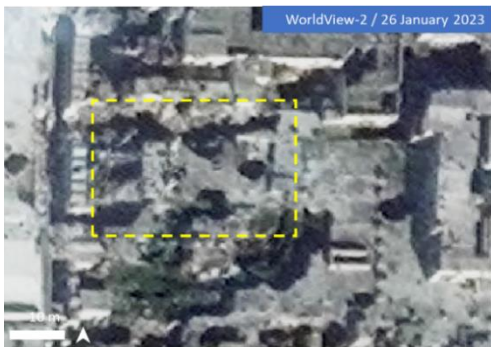
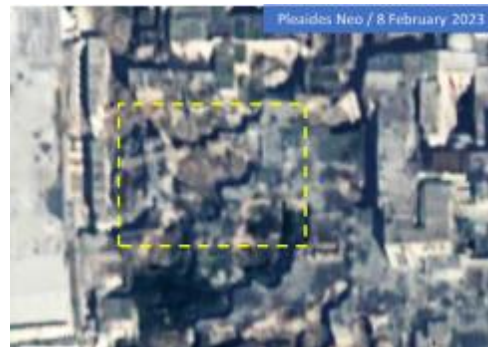
Figure 18. These images illustrate severe Bayt Ghazale, Ancient City of Aleppo

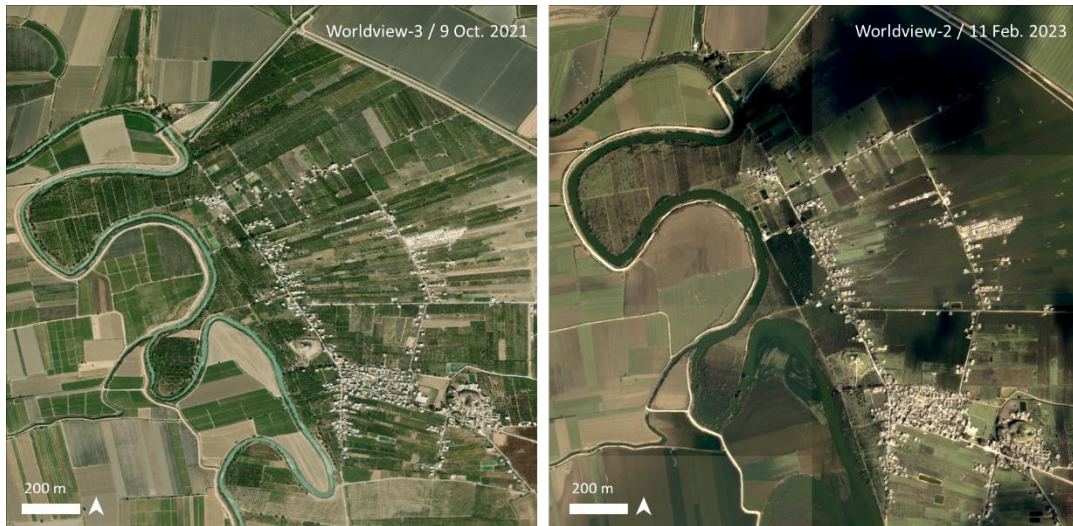
Figure 23. The Orontes River before and after floods. The pre-image is acquired by Worldview-3 on the 9th of October 2021, while the post image is acquired by Worldview-2 on the 11th of February 2023. The post image shows extensive floods and the affected village Al Tlouf.

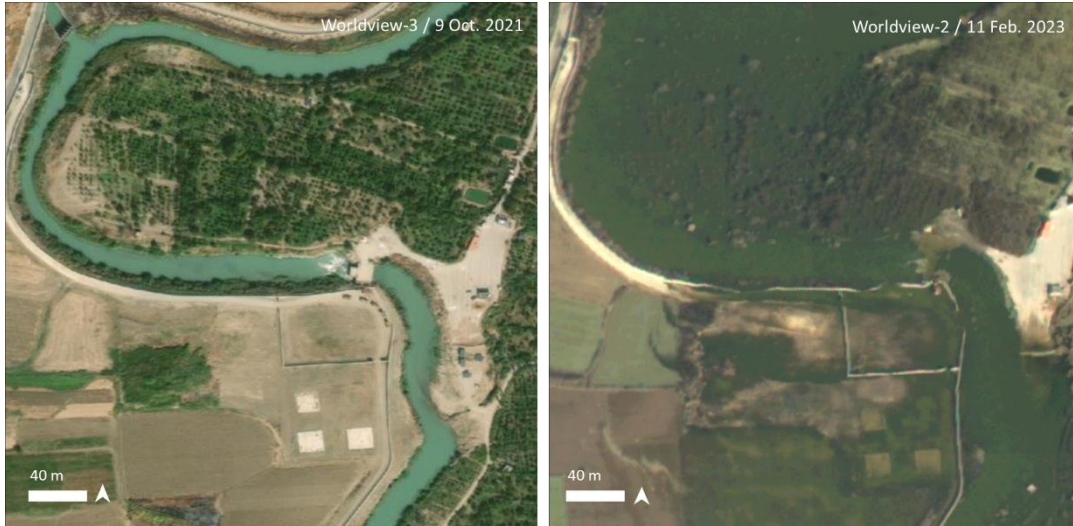
Figure 24. The Orontes River before and after floods. The pre image is acquired by Worldview-3 on the 9th of October 2021, while the post image is acquired by Worldview-2 on the 11th of February 2023. The post image shows damage on water infrastructure.

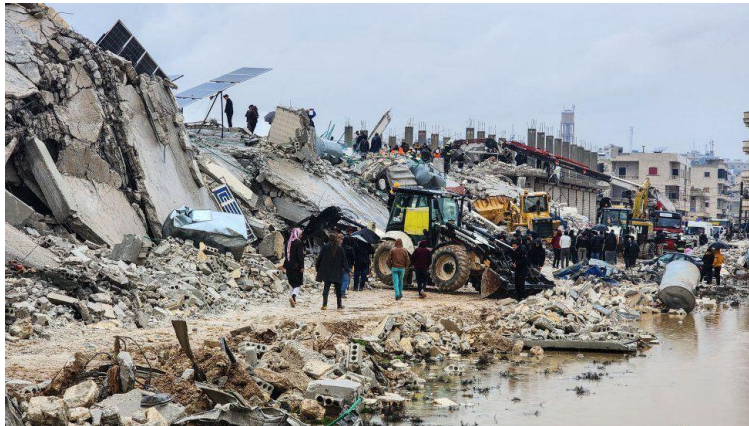
Figure 28. Collapsed building in Idleb region triggered by the M 7.8 Marash/Antep (Kehramanmarash) Earthquake as of 6 February 2023.

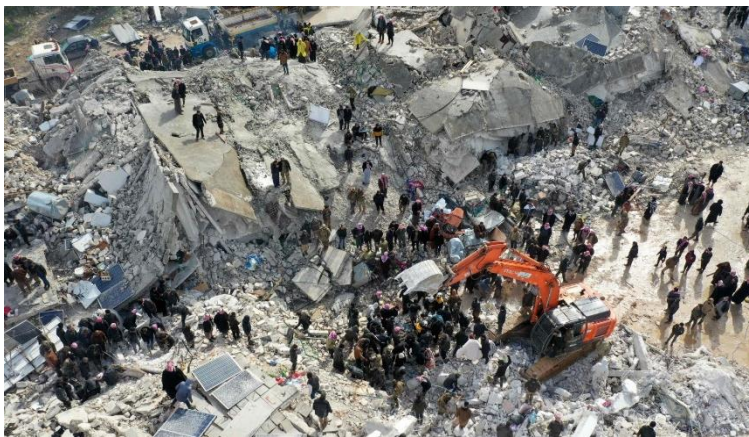
Figure 29. Collapsed building and rescue team searching for victims in the village of Besnia near the town of Harim, Idleb Governorate, Syria

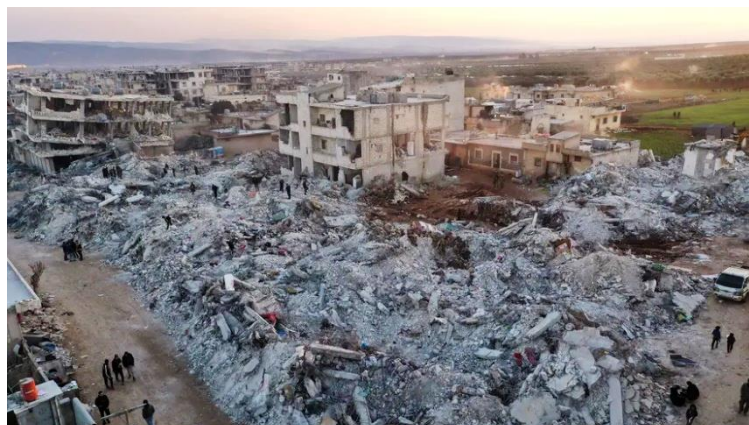
Figure 30. Completely collapsed buildings in the town of Jindires, Syria

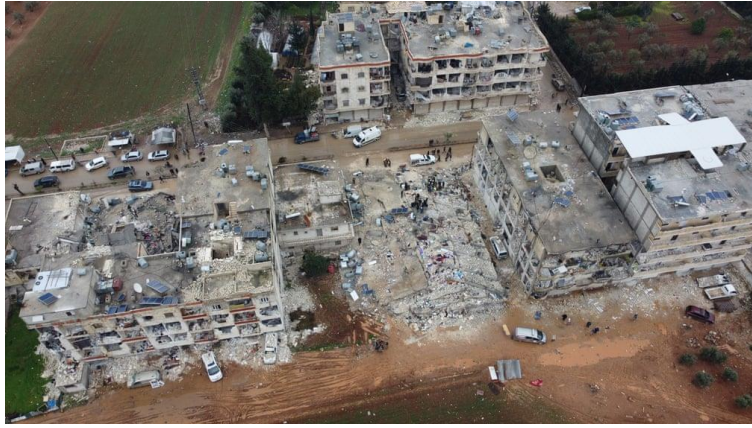
Figure 31. Collapsed building in in the Cenderes district of Aleppo, Syria.
Credit photo: Anadolu Agency/Getty Images

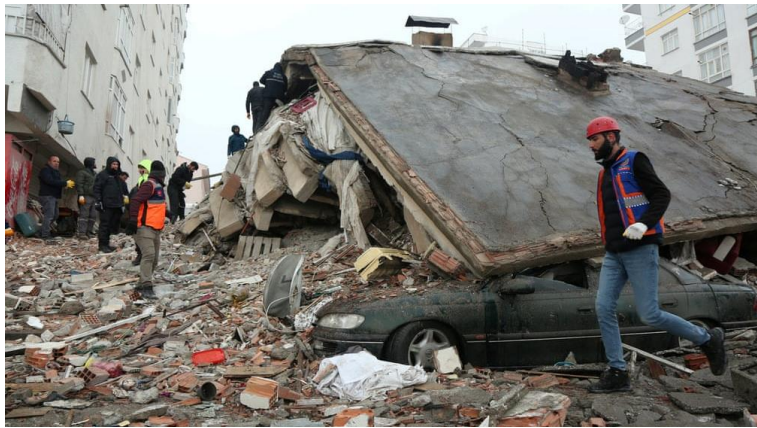
Figure 32. Collapsed structures, and rescue team searching for survivors in Diyarbakir city in Türkiye.
Credit photo: Sertaç Kayar/Reuters

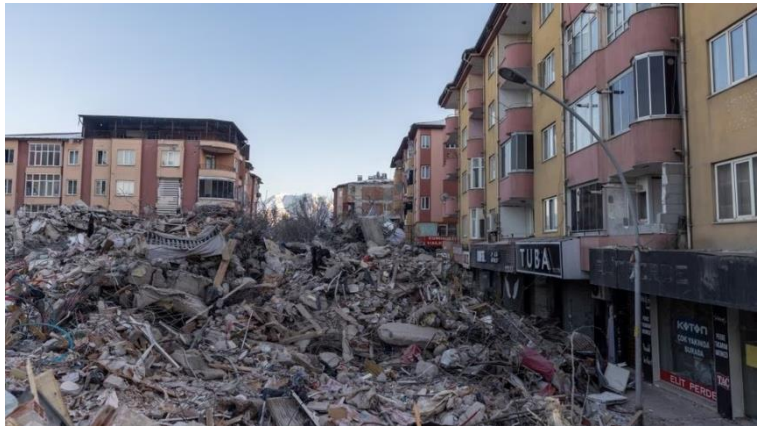
Figure 33. Collapsed structures in Elbistan, Türkiye.
Credit photo: REUTERS/Maxim Shemeto
