# PRELIMINARY SATELLITE-DERIVED FLOOD ASSESSMENT

Sava & Sofia Regions, Madagascar

Status: Flooded agricultural areas and potentially affected structures observed

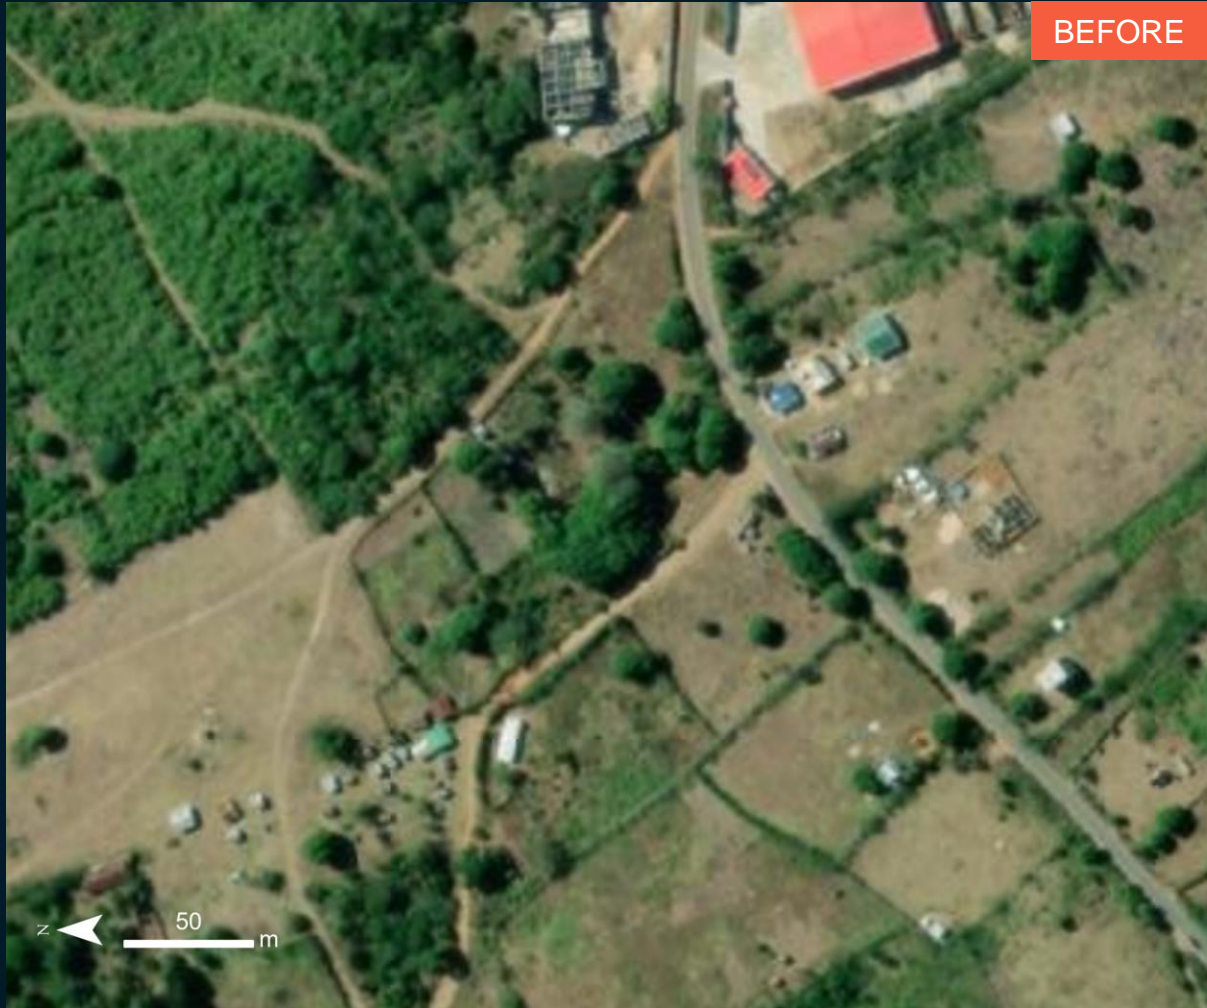
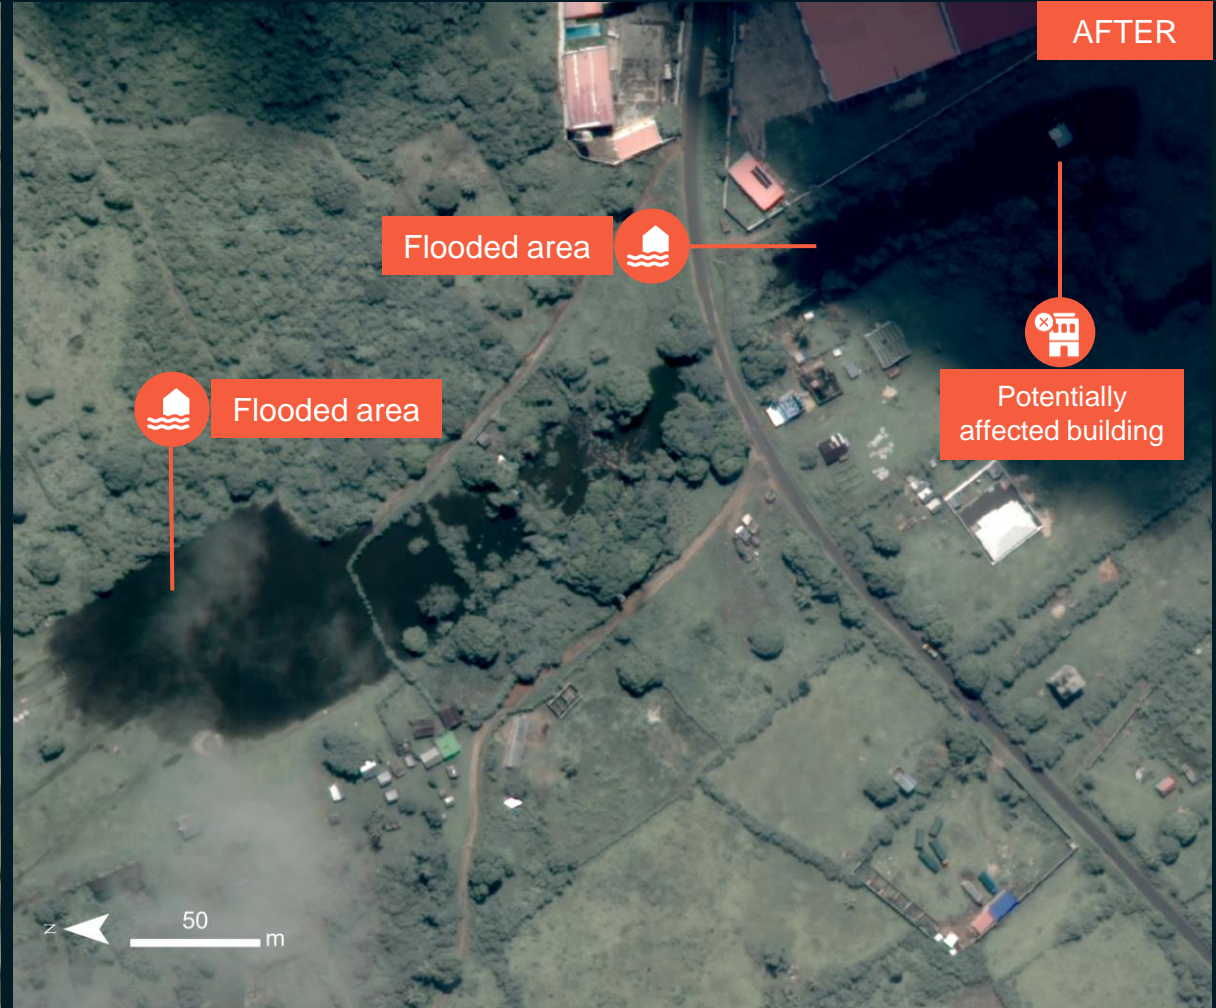
# AOI 1-1: Vohemar Commune, Vohemar District, Sava Region

Flooded areas and potentially affected structures observed

WorldView-3 / 10 June 2021

WorldView-3 / 31 March 2024

Further action(s): continue monitoring

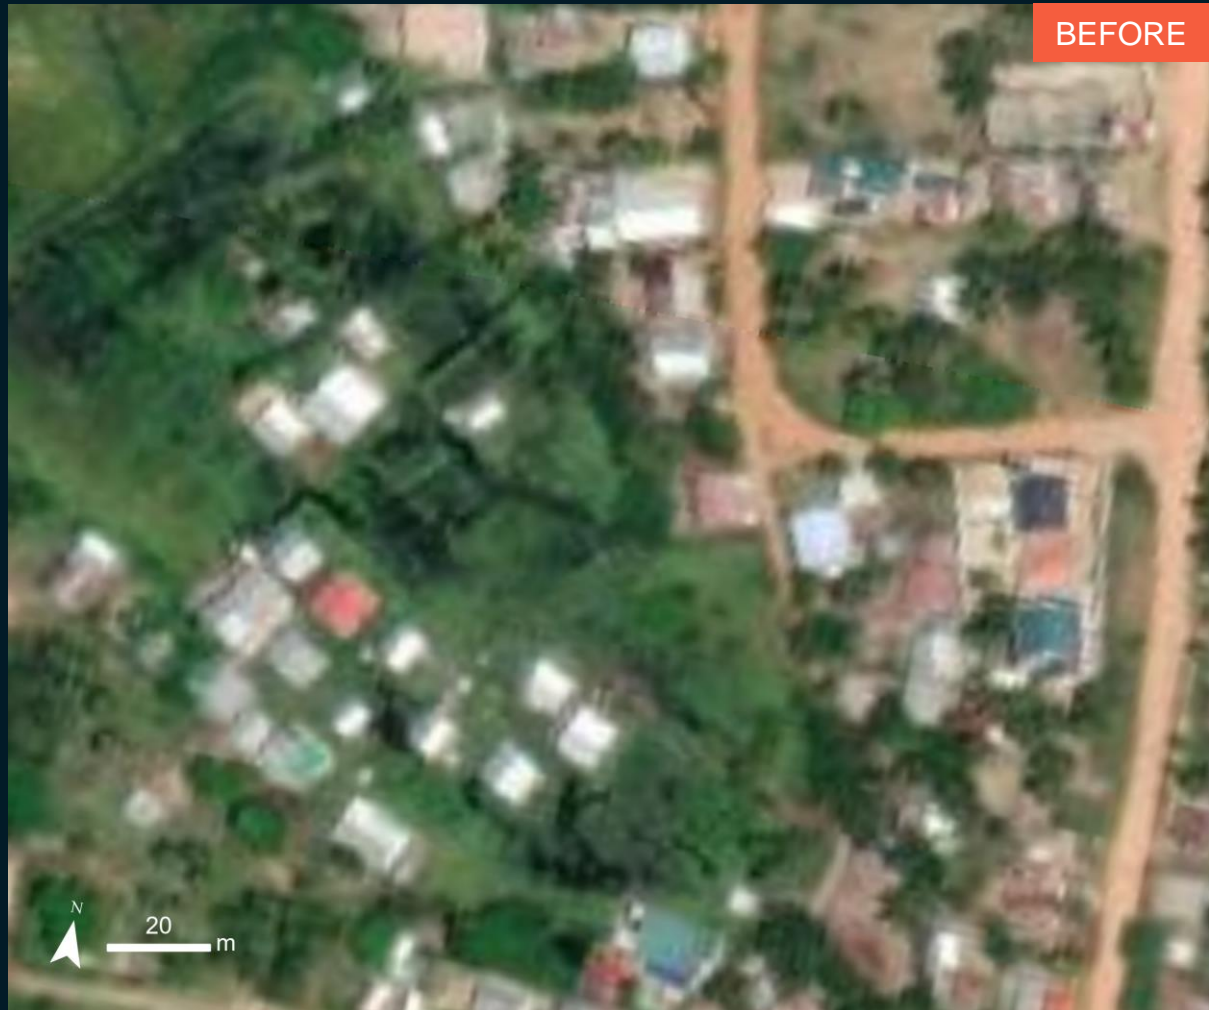
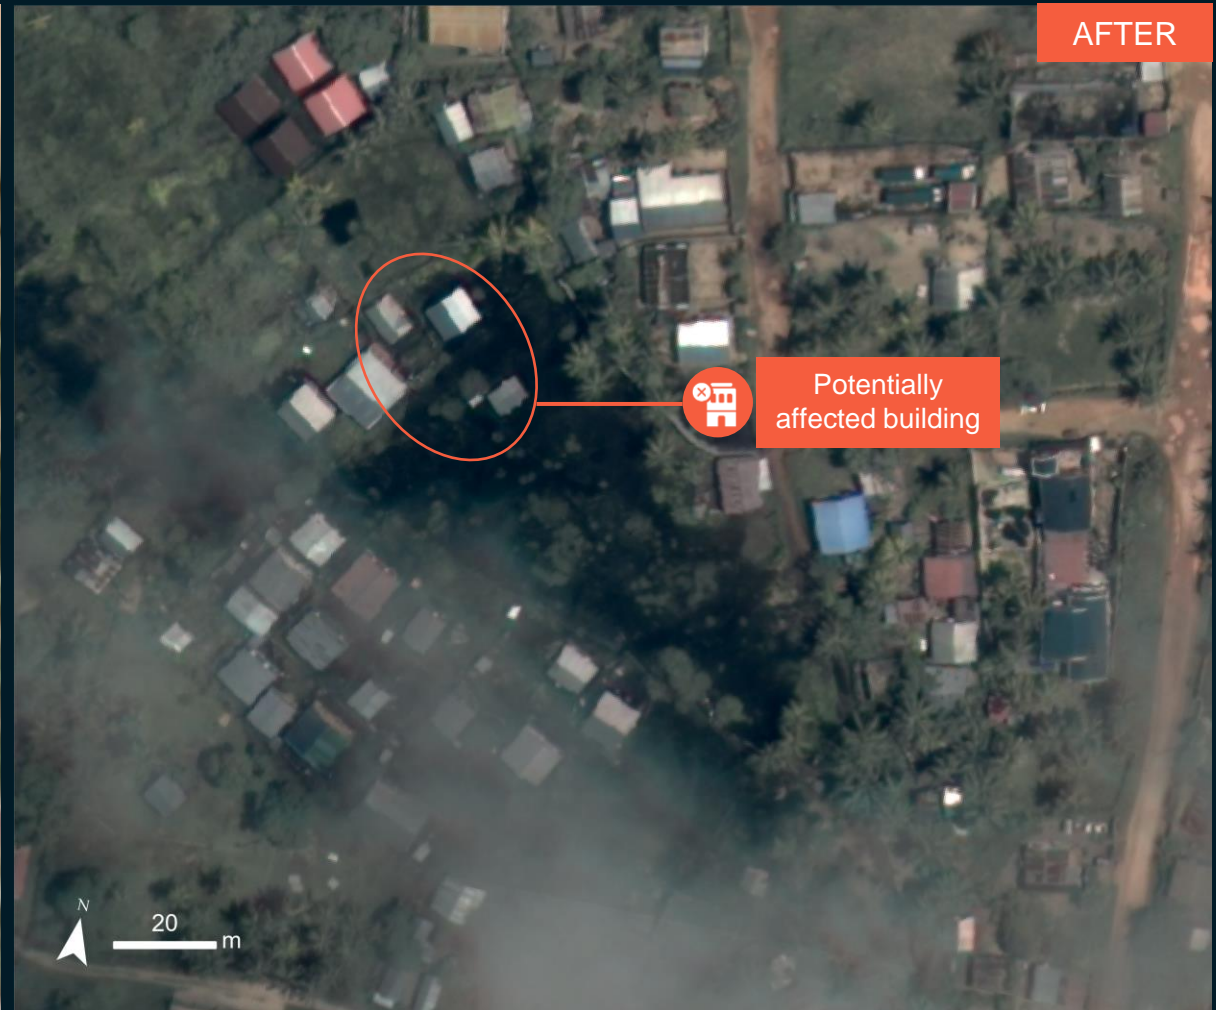
# AOI 1-2: Vohemar Commune, Vohemar District, Sava Region

Potentially affected structures

Potentially affected building

WorldView-3 / 31 January 2023

WorldView-3 / 31 March 2024

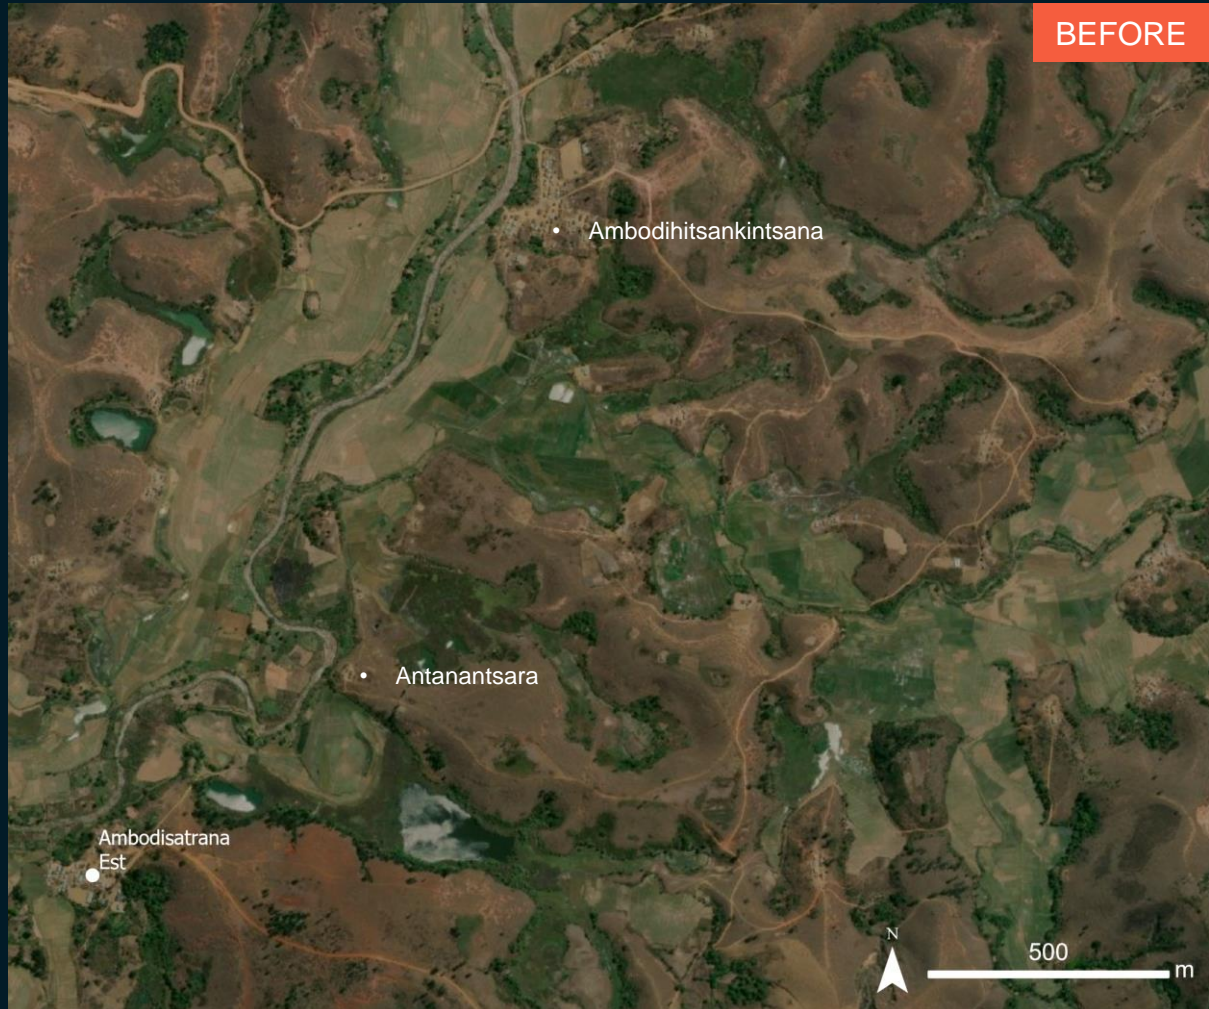
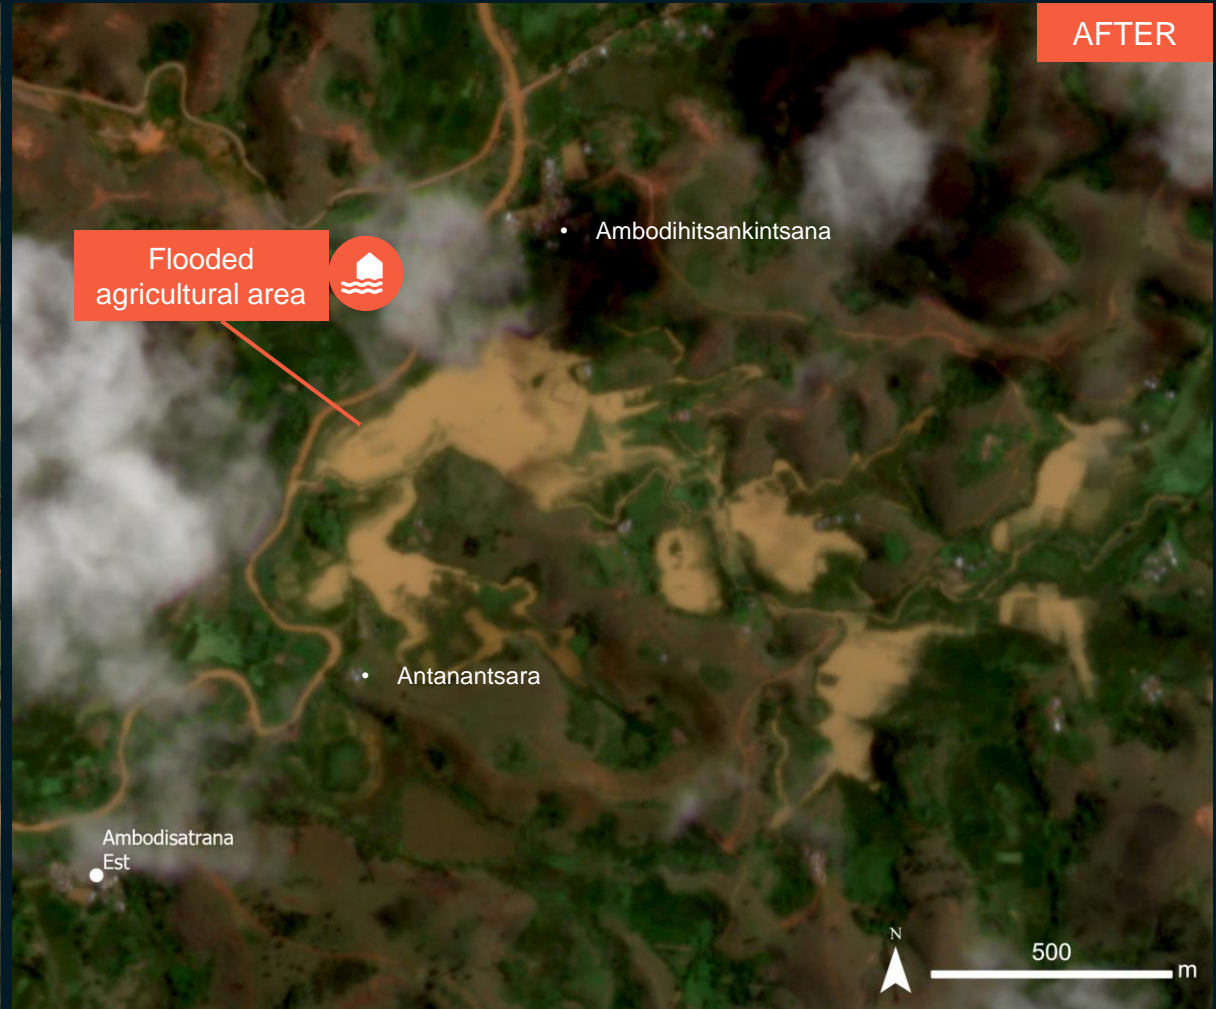
# AOI 2-1: Bealanana Commune, Bealanana District, Sofia Region

Flooded area observed

GeoEye-1 / 12 September 2019

PlanetScope / 01 April 2024

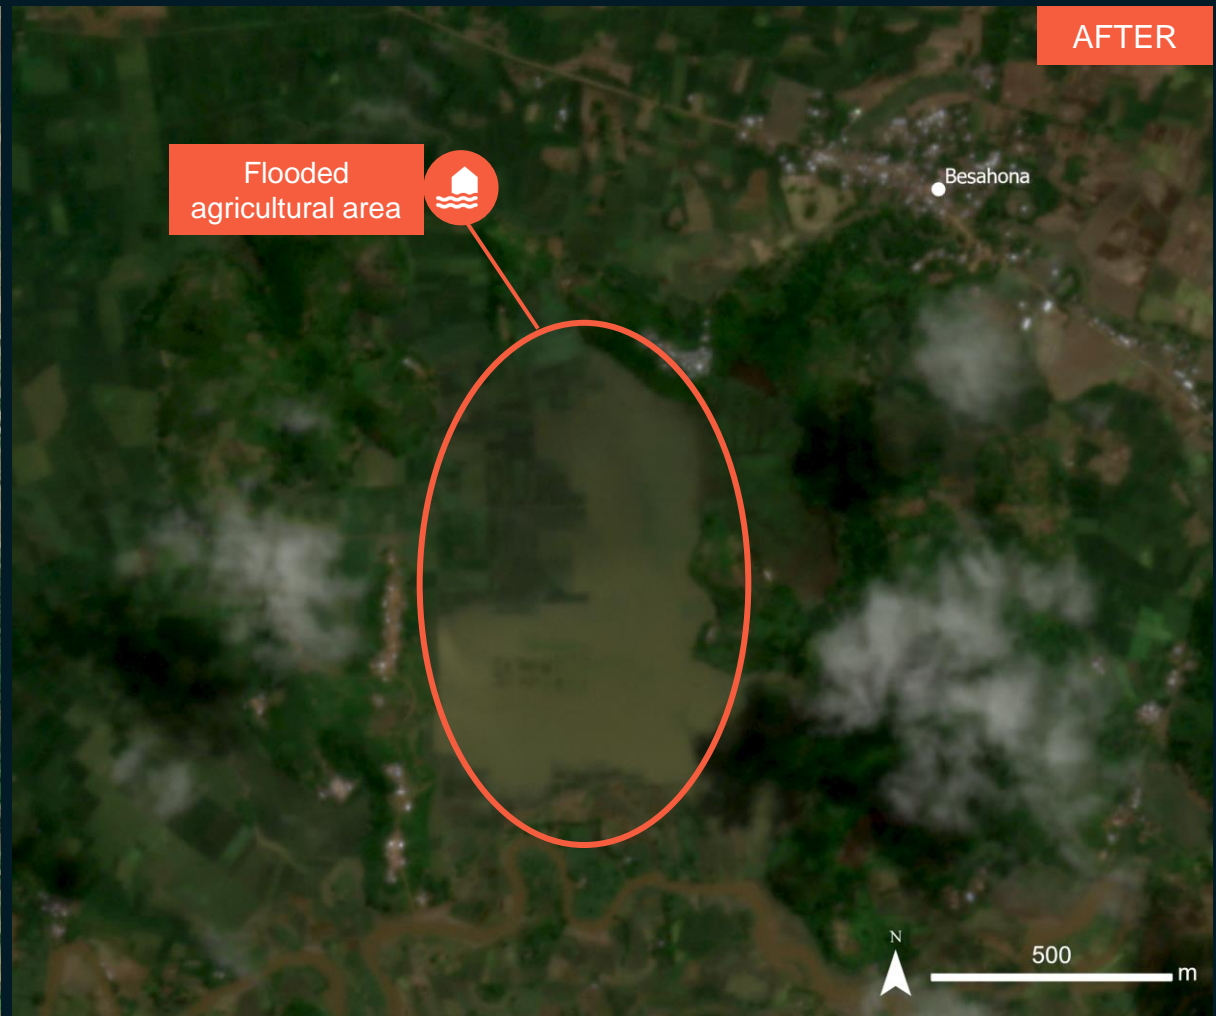
# AOI 3-1: Matsohely & Andranomena Commune, Andapa District, Sava Region

Flooded agricultural area observed

WorldView-2 / 20 January 2023

PlanetScope / 31 March 2024

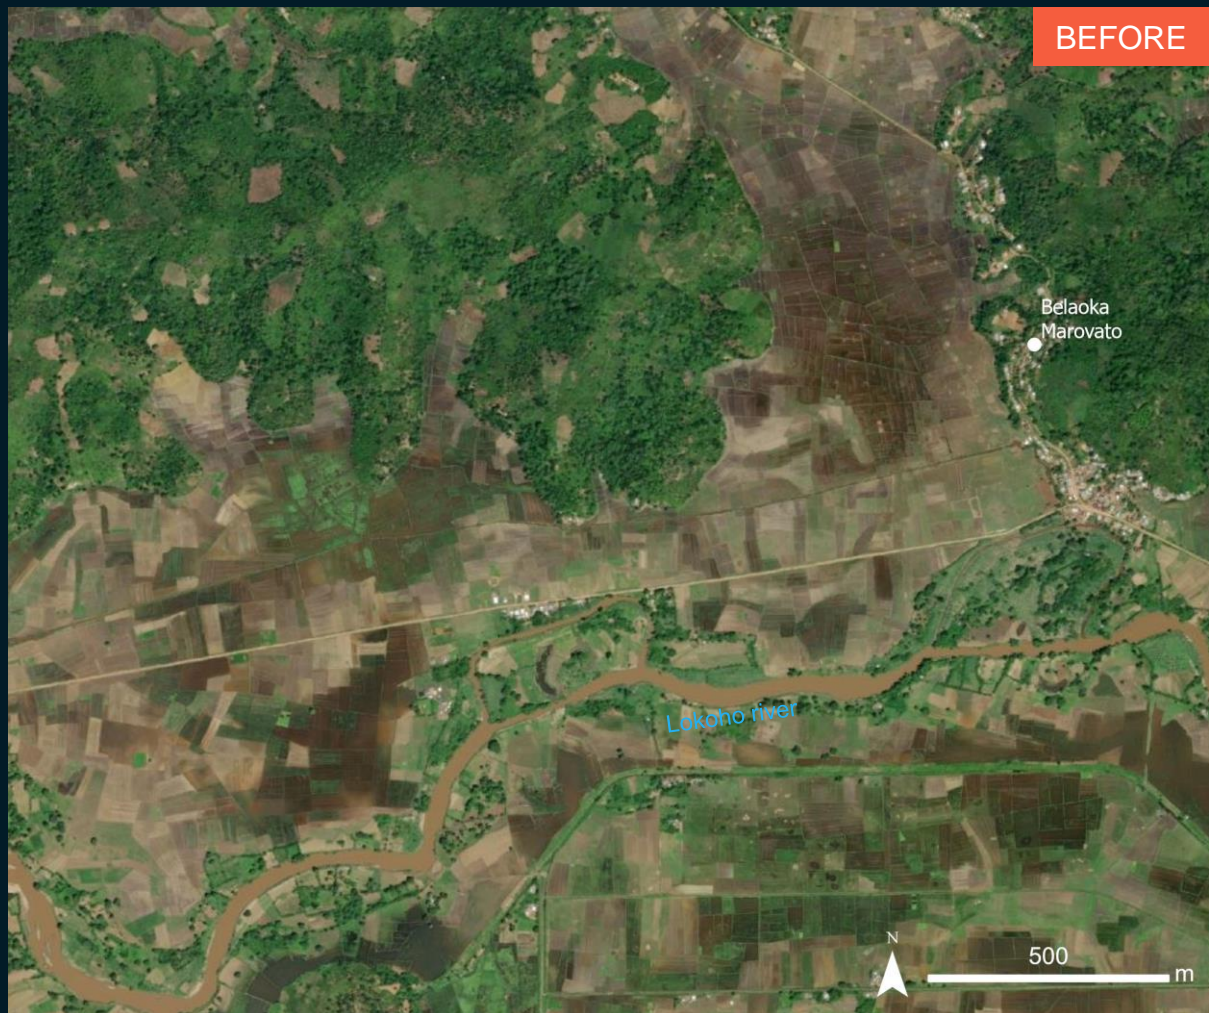
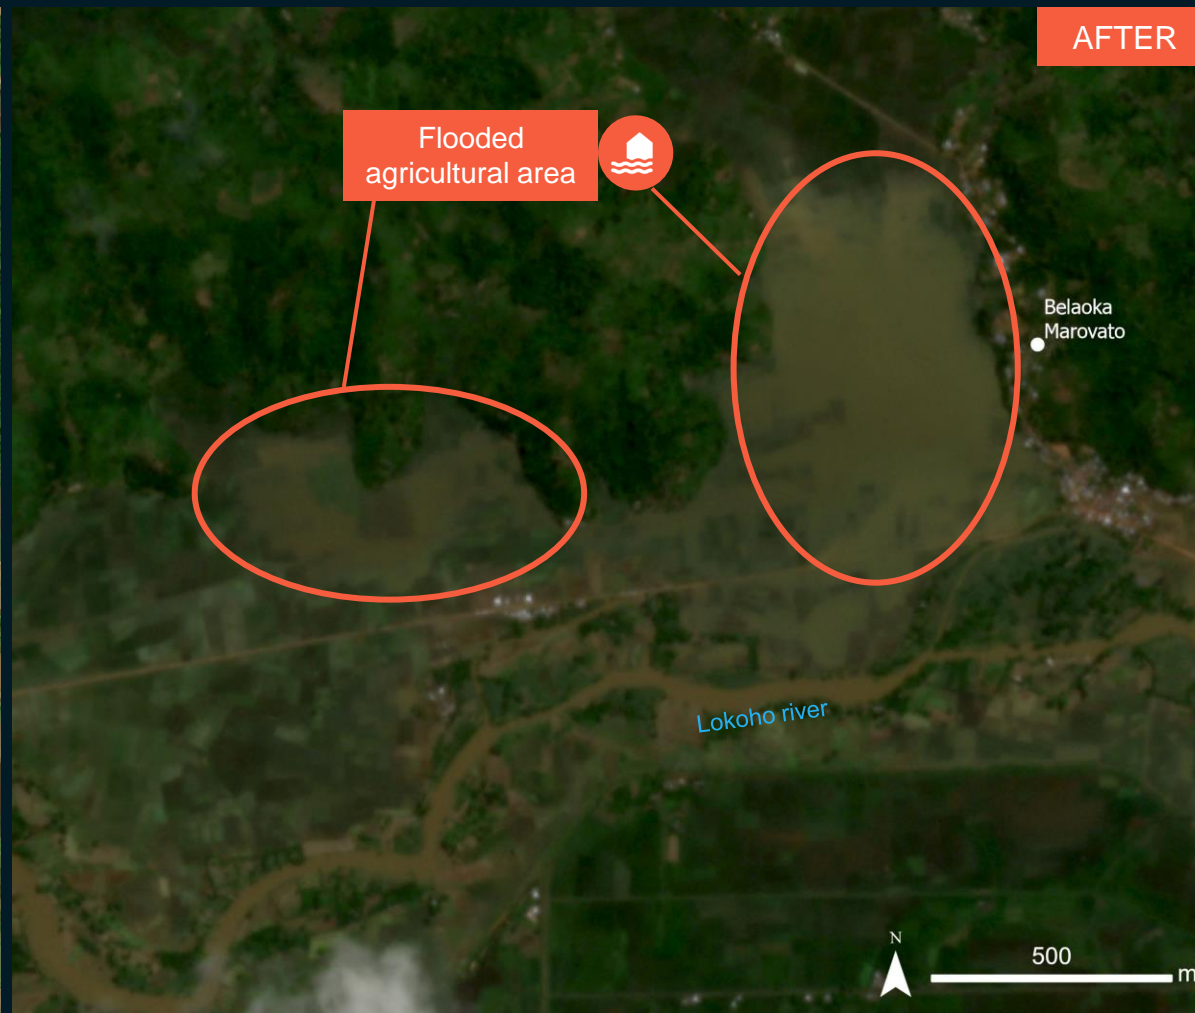
# AOI 3-2: Belaoka Marovato Commune, Andapa District, Sava Region

Flooded agricultural area observed

WorldView-2 / 20 January 2023

PlanetScope / 31 March 2024

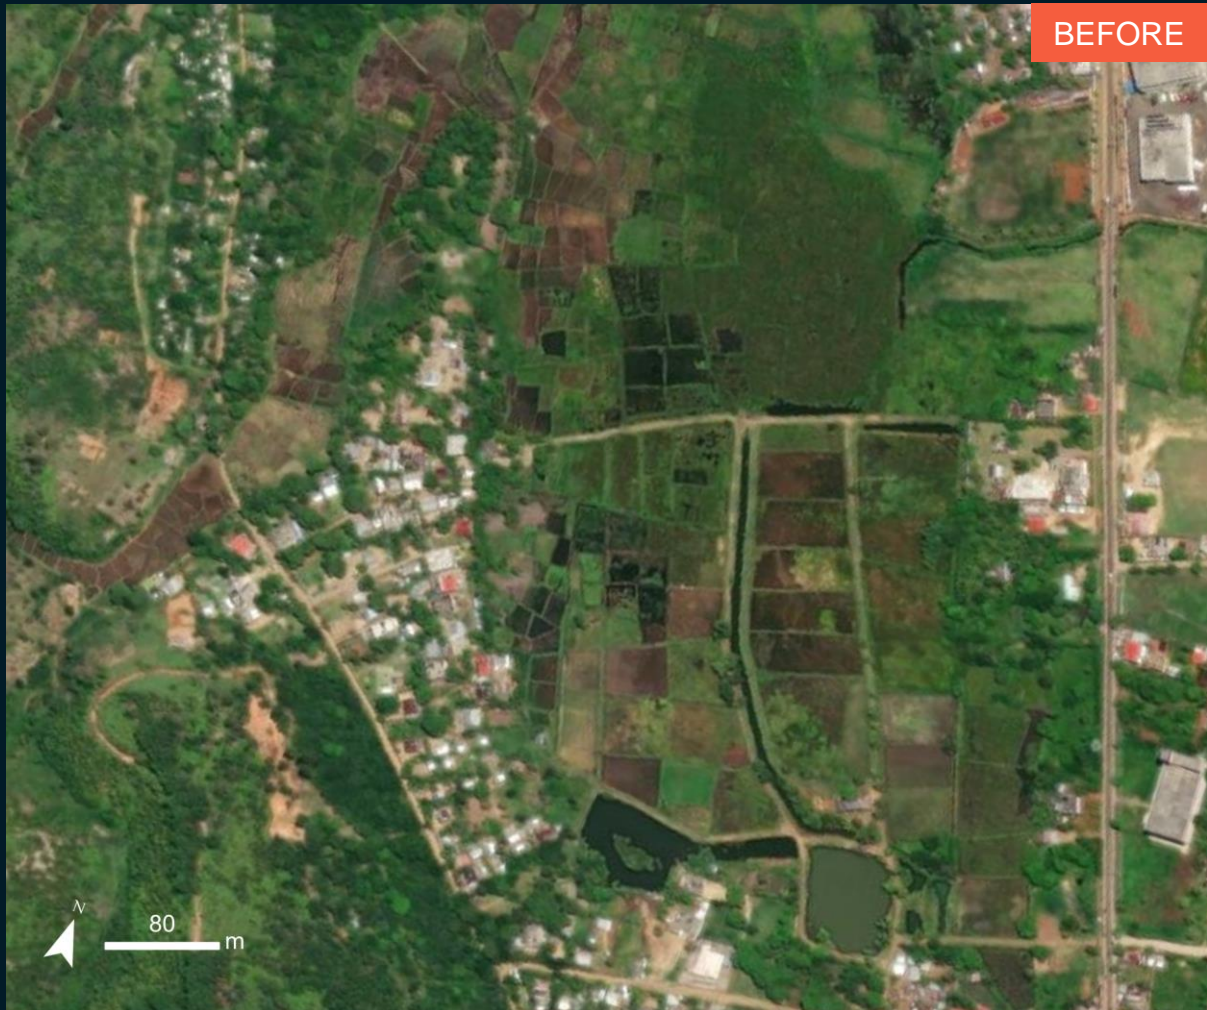
# AOI 4: Antalaha Town, Antalaha District, Sava Region

Flooded agricultural fields observed

WorldView-2 / 06 March 2023

WorldView-3 / 31 March 2024
