Flood Inundation Areas Surrounding Vijayawada, Andhra Pradesh

Based on the analysis of CAS500-1 Satellite Image on 12.09.2024

Charter Call 1036 AOI No.10

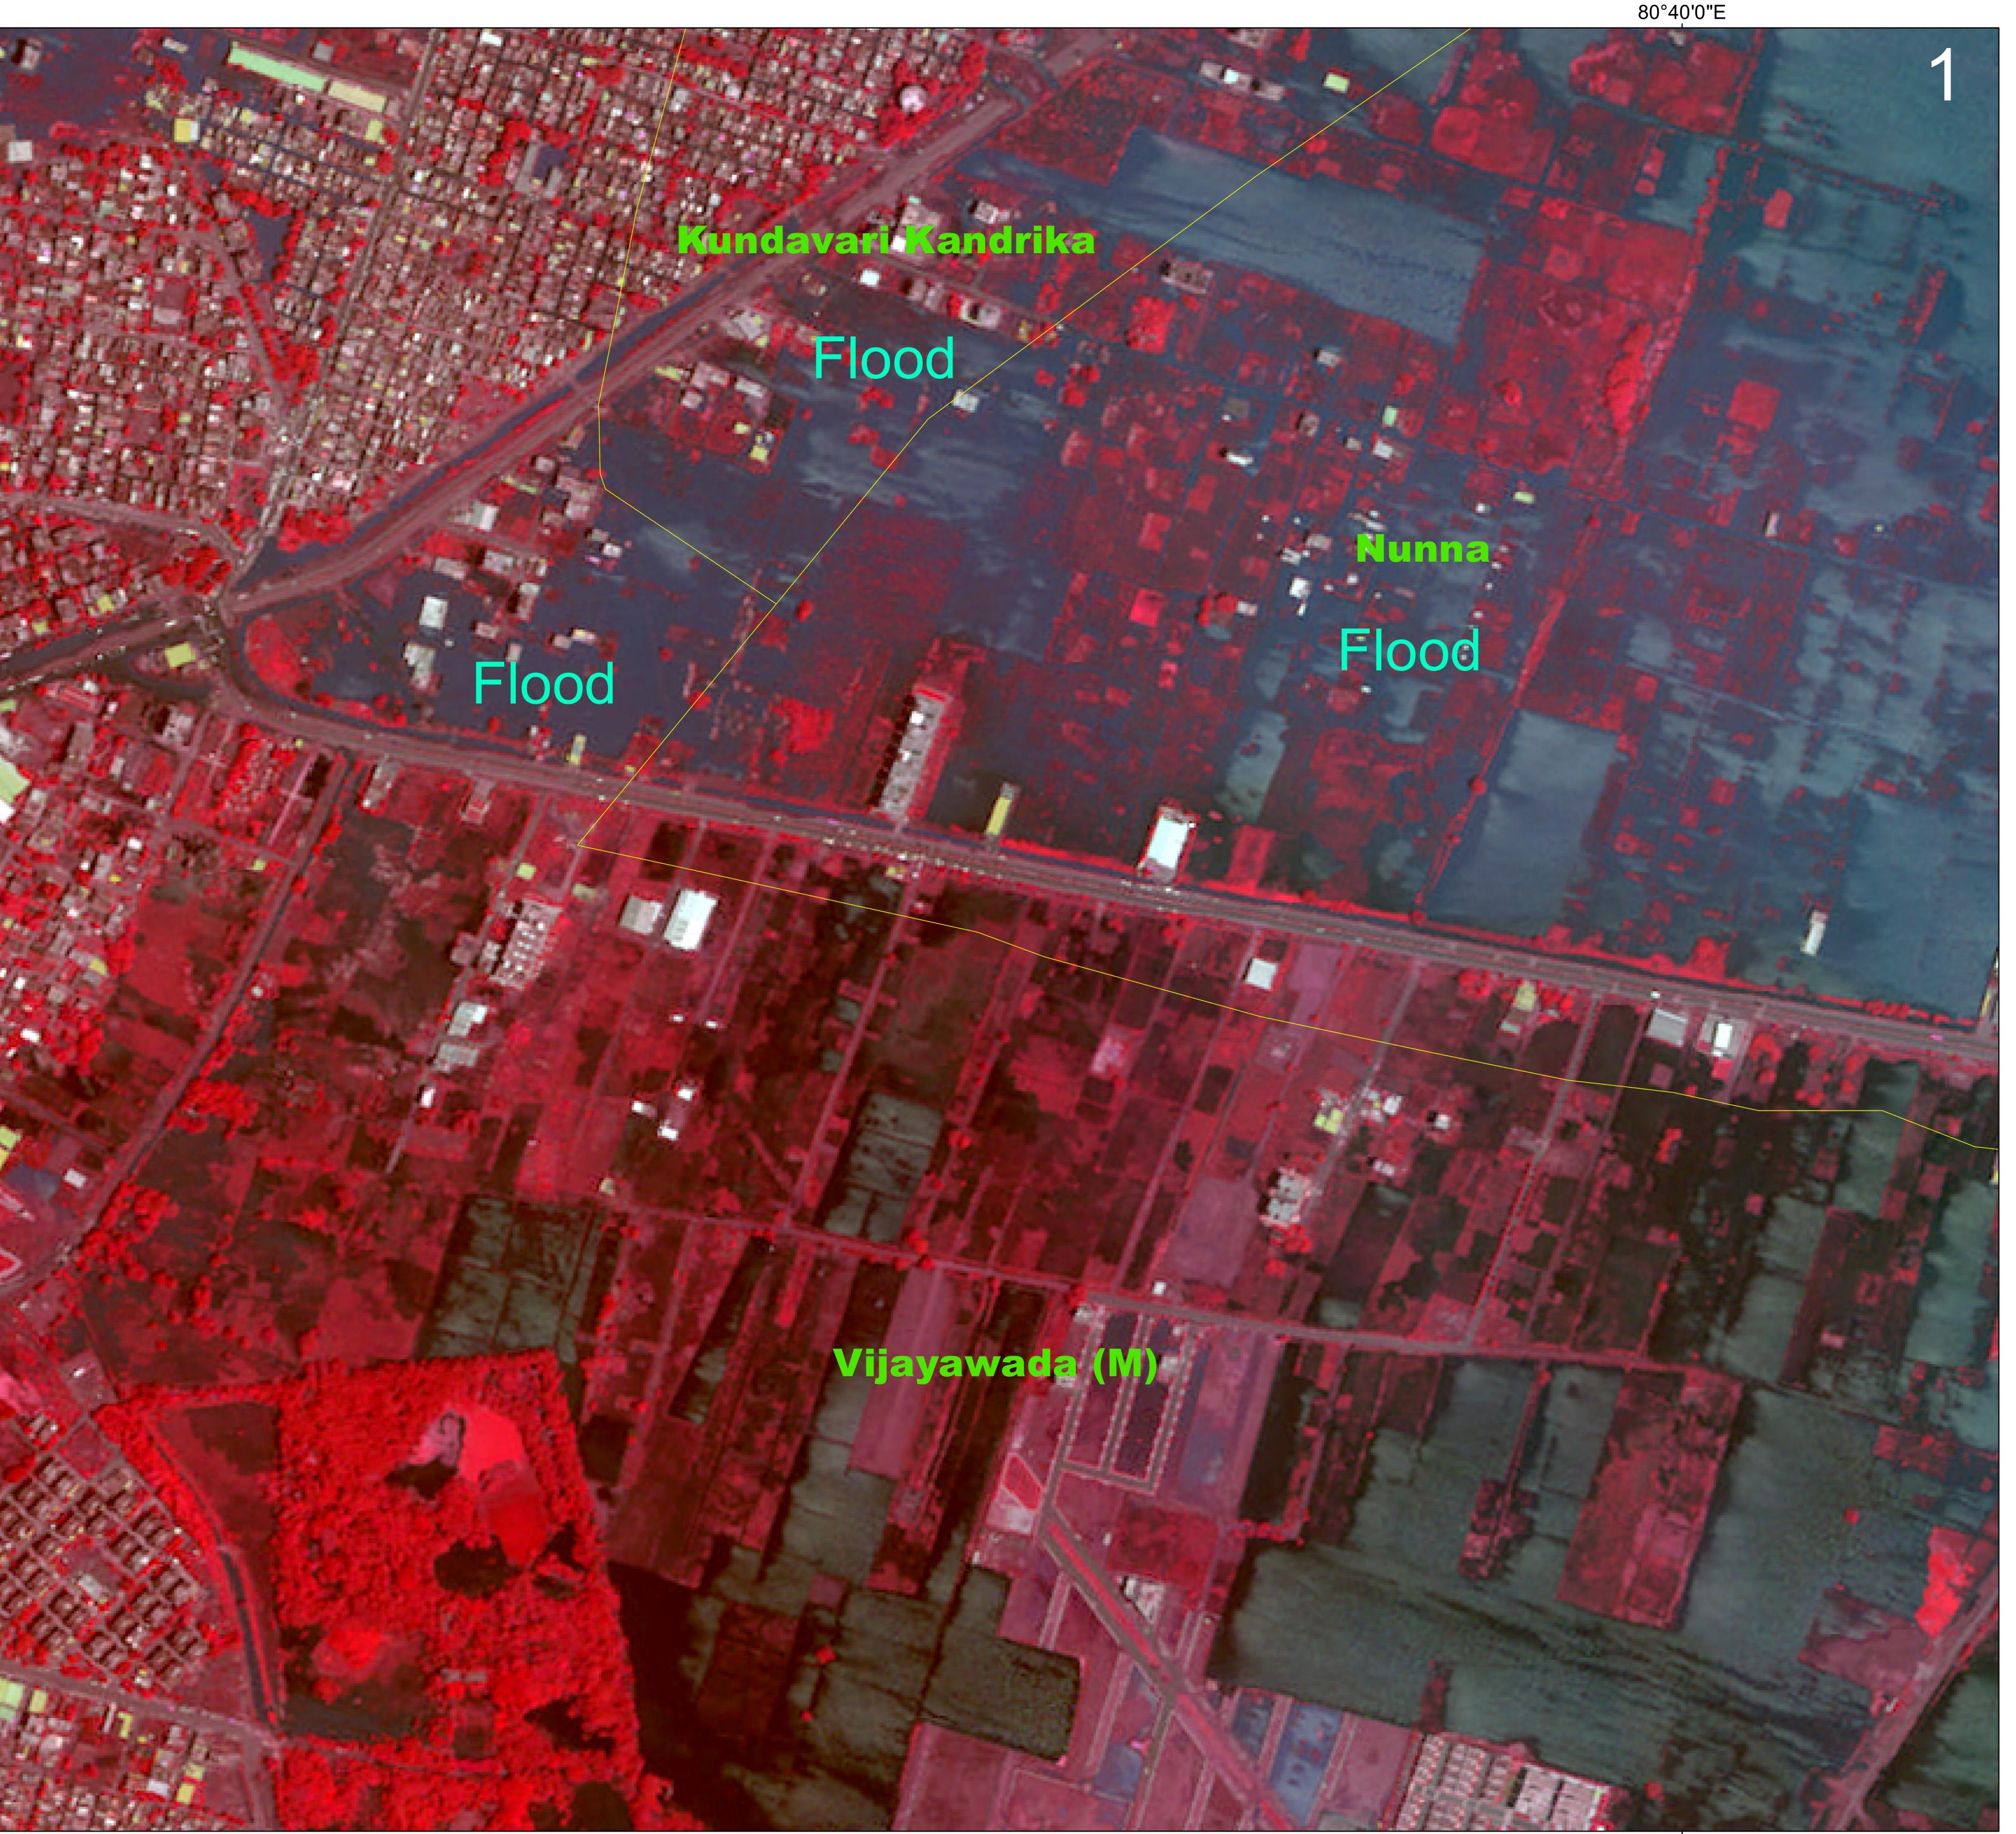
Flood Inundation Areas Surrounding Vijayawada, Andhra Pradesh

Based on the analysis of CAS500-1 Satellite Image on 12.09.2024

Heavy rains are witnessed in Andhra Pradesh and overflow is observed in Krishna River / Tributaries at Vijayawada. This map highlights the areas of flood inundation / Standing water after the heavy rains. Disclaimer: This Map is prepared on rapid mapping mode for immediate use and sharing amongst official agencies. This provides preliminary results. Flood inundation may include rain water accumulation / flood water in low lying areas

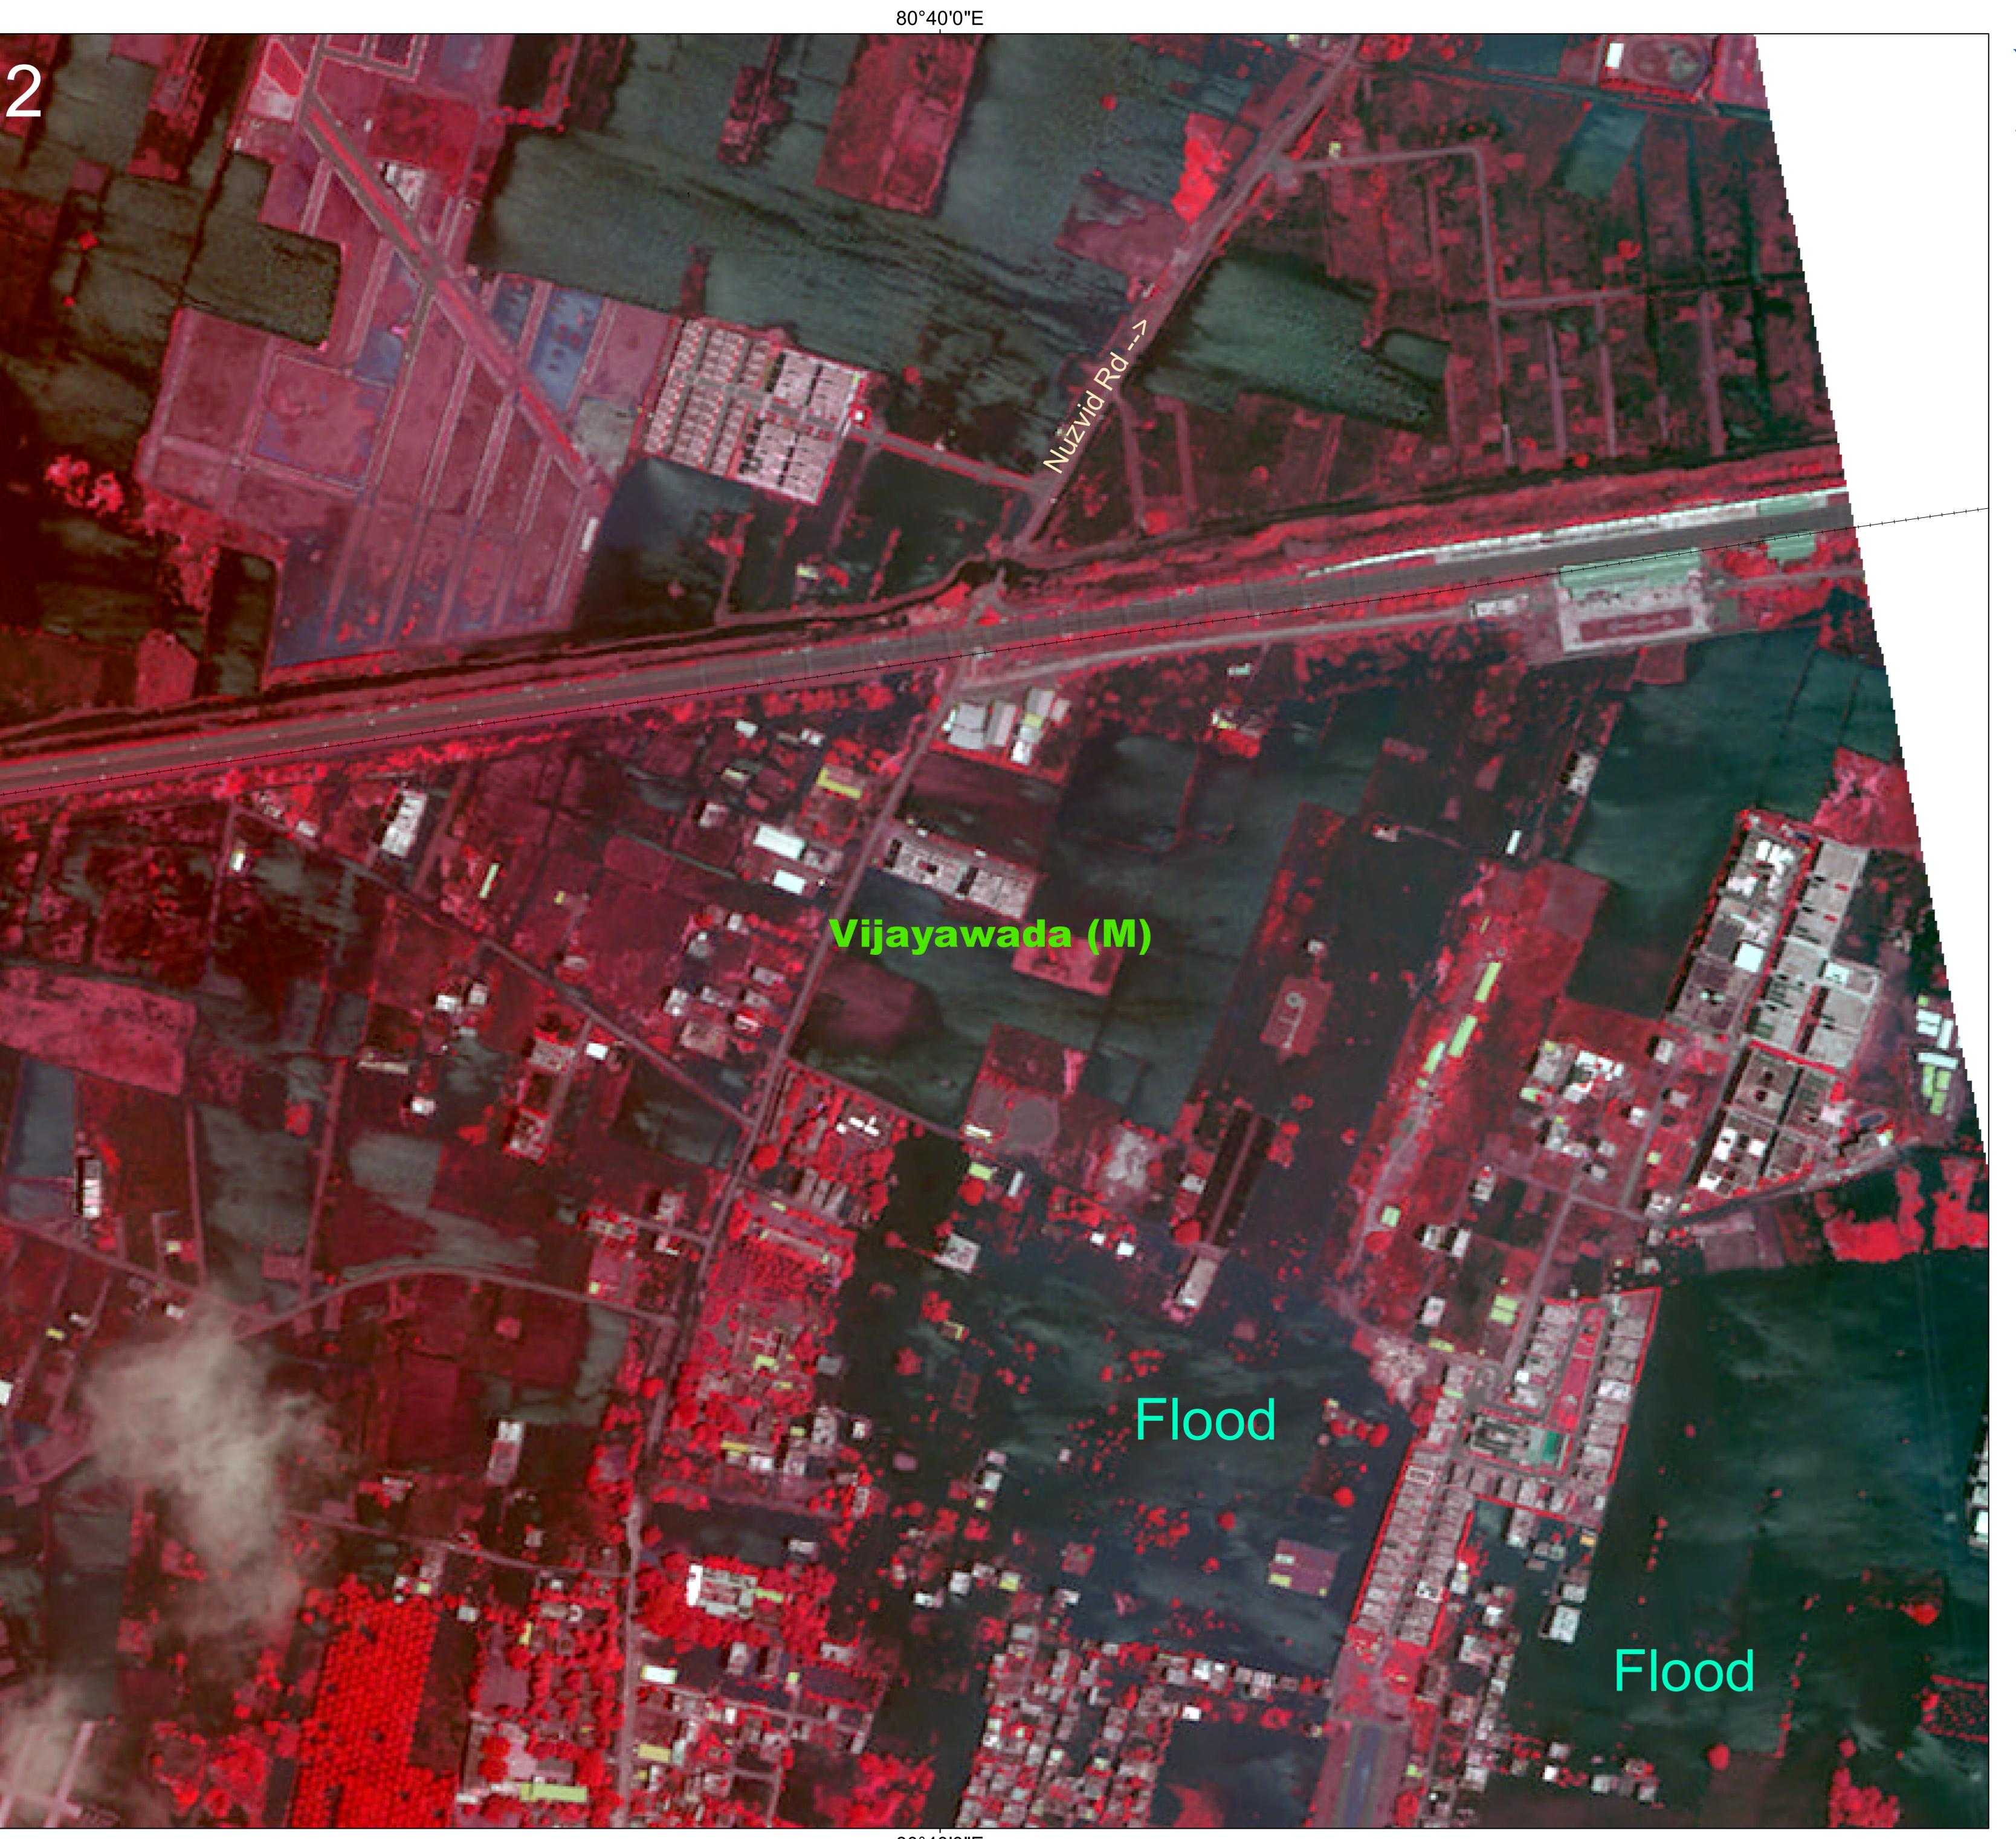
Flood Inundation Areas Surrounding Nunna, Kundavari Knadrika and Vijayawada (M) Villages, Andhra Pradesh

Based on the analysis of CAS500-1 Satellite Image on 12.09.2024

Heavy rains are witnessed in Andhra Pradesh and overflow is observed in Krishna River / Tributaries at Vijayawada. This map highlights the areas of flood inundation / Standing water after the heavy rains. Disclaimer: This Map is prepared on rapid mapping mode for immediate use and sharing amongst official agencies. This provides preliminary results. Flood inundation may include rain water accumulation / flood water in low lying areas

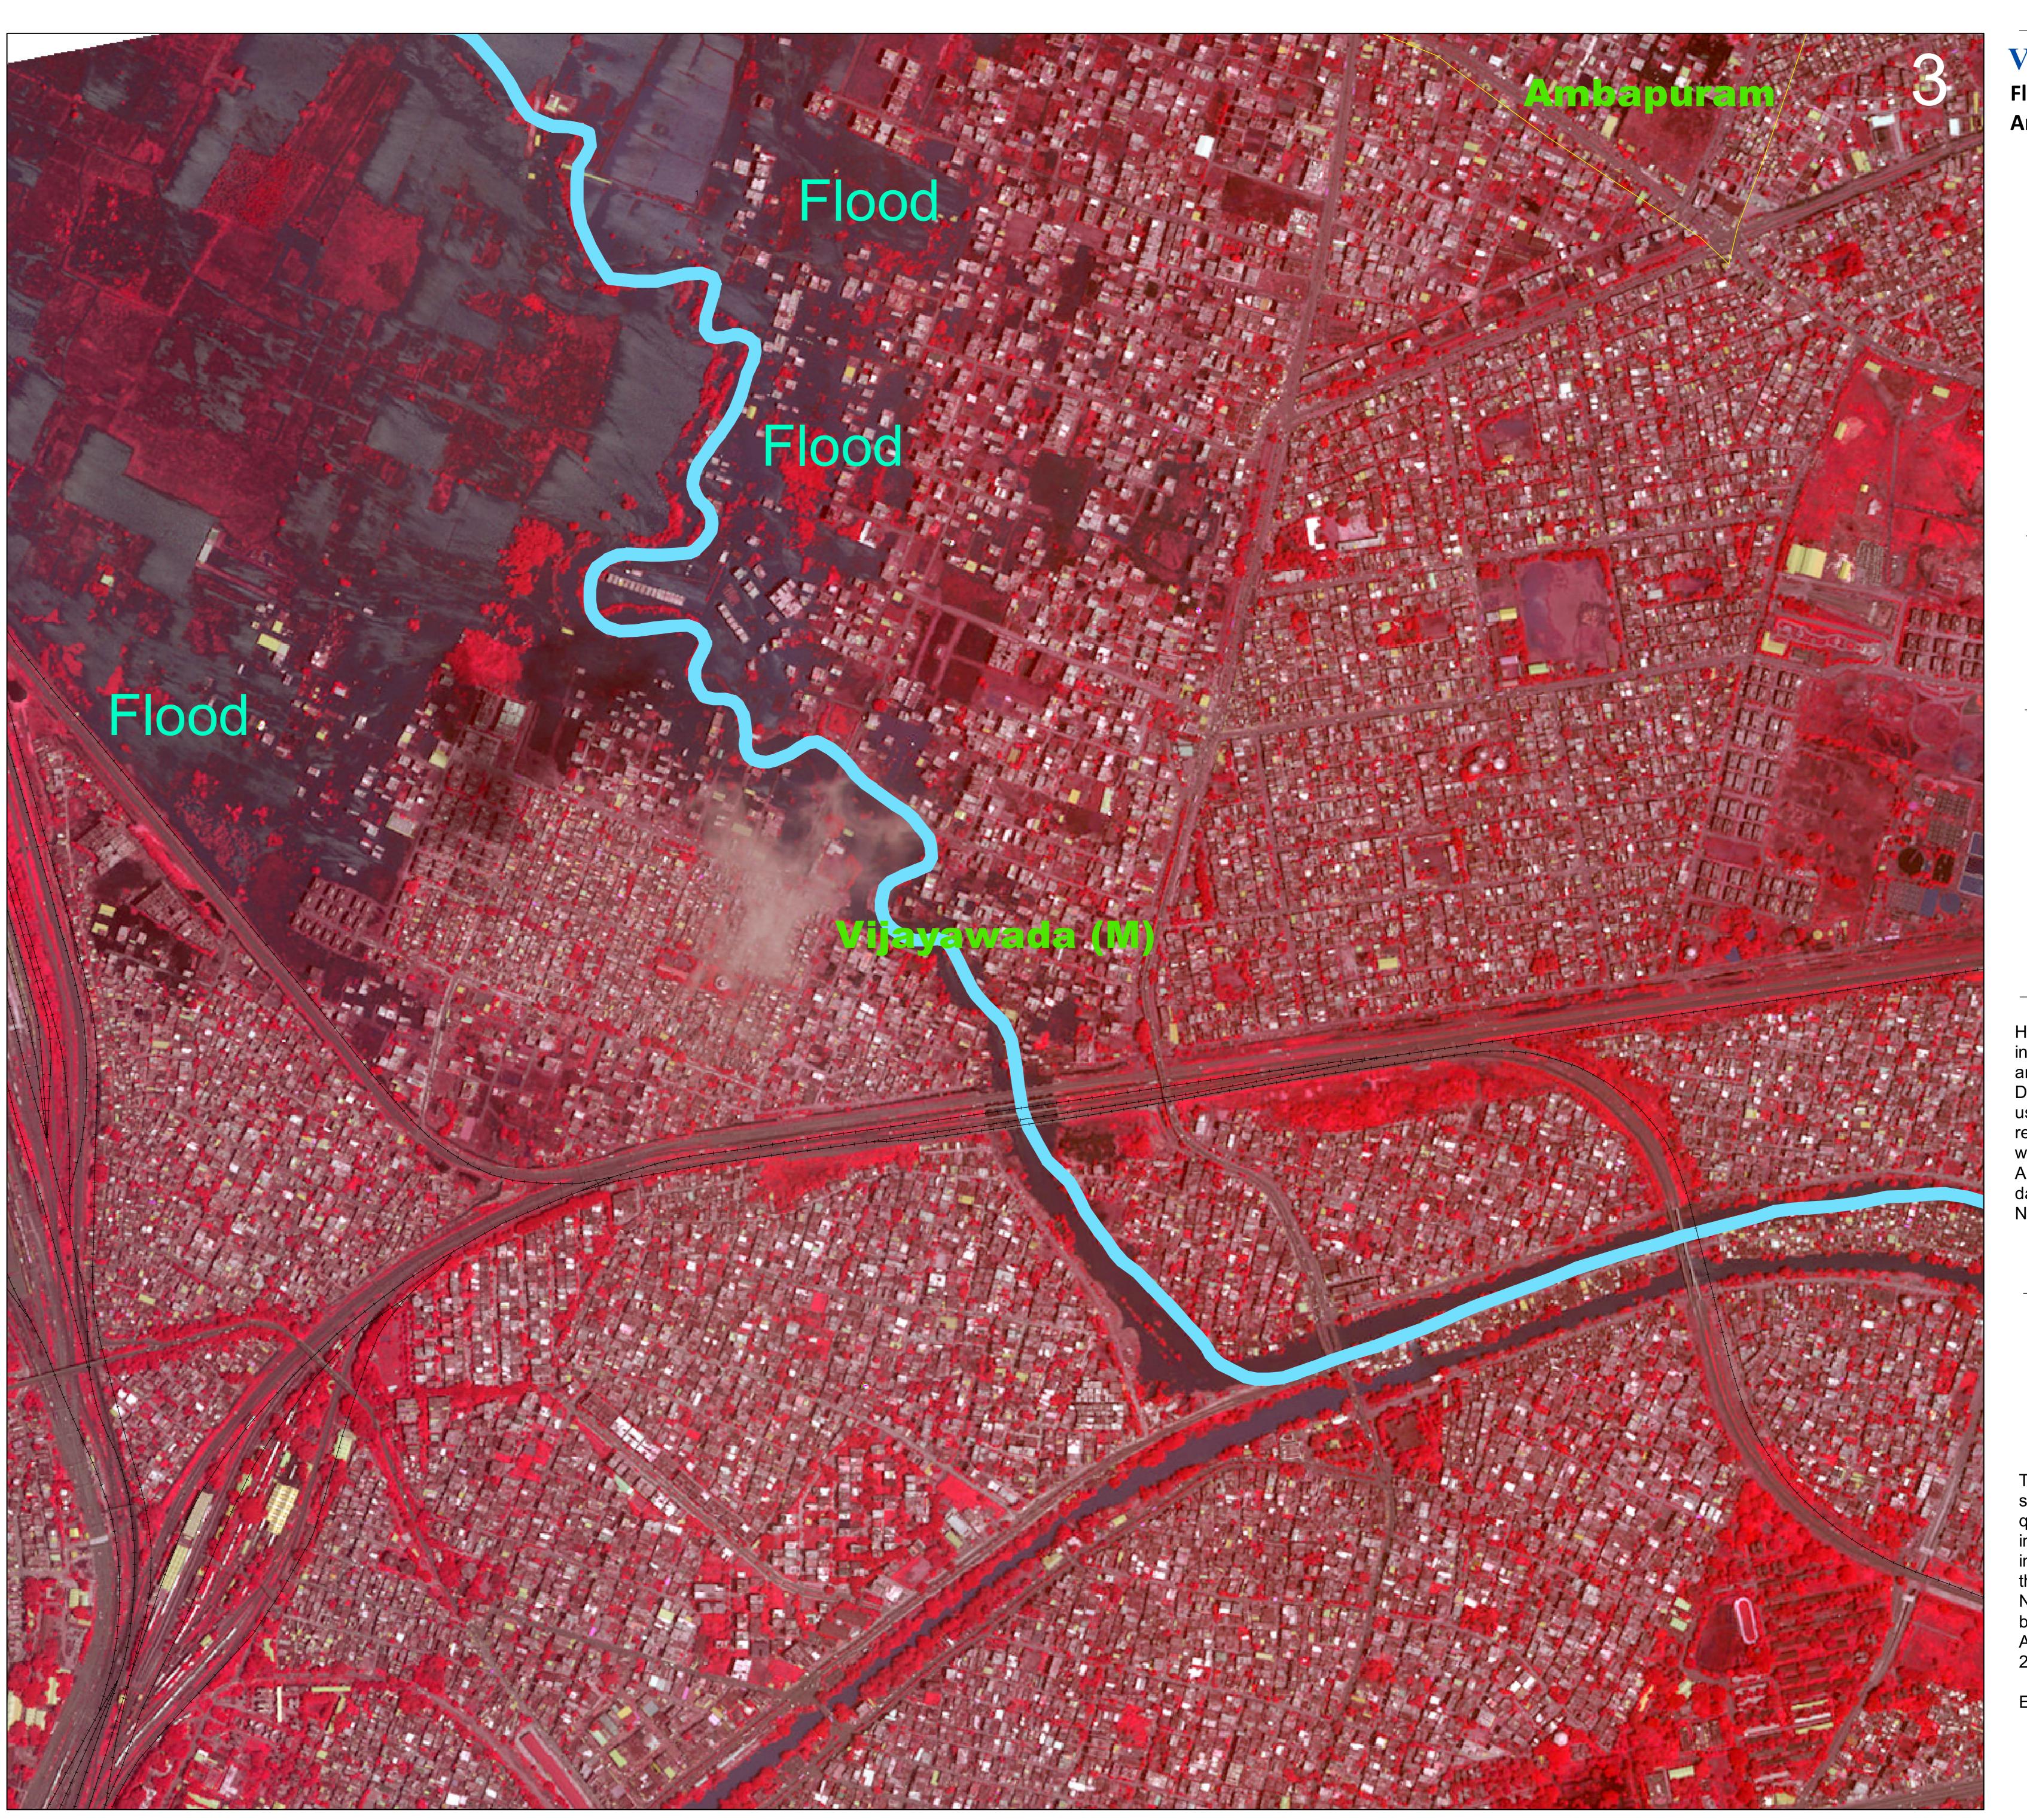
Flood Inundation Areas Surrounding Vijayawada (M), **Andhra Pradesh**

Based on the analysis of CAS500-1 Satellite Image on 12.09.2024

Heavy rains are witnessed in Andhra Pradesh and overflow is observed in Krishna River / Tributaries at Vijayawada. This map highlights the areas of flood inundation / Standing water after the heavy rains. Disclaimer: This Map is prepared on rapid mapping mode for immediate use and sharing amongst official agencies. This provides preliminary results. Flood inundation may include rain water accumulation / flood water in low lying areas
