Situation as of 31/10/2024 10:22 UTC  
Grading - Overview map 01

**Event** On 29 October 2024 at 14:30 UTC, an extraordinary rainfall event affected the Valencia region. High water levels in rivers caused flooding in Ribera Alta, Horta, La Plana de Utiel and Letur river. On 31 October 2024, extraordinary precipitation caused flooding in the Castellon Province area. Copernicus EMS Rapid Mapping is requested to provide emergency mapping of flood extent, Monitoring and classification damages emergency mapping.

### EMSR773 - AOI03 Flood in Spain HORTA SUD

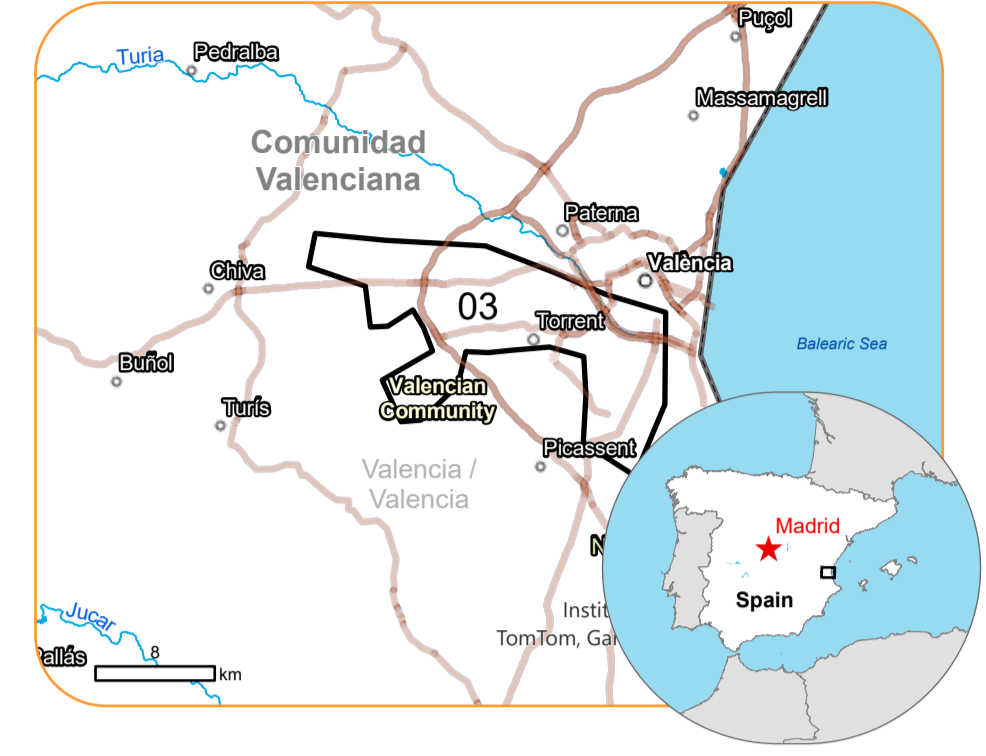
**Dike breach 3 No.**  
Flooded area 645.8 ha  
Flooded trace 3533.2 ha

**Affected population**  
~60000

**Built-up**  
3906 No.

**Water infrastructure**  
12.0 ha

**Road**  
531.6 km

**Airport or heliport**  
0.1 ha  
0.2 km

**Railway**  
15.2 km

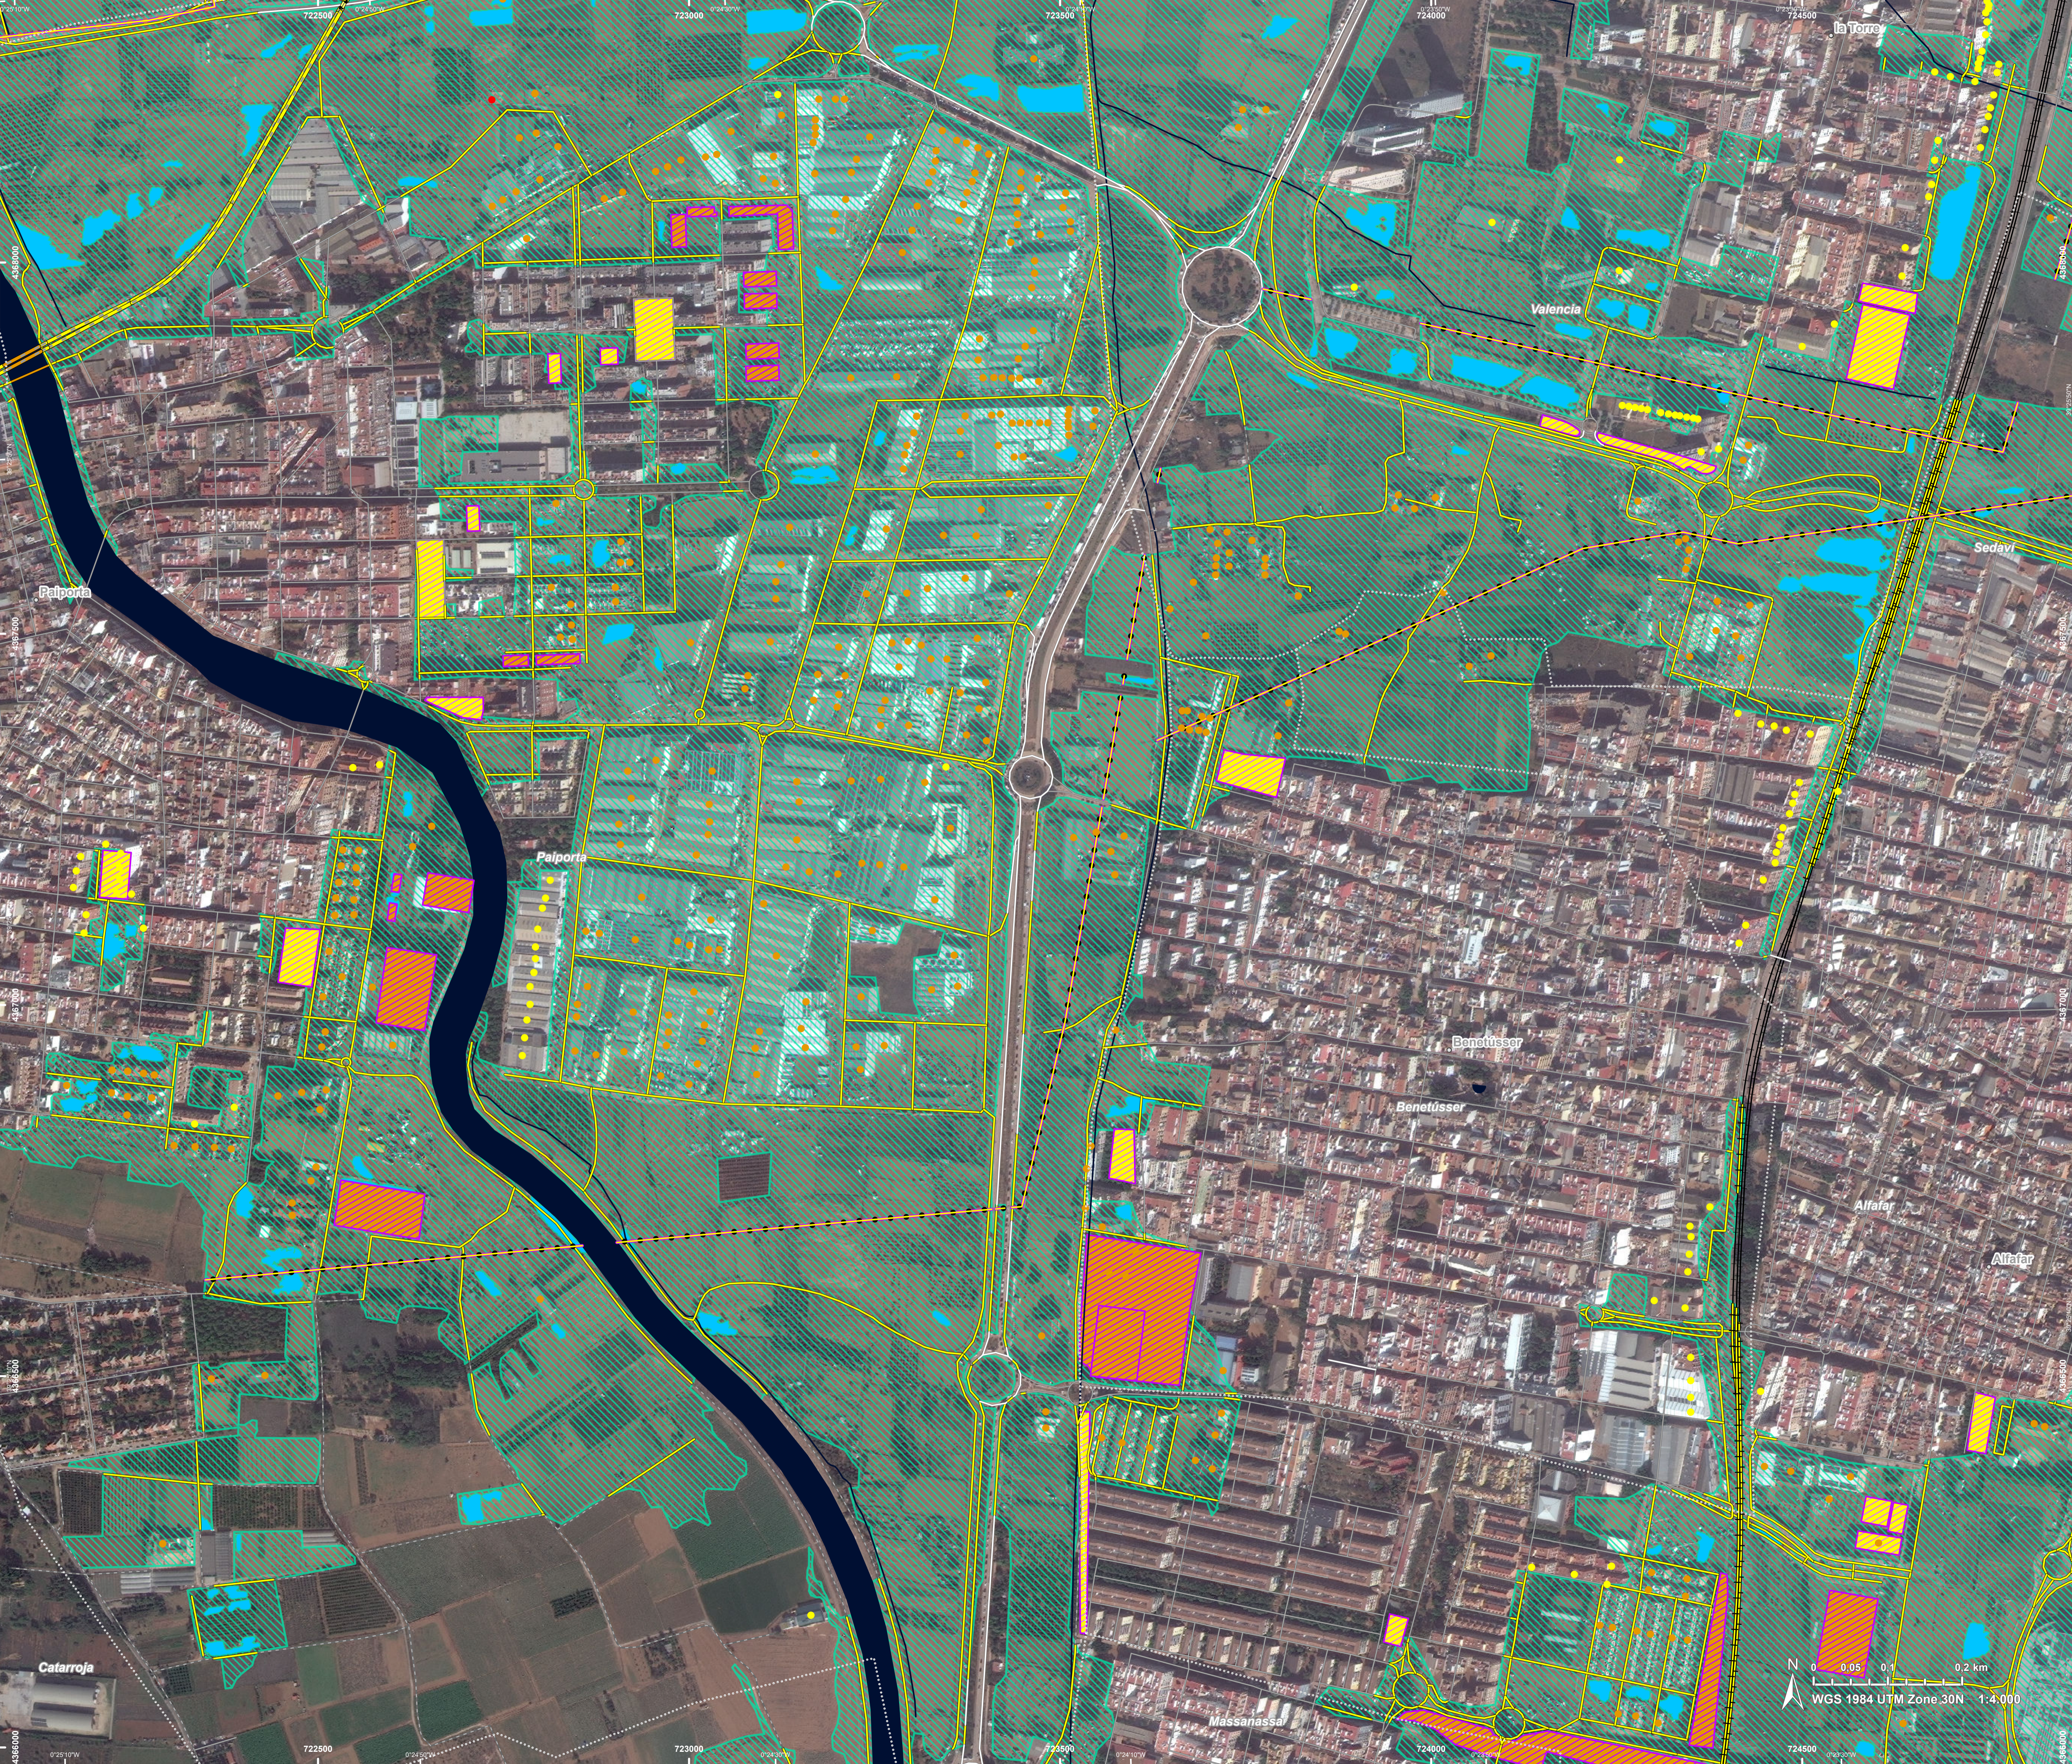
<b>Crisis Information</b>	
Flooded Area	Bridge, elevated highway, tunnel and subway, Damaged
Flood trace	Bridge, elevated highway, tunnel and subway, Possibly damaged
Destroyed	Main road, No visible damage
Damaged	Local road, No visible damage
Possibly damaged	Track, No visible damage
<b>Facilities Grading</b>	
Long-distance pipeline or line, Possibly damaged	Railway, No visible damage
Local pipeline or line, Possibly damaged	Subway, No visible damage
Damaged	Administrative Boundaries
Possibly damaged	Municipality
<b>Transportation Grading</b>	
Road, Damaged	Placenames
Road, Possibly damaged	Placename
Railway, Possibly damaged	Hydrography
	Lake, River
