# *Preliminary satellite derived flood assessment in White Nile State, Sudan*

Production Date:  
09 Sep 2019

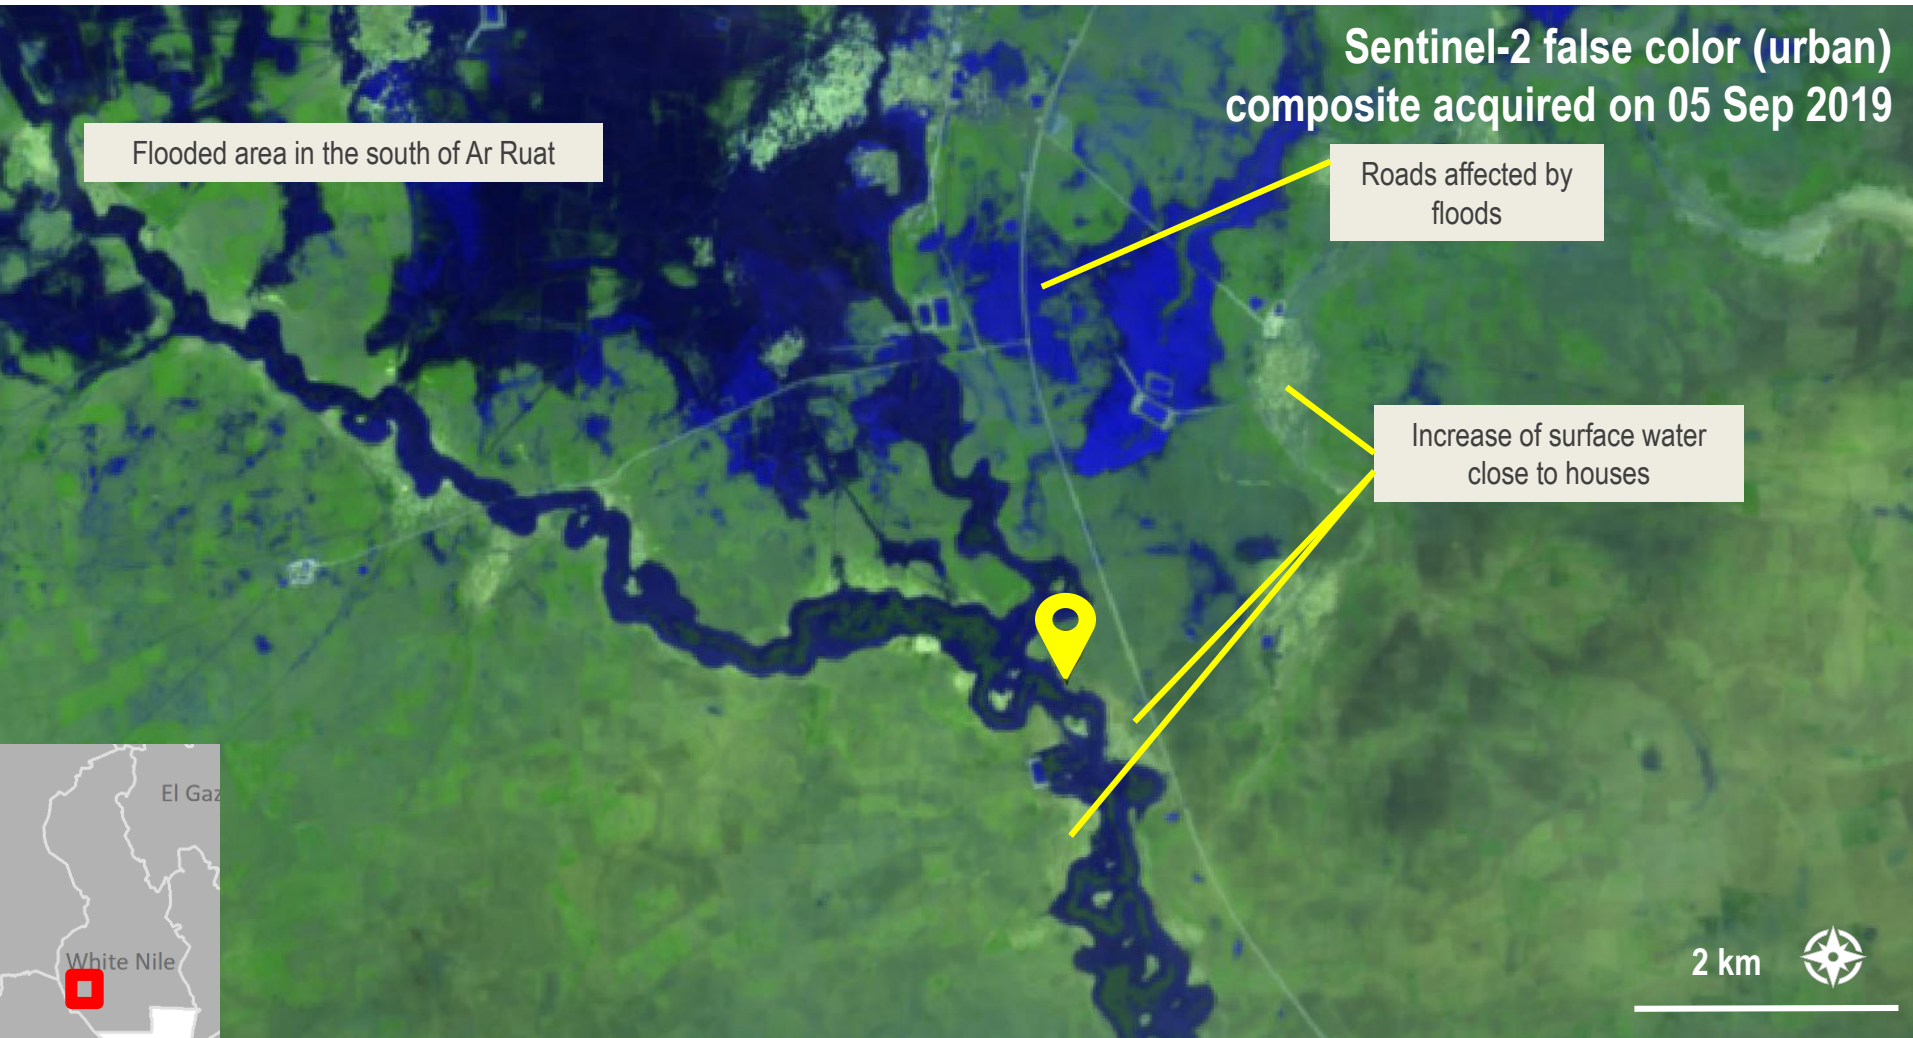
# AOI 1 South of Ar Ruat, White Nile State, Sudan

The water surface in the south of White Nile State detected by Sentinel-2 on 05 Sep 2019 increased since 31 Aug 2019; affected roads are indicated

- AOI 1: South of Ar Ruat – Water surface in the south of White Nile State detected on 05 Sep 2019 was more extensive than in the previous situation detected on 31 Aug 2019, and have affected roads in the region
- AOI 2: North of Ar Rashdi – Extensive flooding detected in the northern zone; evidence of White Nile river overbank flow
- AOI 3: South of Ad Dubaykir – No flooding detected in the AOI but notable flooding in the west of Ad Dubaykir with evidence of affected roads
- AOI 4: West of Dereia - Water surface in the south of White Nile State notably increased from the previous situation detected on 06 Aug 2019; extensive flooded areas in the western and northern zones of the AOI

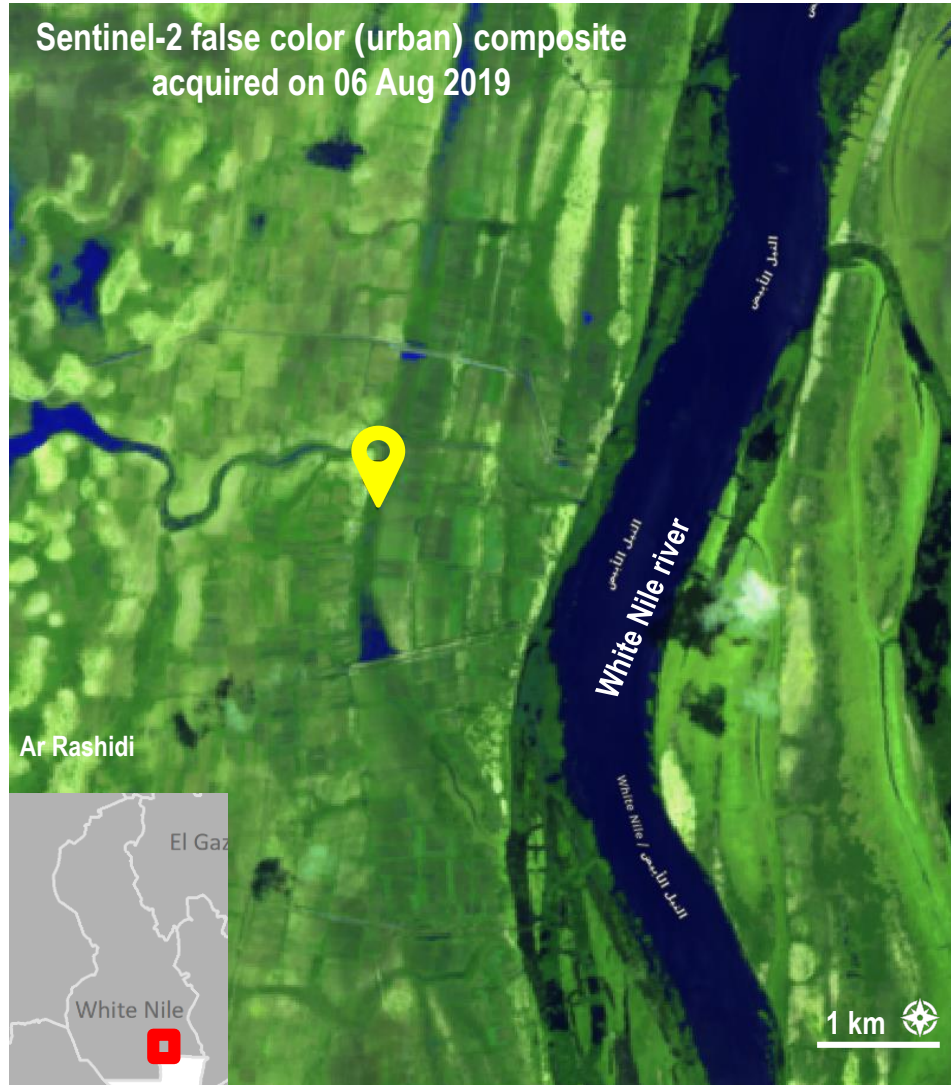
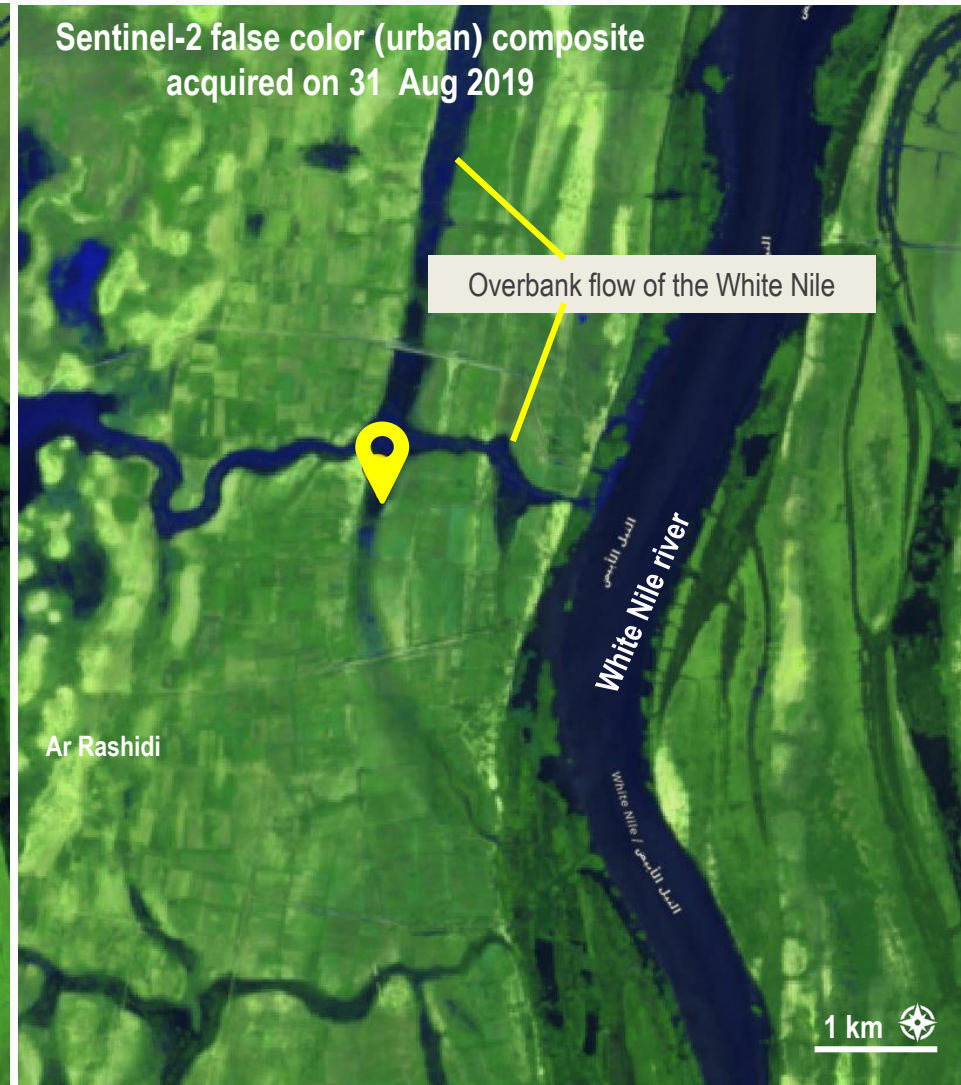
# AOI 2 North of Ar Rashdi, White Nile State, Sudan

Sentinel-2 false color (urban) composite  
acquired on 06 Aug 2019

Sentinel-2 false color (urban) composite  
acquired on 31 Aug 2019
