5 AUGUST 2020

## PRELIMINARY SATELLITE-DERIVED FLOOD ASSESSMENT RANGPUR AND MYMENSINGH DIVISION, BANGLADESH

STATUS: FLOODS DETECTED IN AGRICULTURAL AND URBAN AREAS  
FURTHER ACTION(S): CONTINUE MONITORING

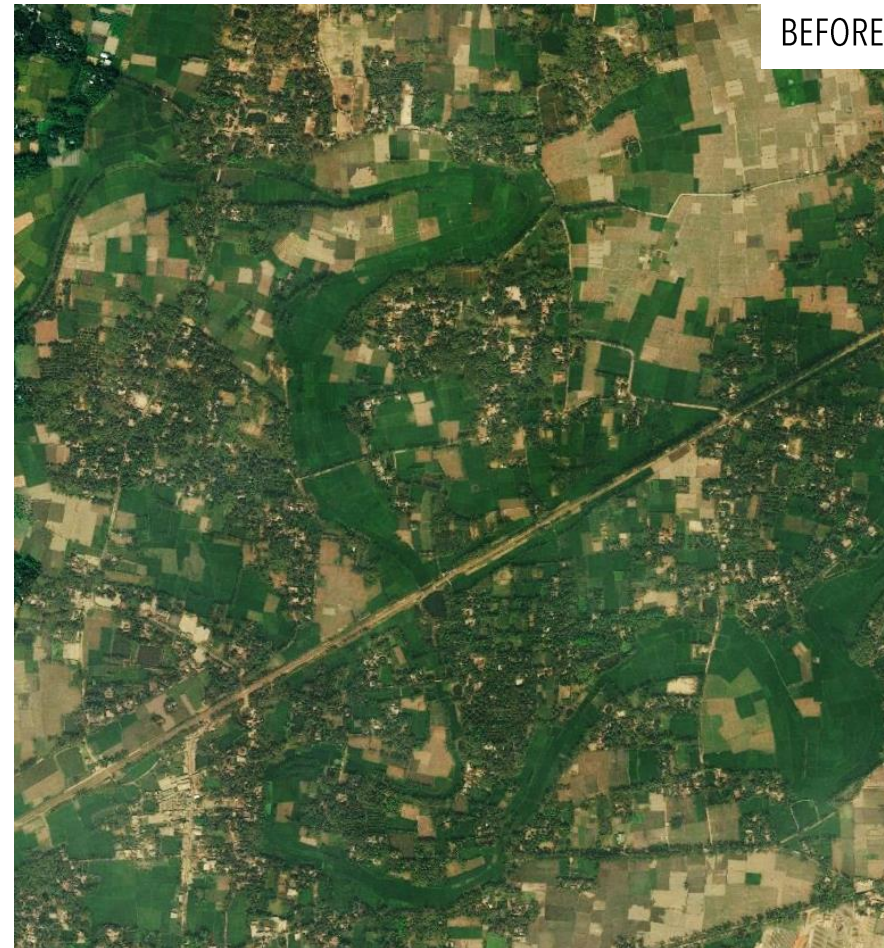
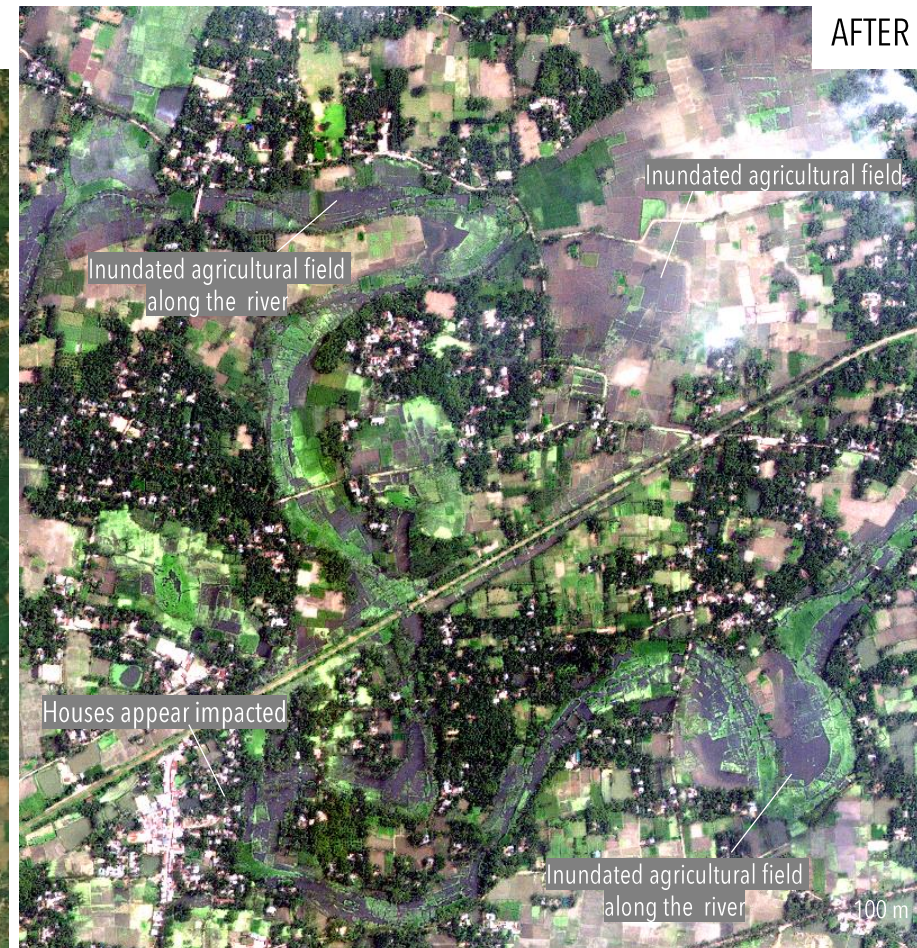
## AOI 1 - KAUNIA UPAZILA, RANGPUR DISTRICT, RANGPUR DIVISION : FLOODS DETECTED

ESRI Base Map

WorldView-2 / 3 August 2020

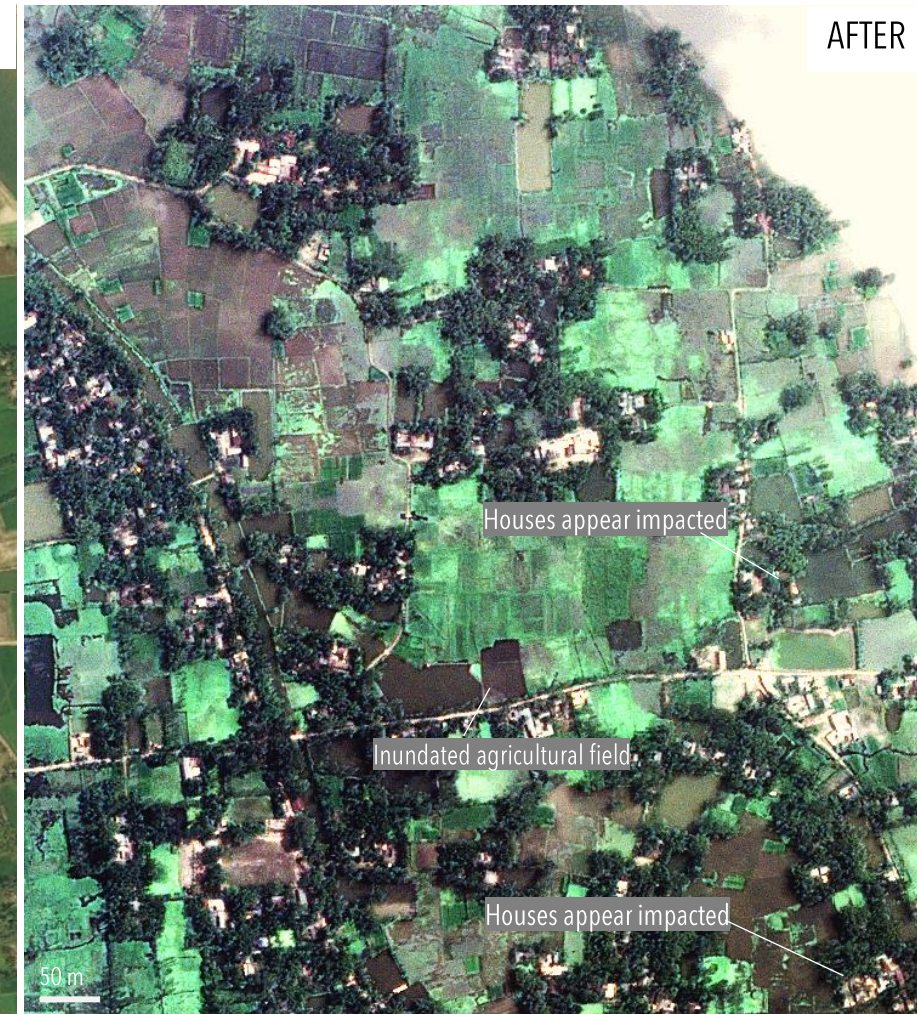
## AOI 1 - KAUNIA UPAZILA, RANGPUR DISTRICT, RANGPUR DIVISION : FLOODS DETECTED

ESRI Base Map

WorldView-2 / 3 August 2020

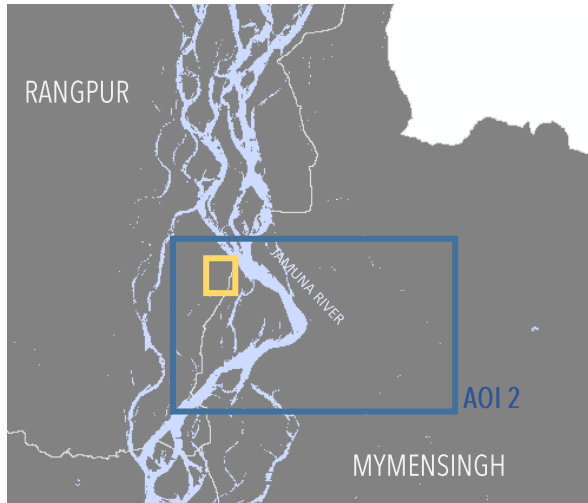
Image Center :  
89°39'24.73"E  
25°11'46.508"N

## AOI 2 – FULCHHARI UPAZILA, GAIBANDHA DISTRICT, RANGPUR DIVISION : FLOODS DETECTED NEAR THE JAMUNA RIVER

- Flood waters detected in both AOIs
- Severe impact to the agricultural field can be observed in AOI2 as of 03 August 2020
- Many houses are inundated or surrounded by flood waters in AOI 2 as of 03 August 2020
- Damaged roads can be observed in AOI2 as of 03 August 2020

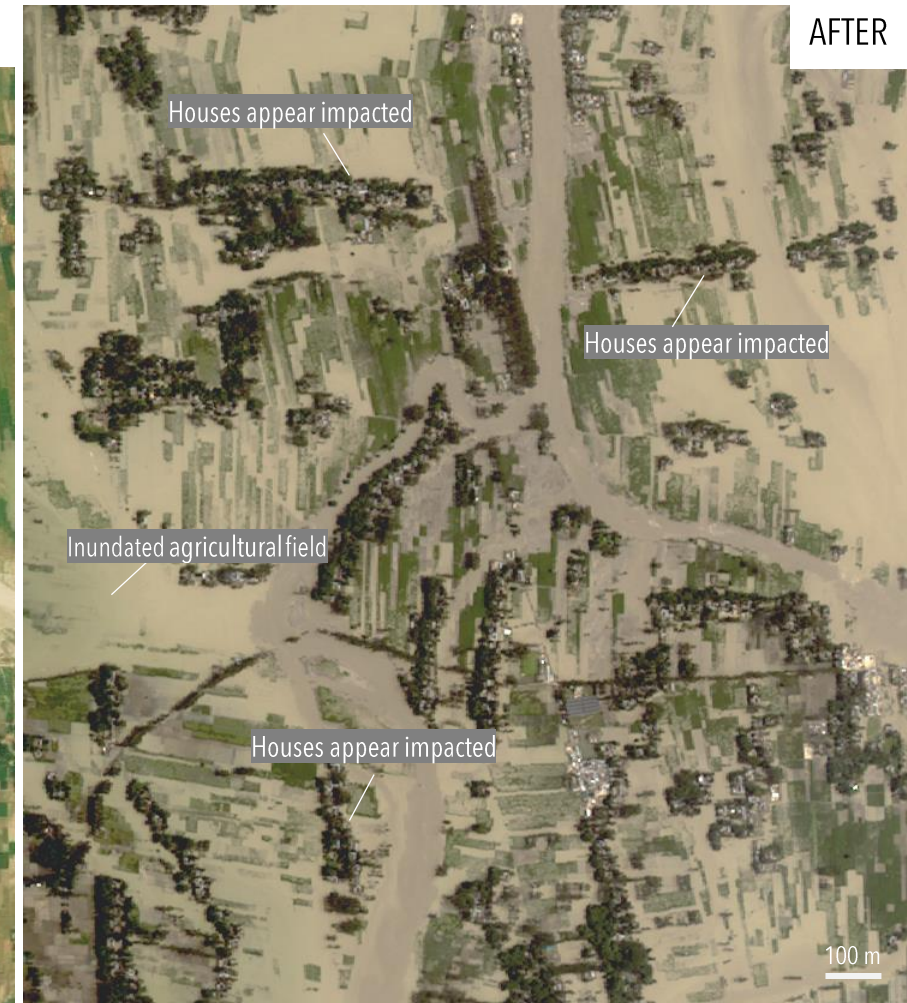
ESRI Base Map

WorldView-2 / 3 August 2020

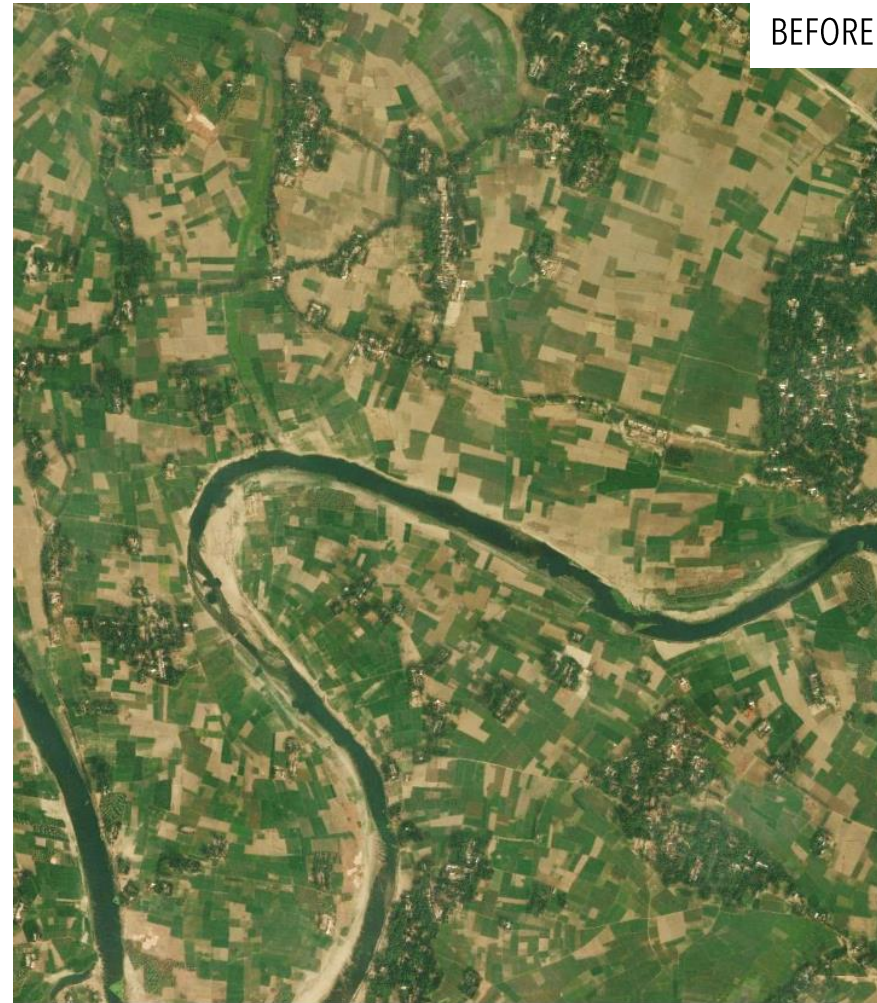
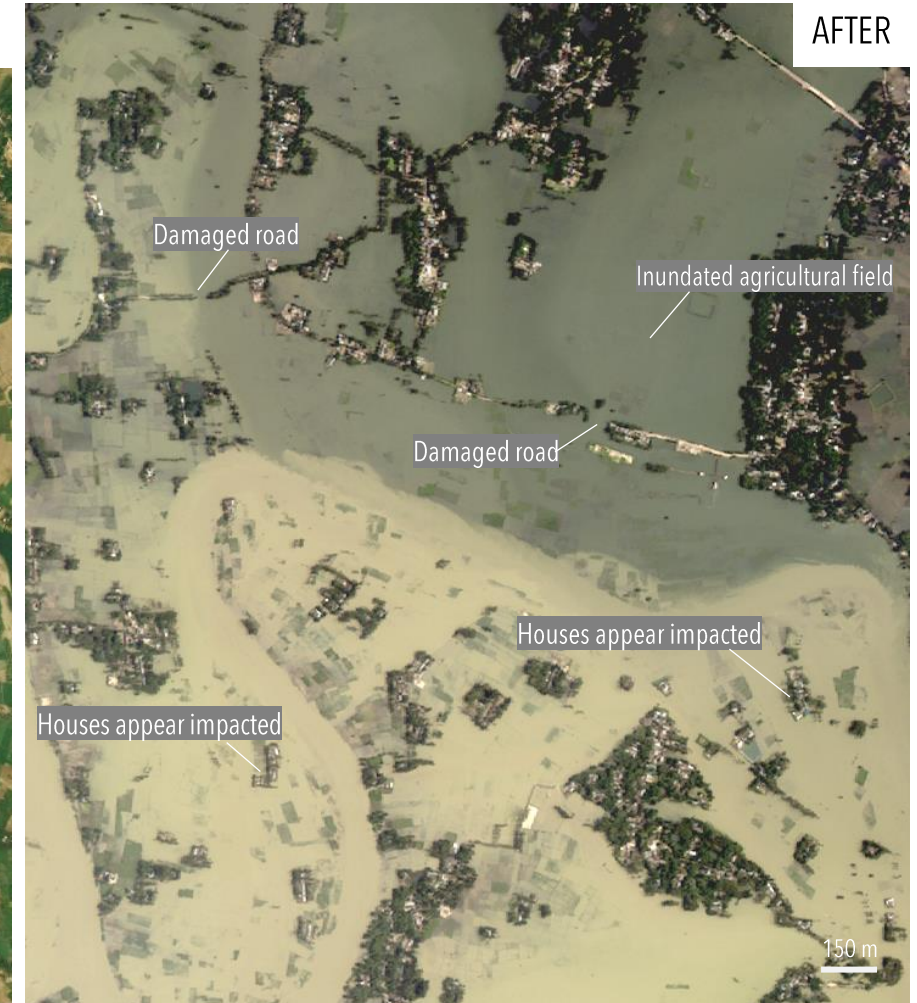
## AOI 2 – BAKSHIGANJ UPAZILA, JAMALPUR DISTRICT, MYMENSINGH DIVISION : FLOODS DETECTED

ESRI Base Map

WorldView-2 / 3 August 2020
