Damage assessment of the Cultural Heritages Sites in Tongatapu Island, Tonga – Tropical Cyclone GITA-18

23 February 2018

UNITAR – UNOSAT, following the request of UNESCO Office for the Pacific States Samoa, has performed a satellite based analysis of the cultural heritages sites of :

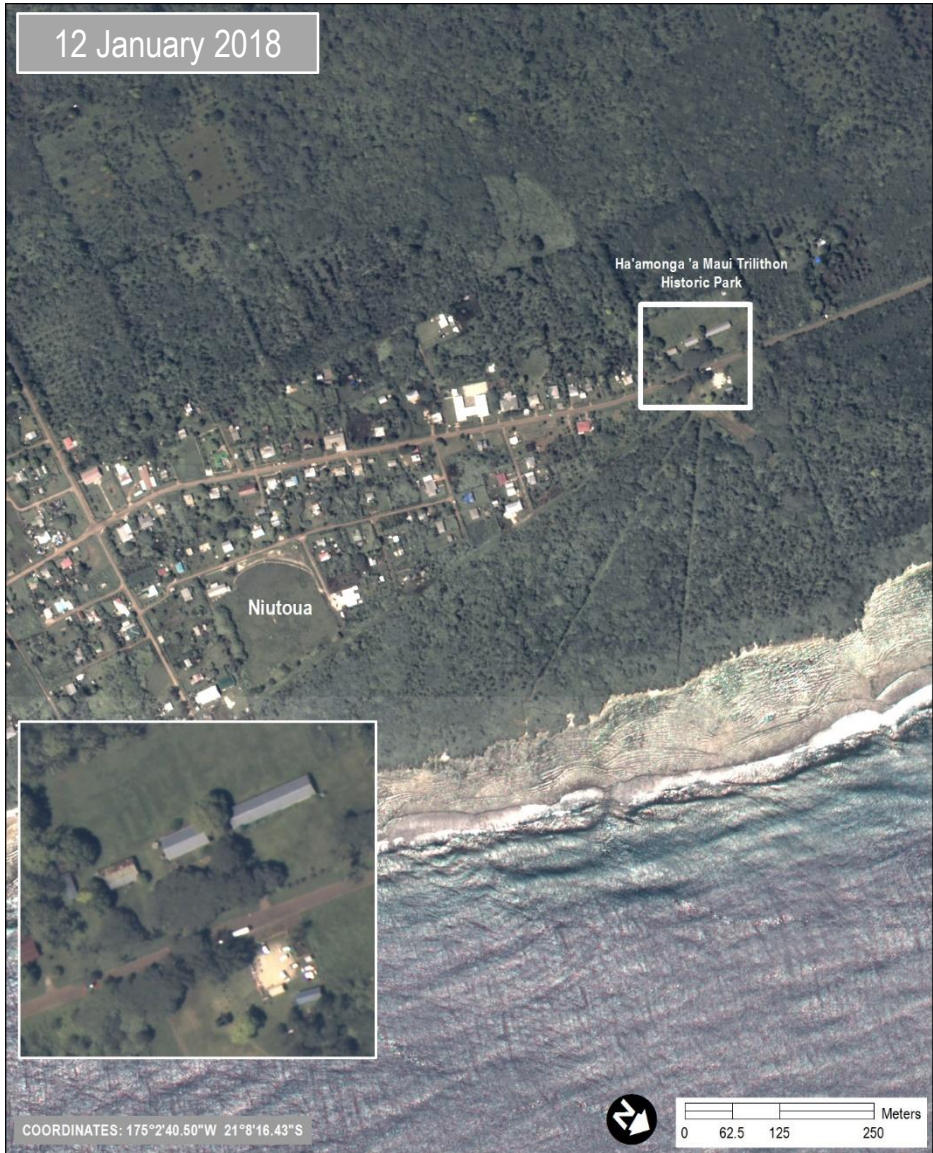
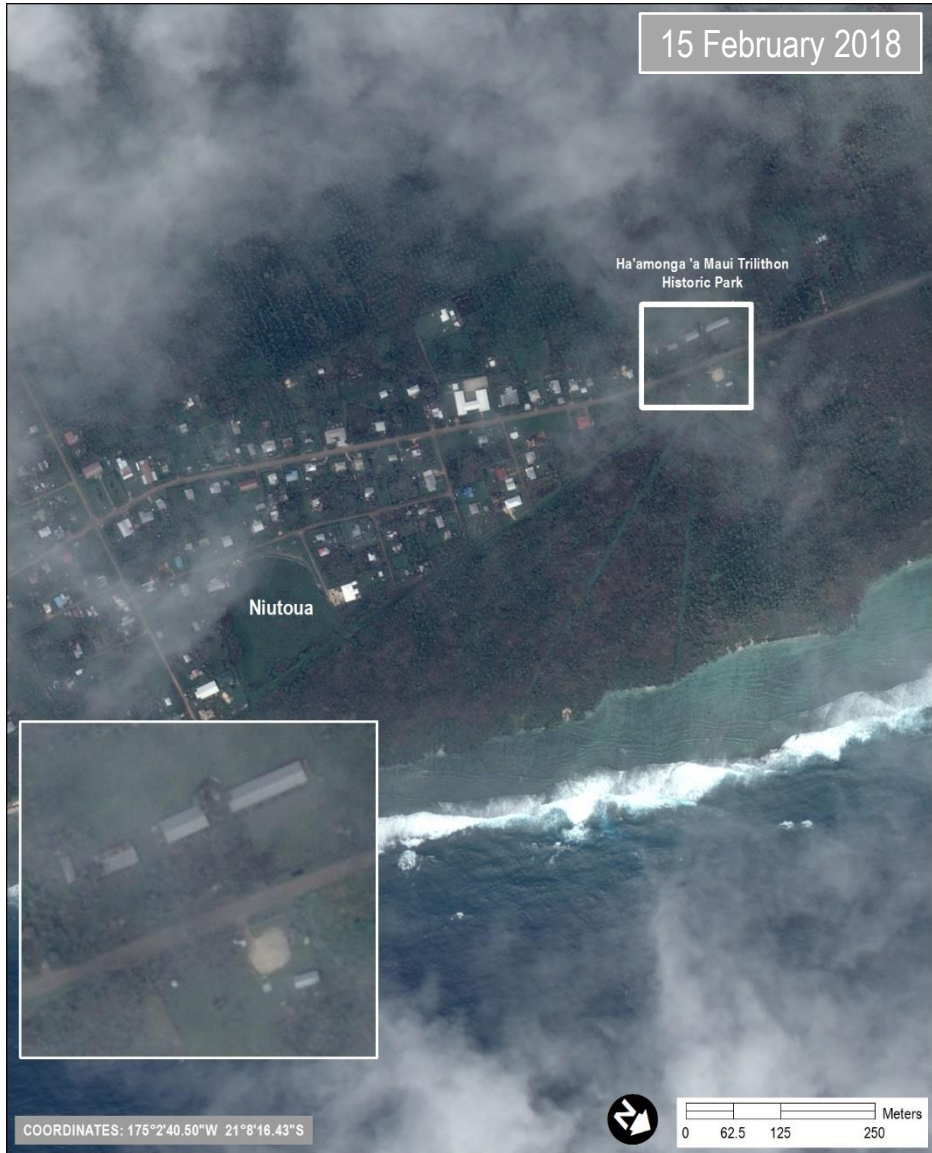
12 January 2018

15 February 2018

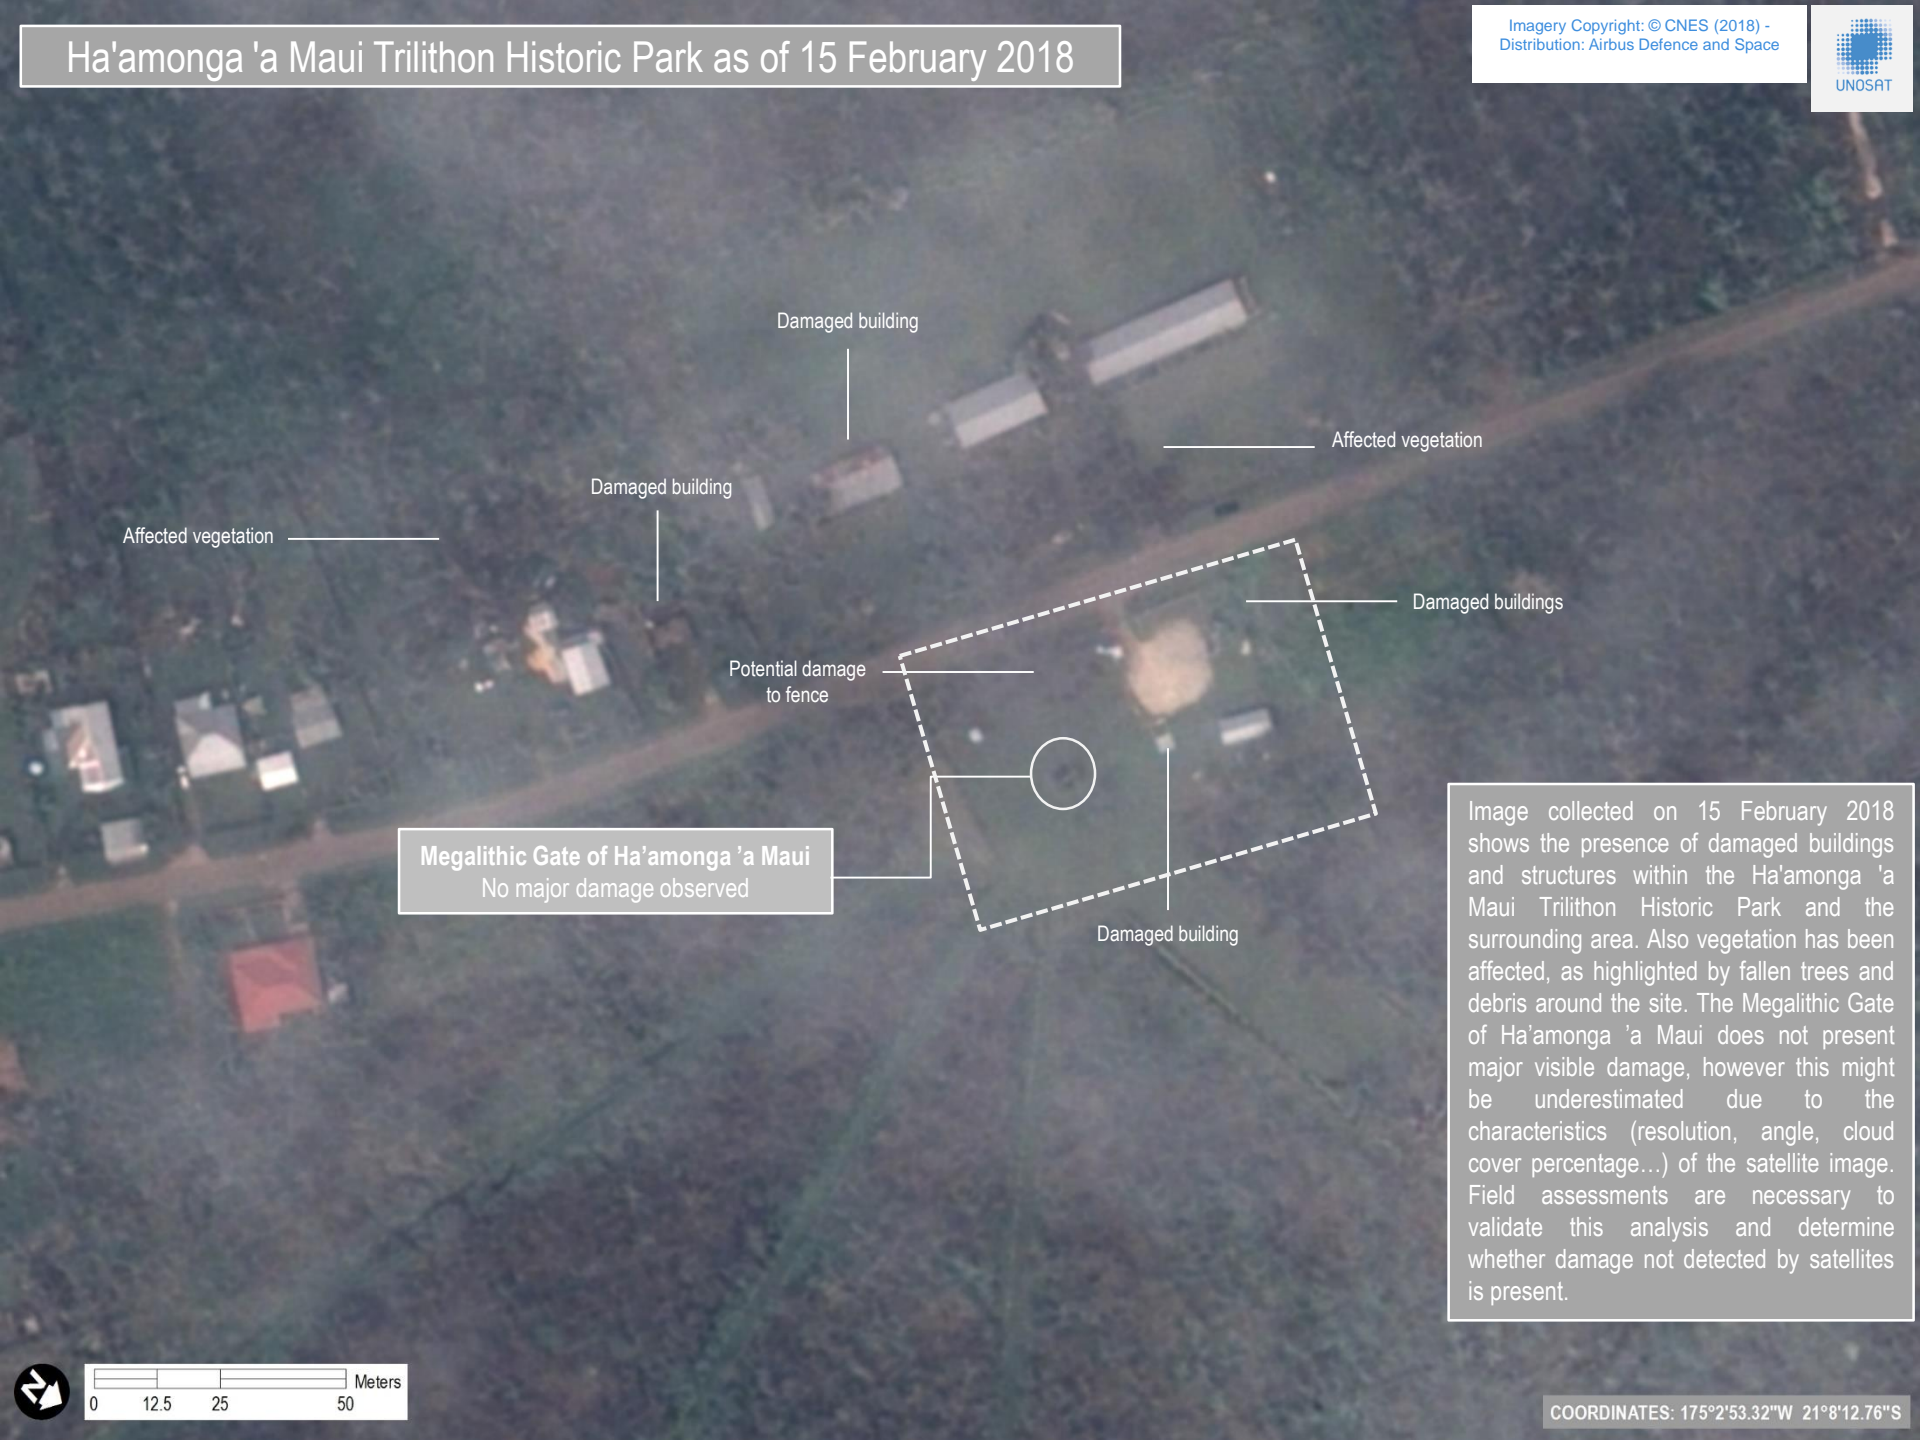
Ha'amonga 'a Maui Trilithon Historic Park as of 15 February 2018

Affected vegetation

Damaged building

Damaged buildings

Potential damage
to fence

Megalithic Gate of Ha'amonga 'a Maui
No major damage observed

Image collected on 15 February 2018 shows the presence of damaged buildings and structures within the Ha'amonga 'a Maui Trilithon Historic Park and the surrounding area. Also vegetation has been affected, as highlighted by fallen trees and debris around the site. The Megalithic Gate of Ha'amonga 'a Maui does not present major visible damage, however this might be underestimated due to the characteristics (resolution, angle, cloud cover percentage...) of the satellite image. Field assessments are necessary to validate this analysis and determine whether damage not detected by satellites is present.

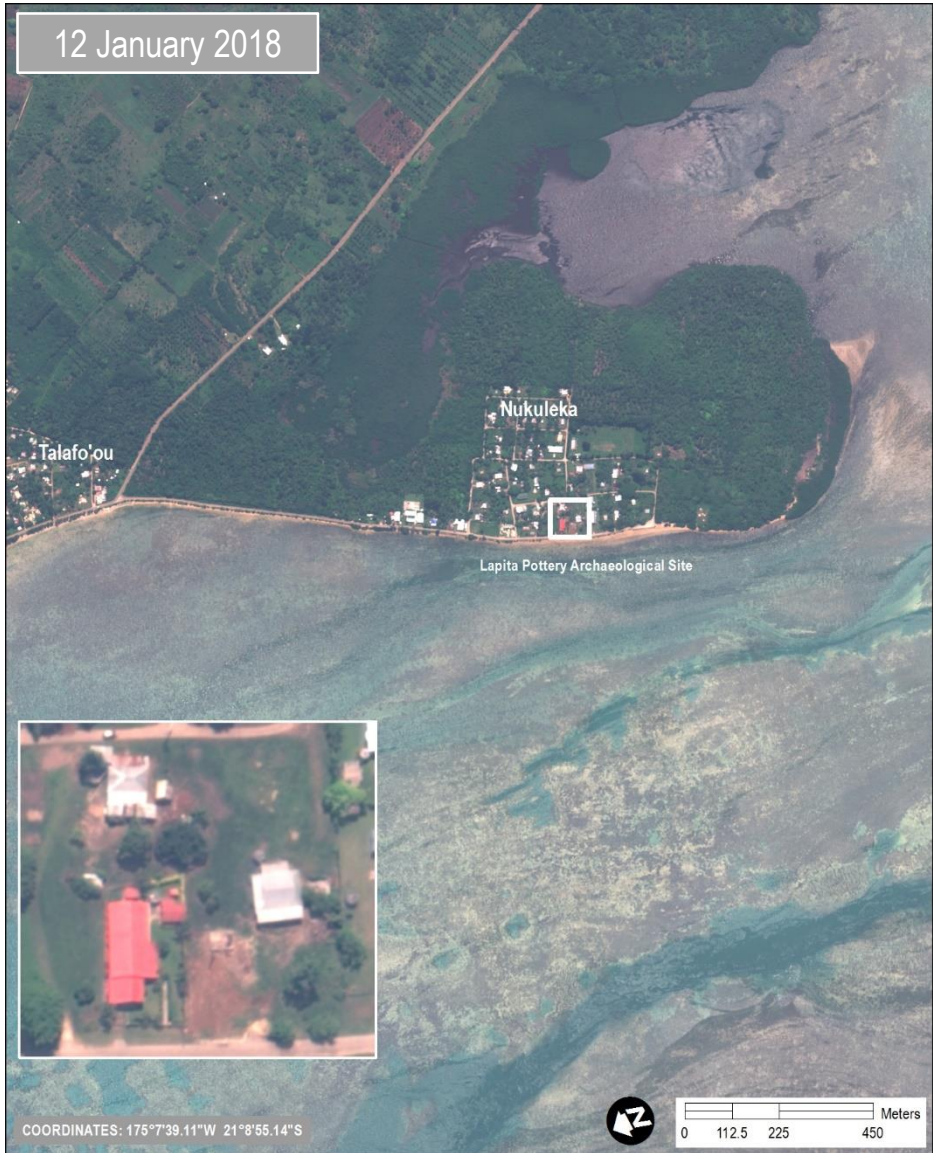
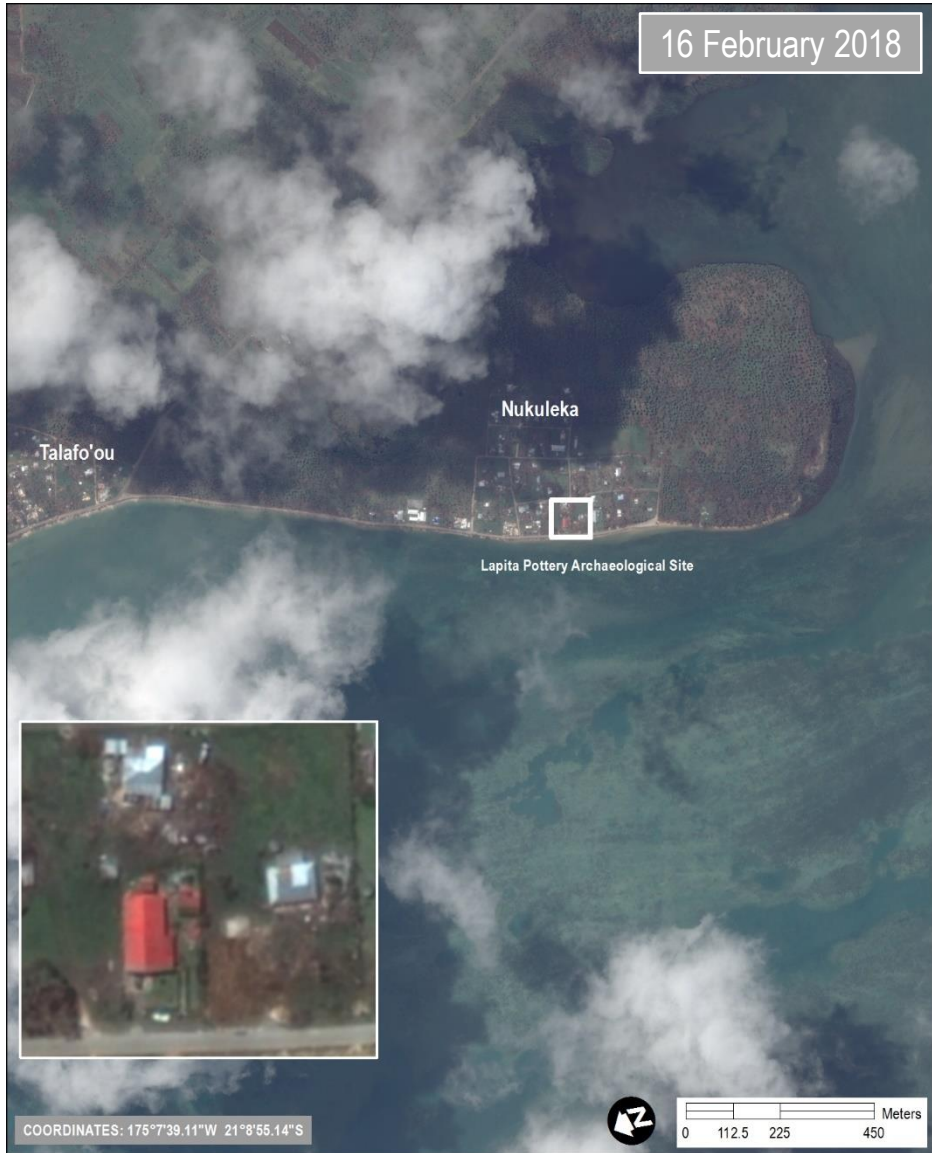
Lapita Pottery Archaeological Site
Visible damaged buildings

Damaged building

Image collected on 16 February 2018 shows the presence of damaged buildings and structures within the Lapita Pottery Archaeological Site. Also affected vegetation, fallen trees and debris are observed in the surrounding area. The damage of the Lapita Pottery Archaeological Site might be underestimated due to the characteristics (resolution, angle, cloud cover percentage...) of the satellite image. Field assessments are needed to validate the analysis and determine whether other damage not observed in the satellite image is present.

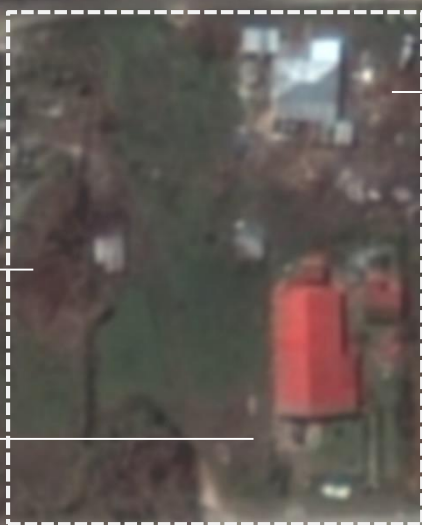
Affected vegetation

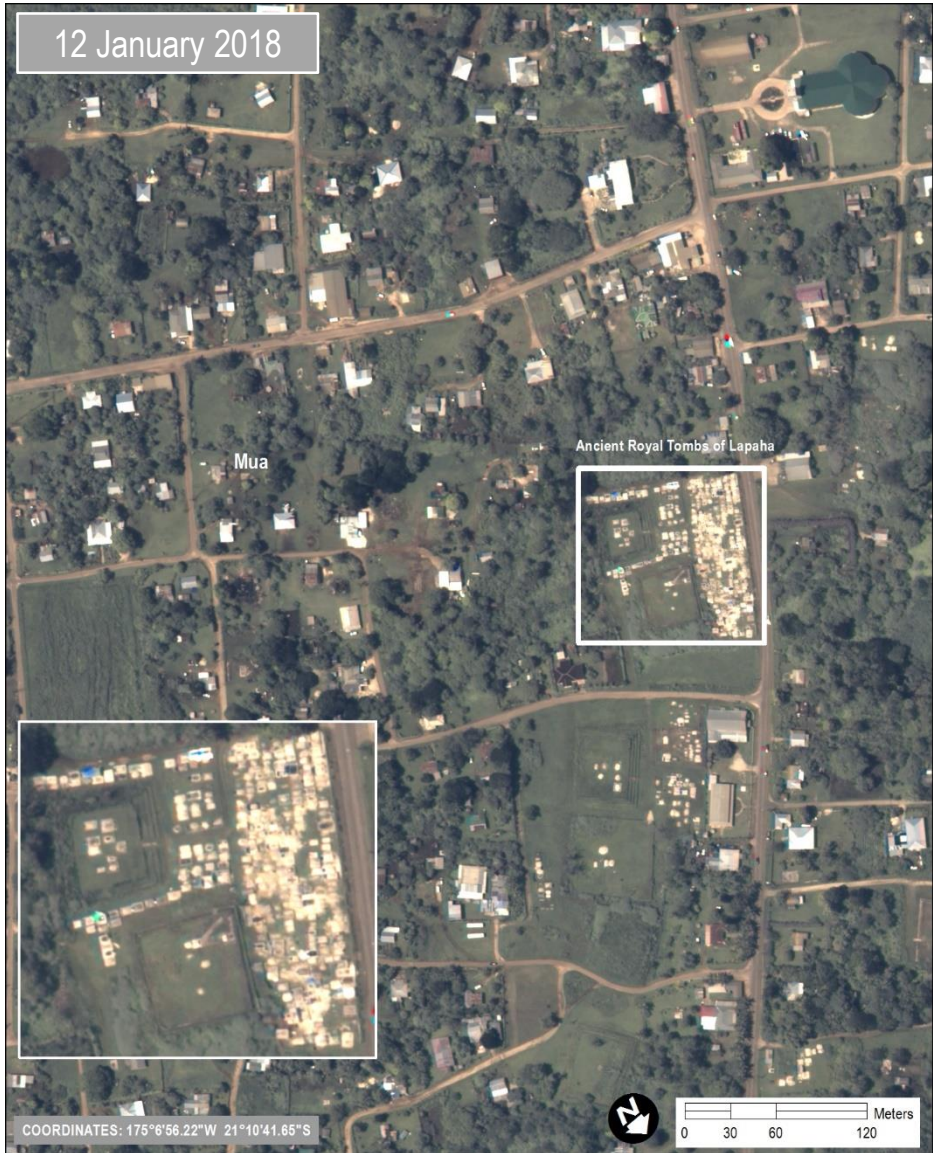
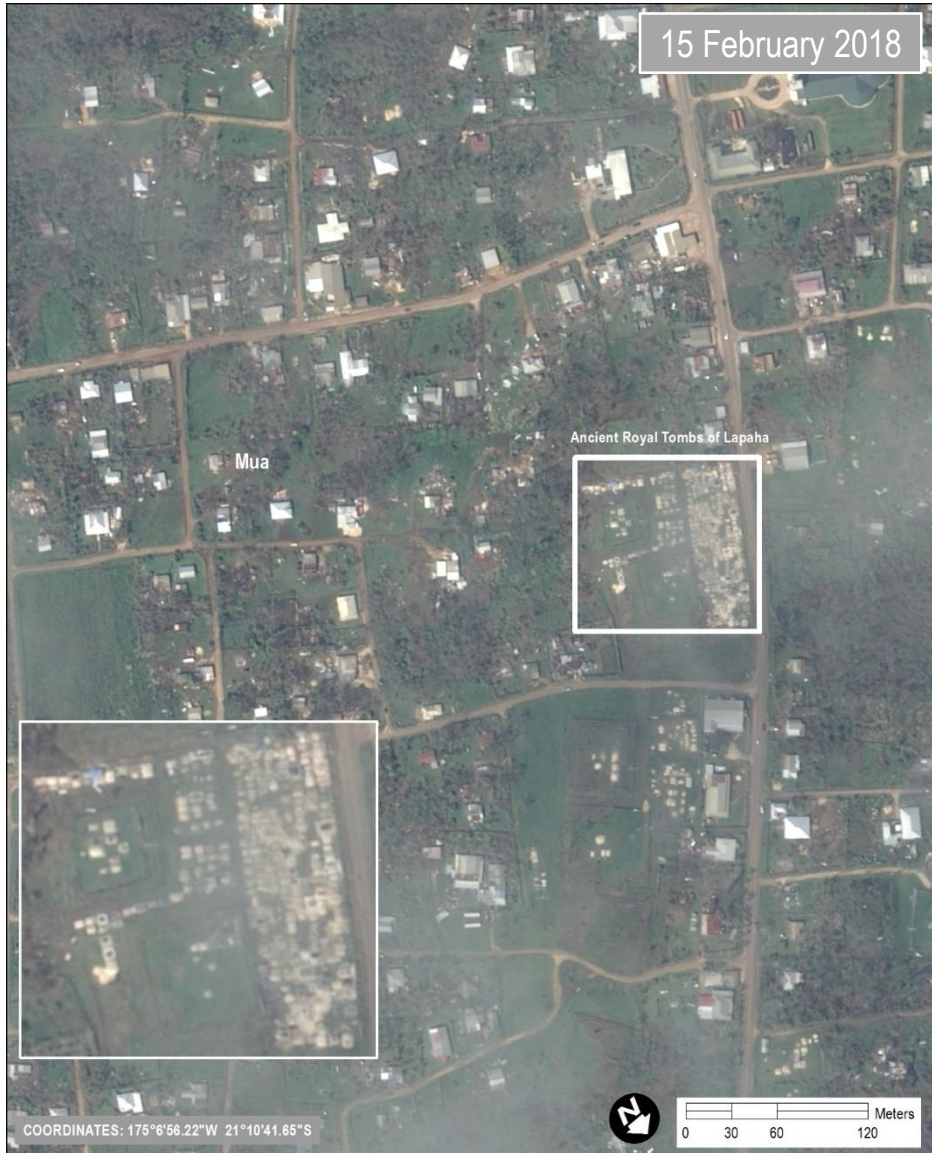
Ancient Royal Tombs of Lapaha as of 15 February 2018

Image collected on 15 February 2018 shows the presence of potentially damaged tombs inside the Ancient Royal Tombs site of Lapaha in the town of Mua. Also affected vegetation, fallen trees and damaged buildings are observed in the surrounding area. The damage of Ancient Royal Tombs of Lapaha might be underestimated due to the characteristics (resolution, angle, cloud cover percentage...) of the satellite image. Field assessments are needed to validate the analysis and determine whether other damage not observed in the satellite images is present.

Ancient Royal Tombs of Lapaha
Potential visible damage

Damaged buildings

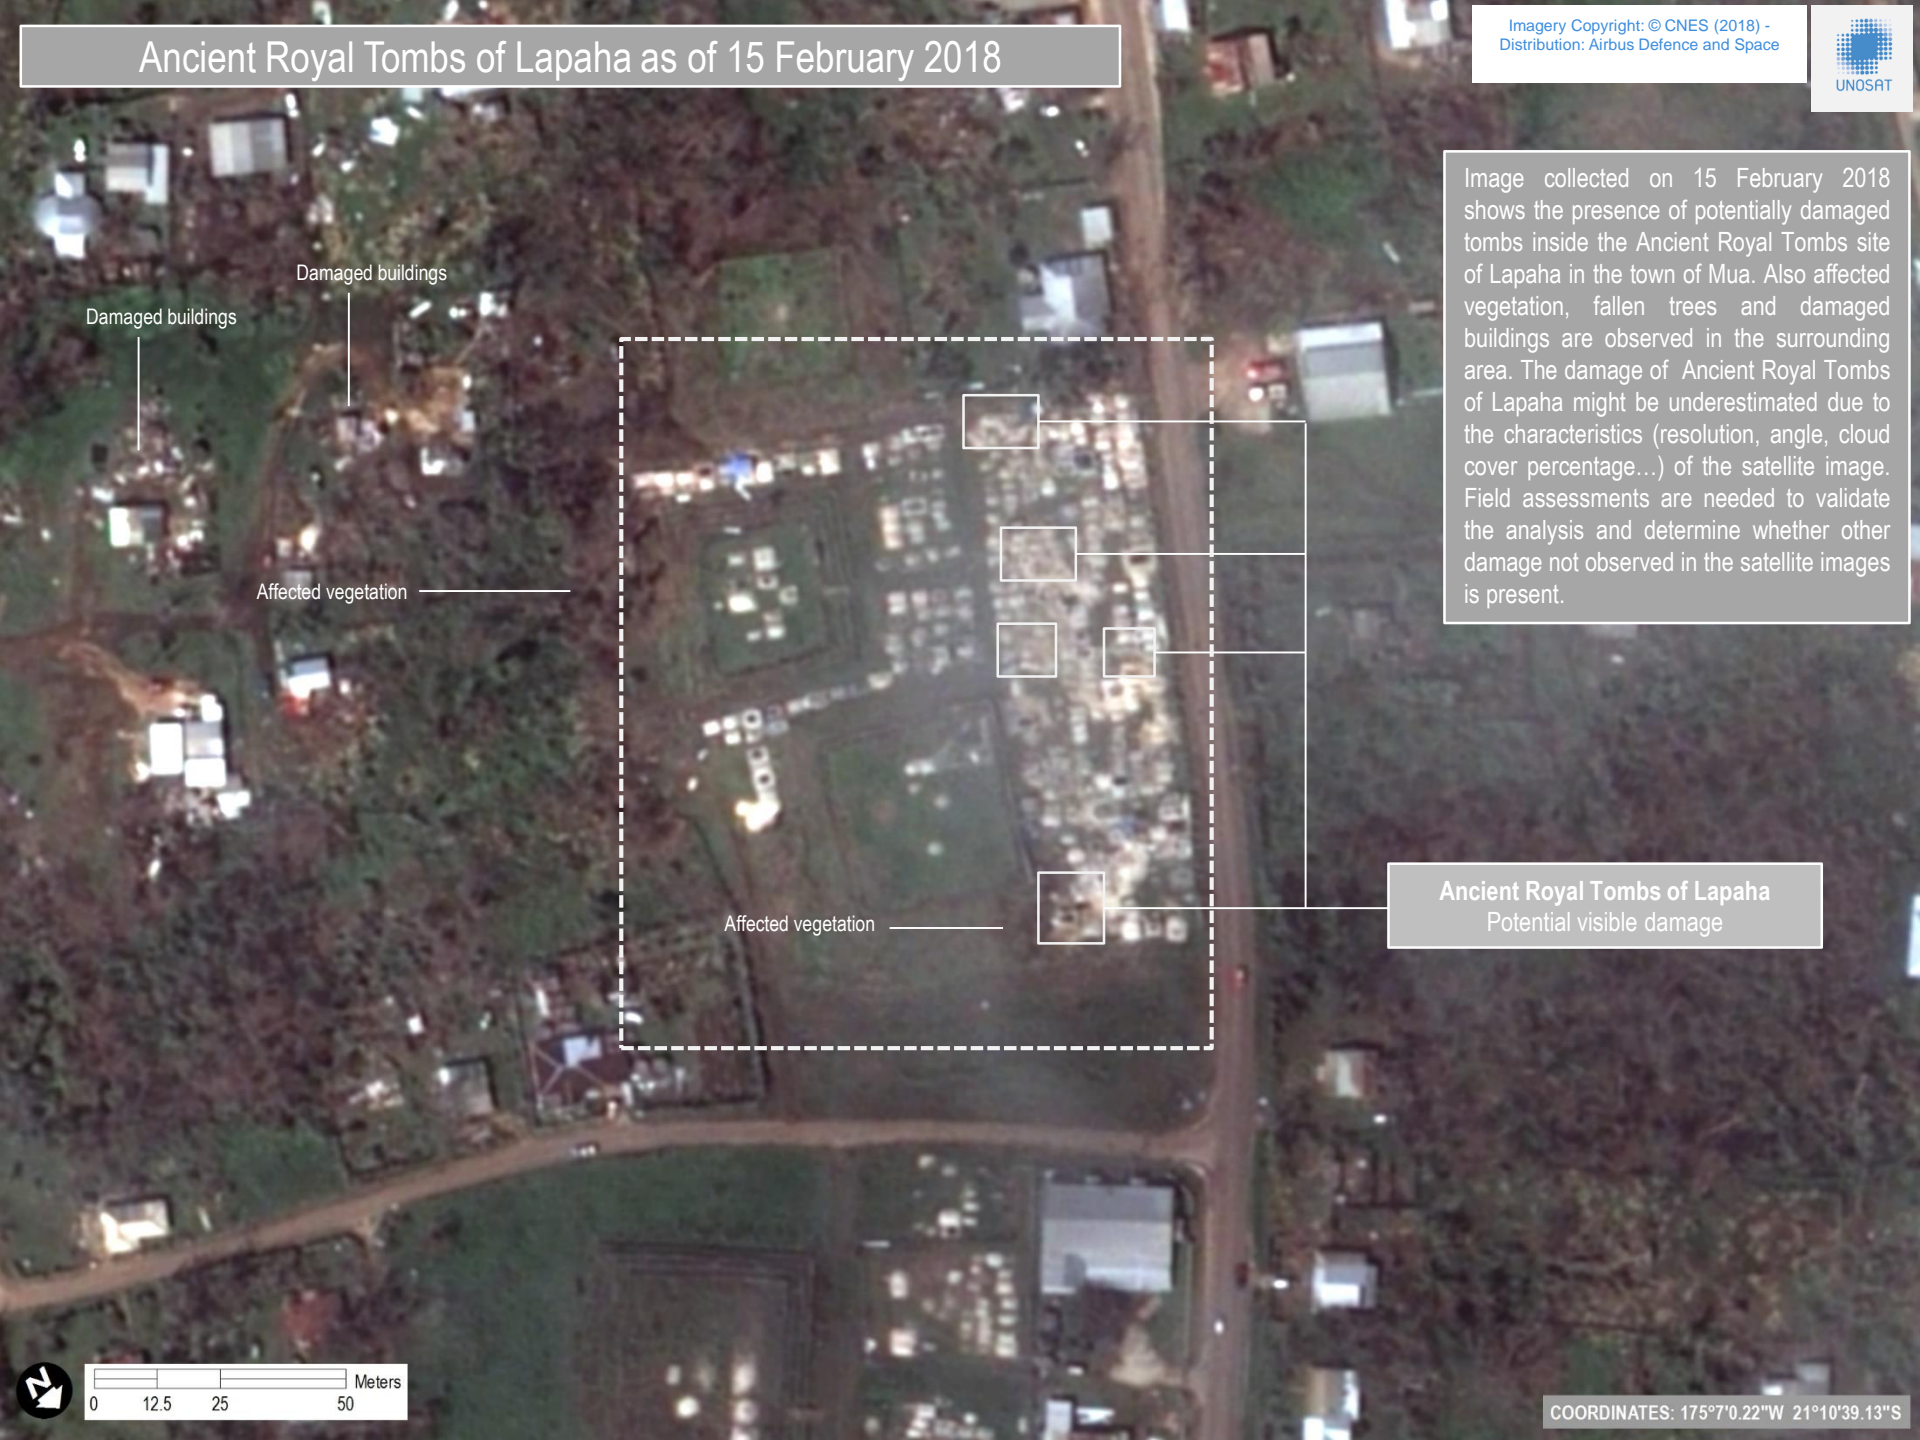
Affected vegetation
