16 December 2024

PRELIMINARY SATELLITE-DERIVED DAMAGE ASSESSMENT

Mecufi and Cidade de Pemba Districts, Cabo Delgado Province, Mozambique

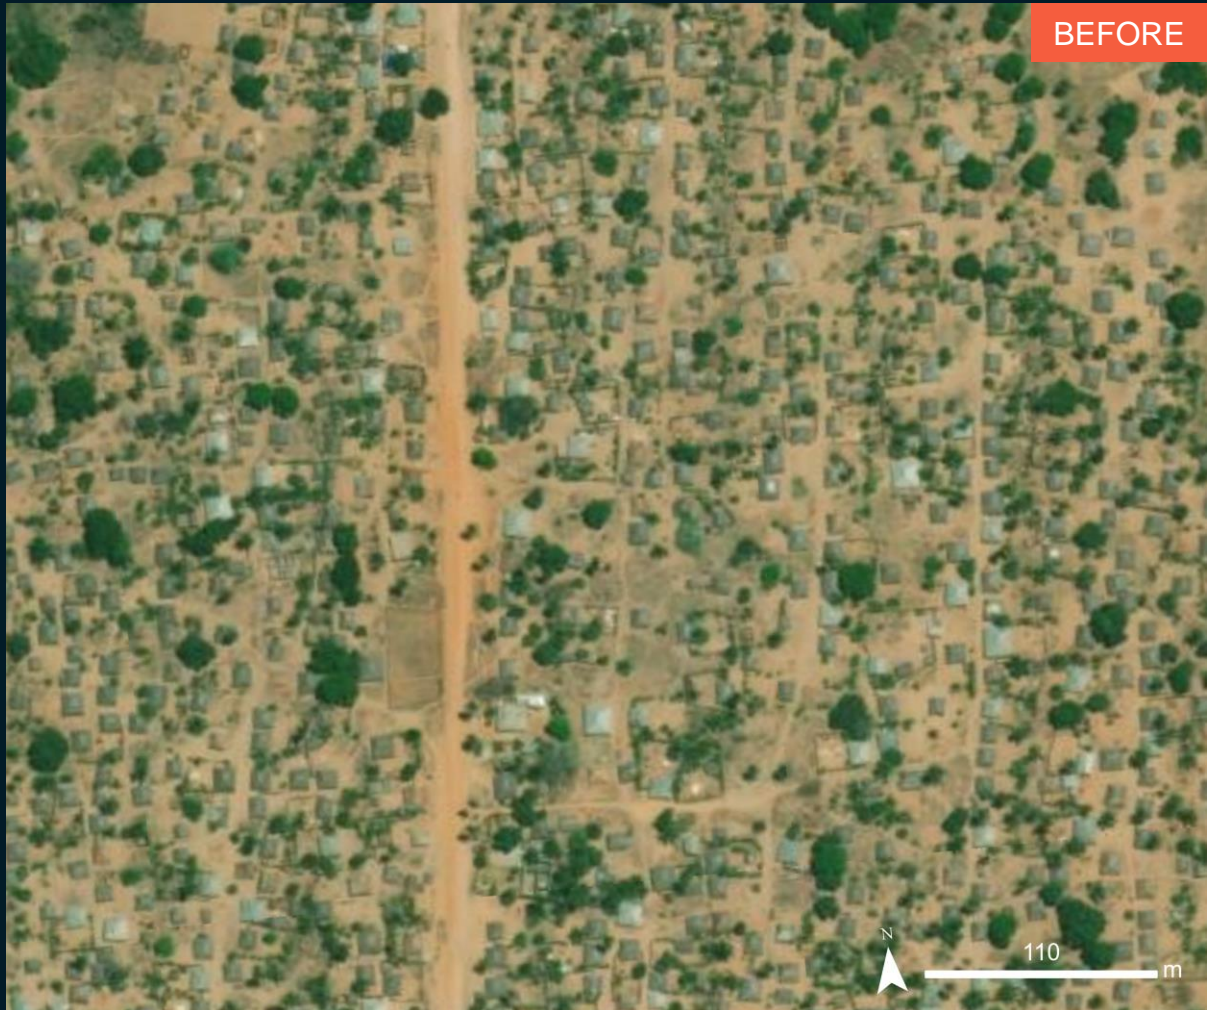
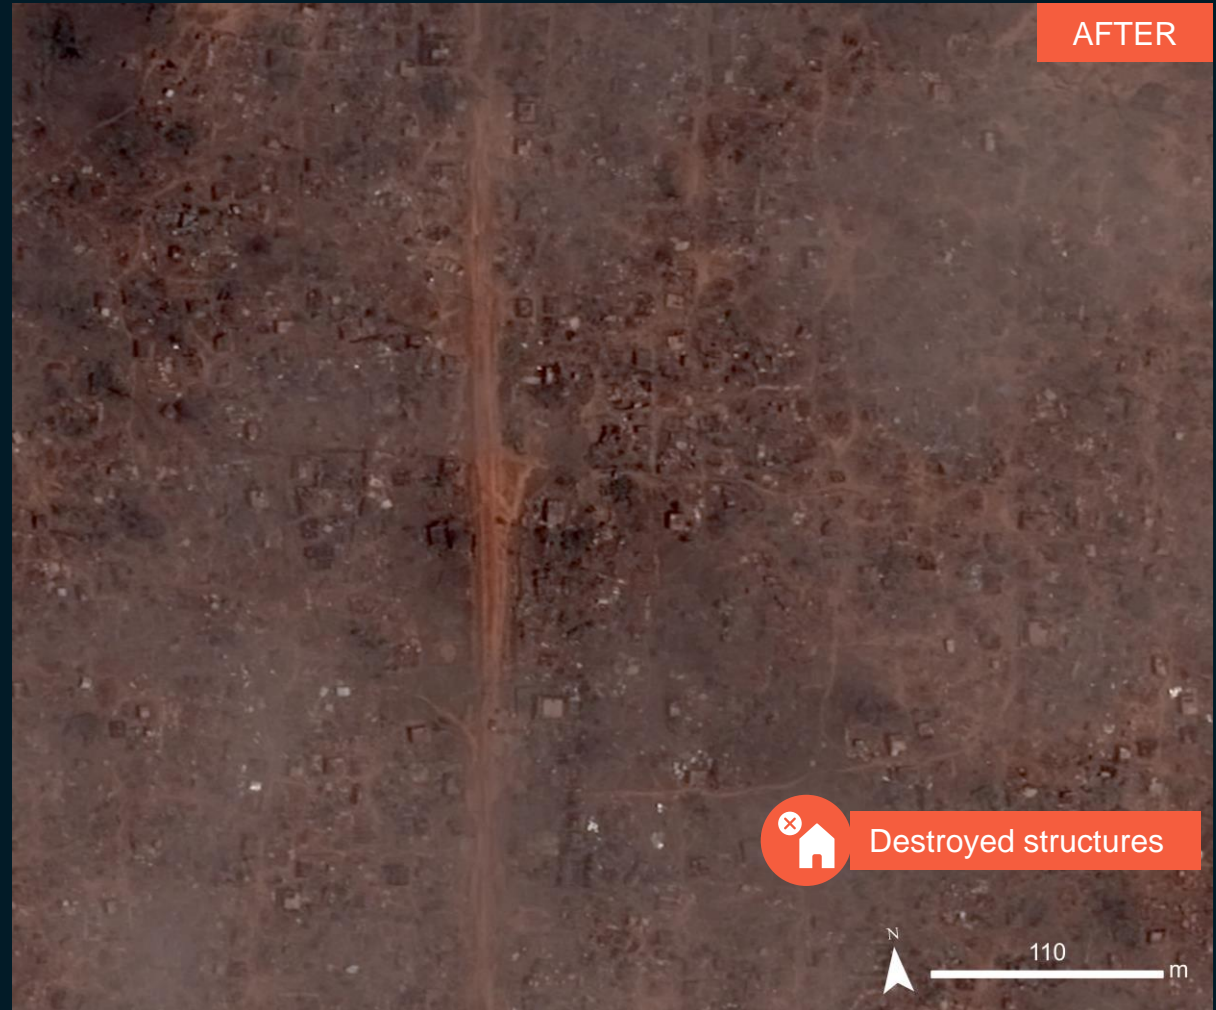
AOI 1 – 1: Muinde Village, Mecufi District, Cabo Delgado Province

Widespread damage & destroyed structures

Destroyed structures

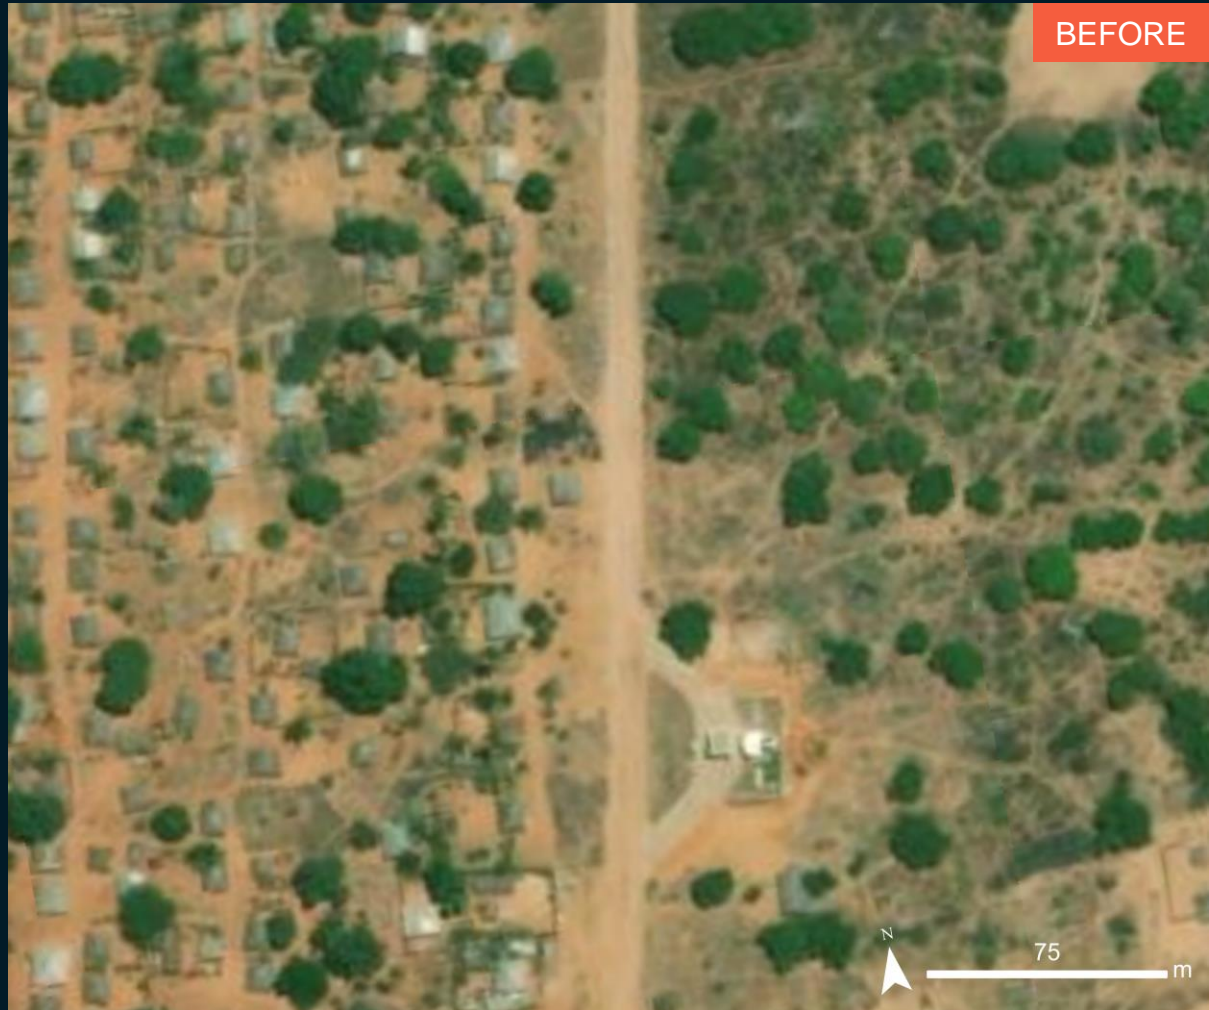
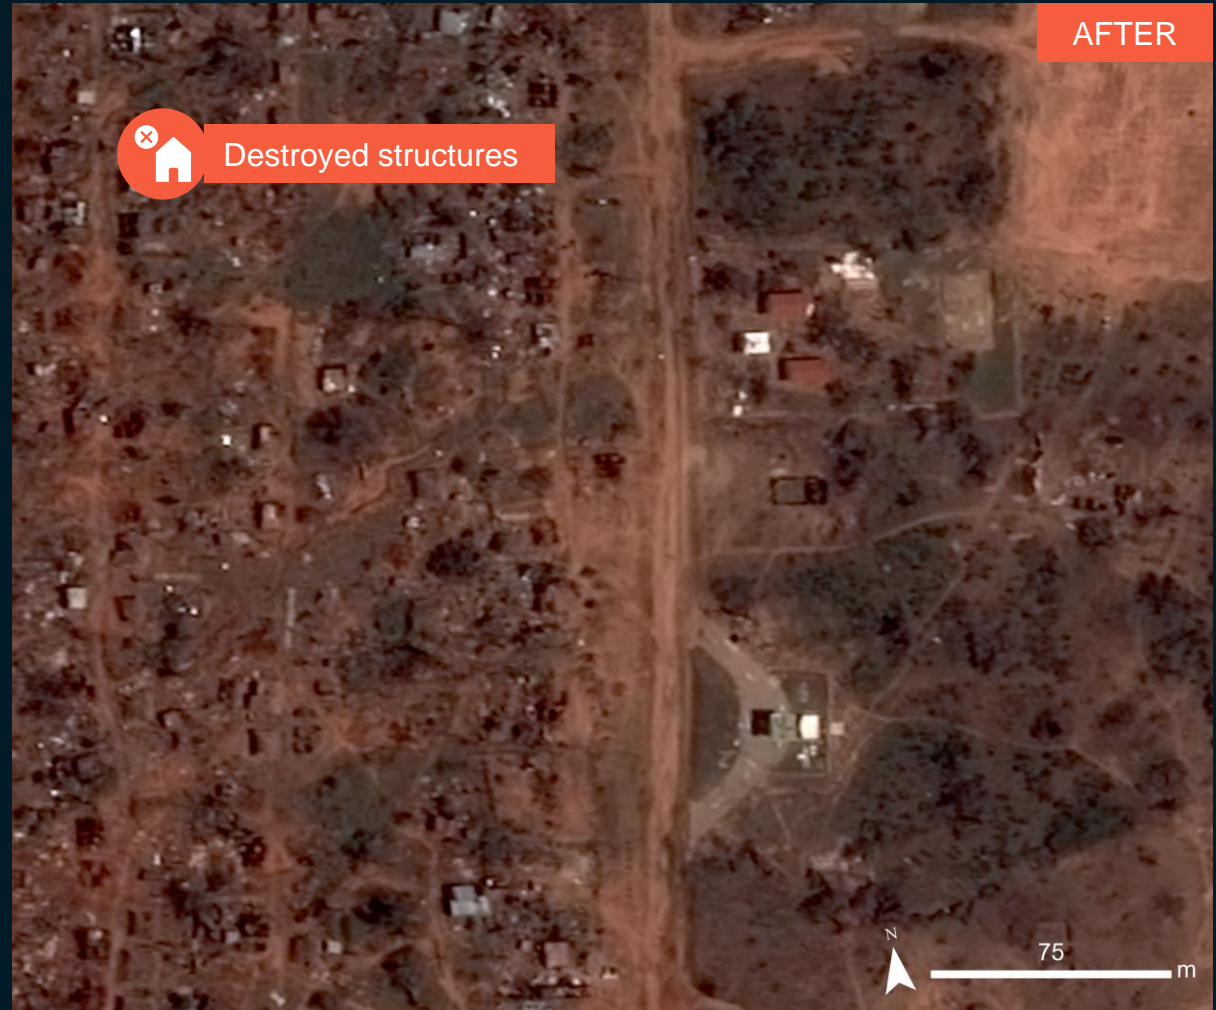
AOI 1 – 2: Mecufi Town, Mecufi District, Cabo Delgado Province

Widespread damage & destroyed structures

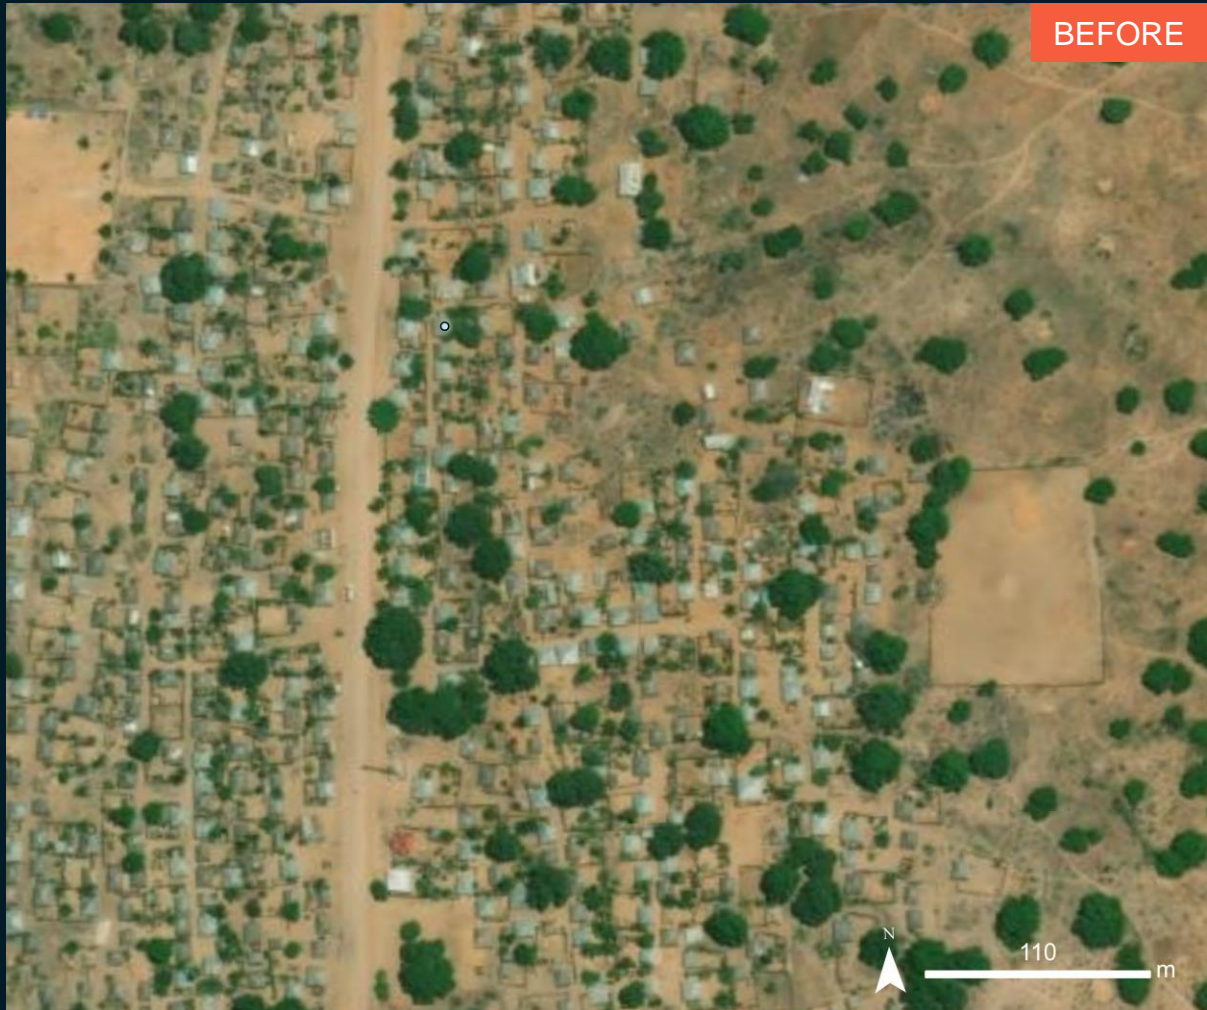
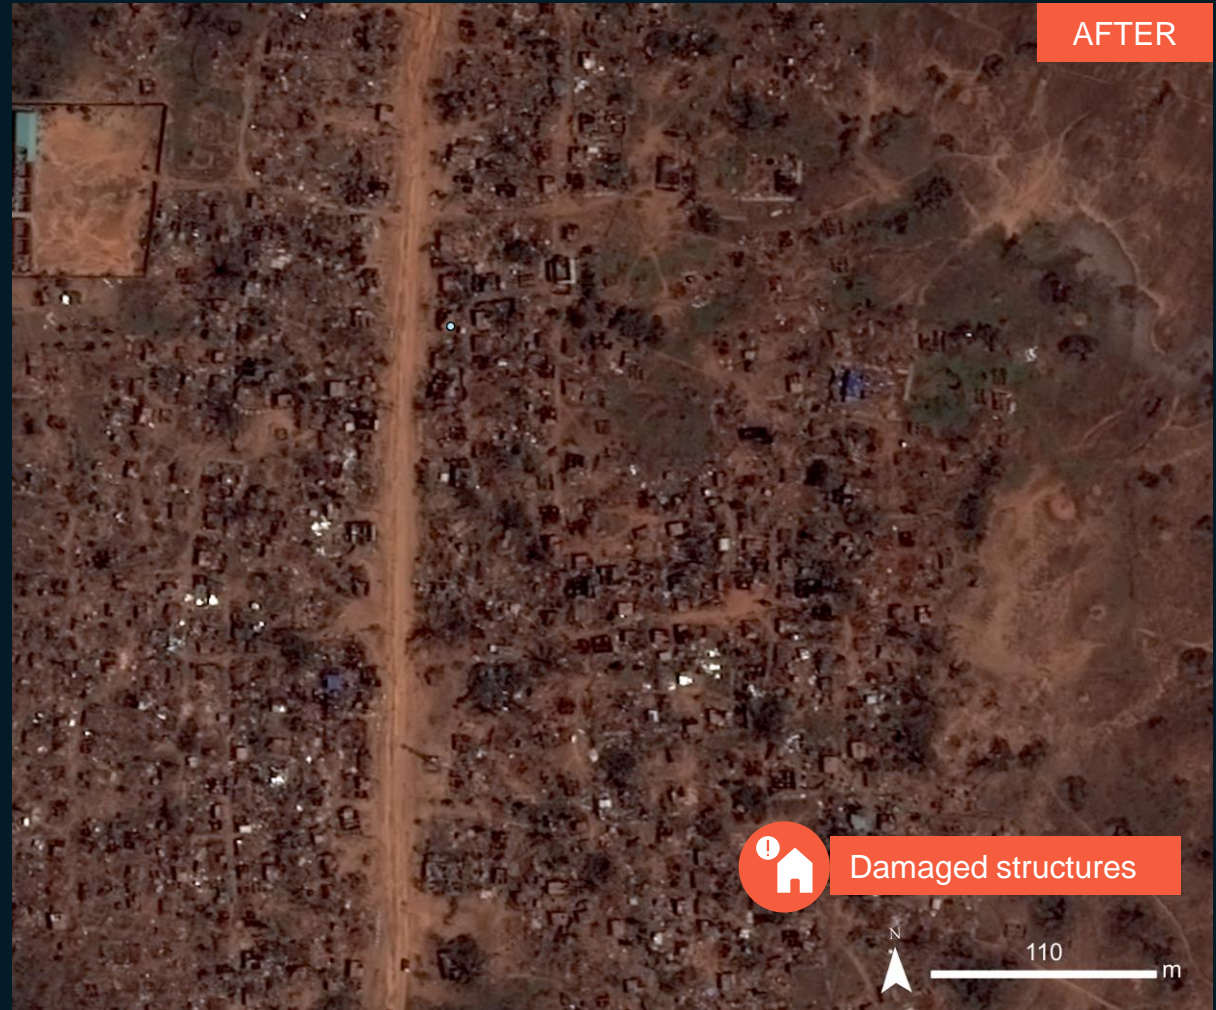
AOI 1 – 3: Ingoma Village, Mecufi District, Cabo Delgado Province

Widespread damage & destroyed structures

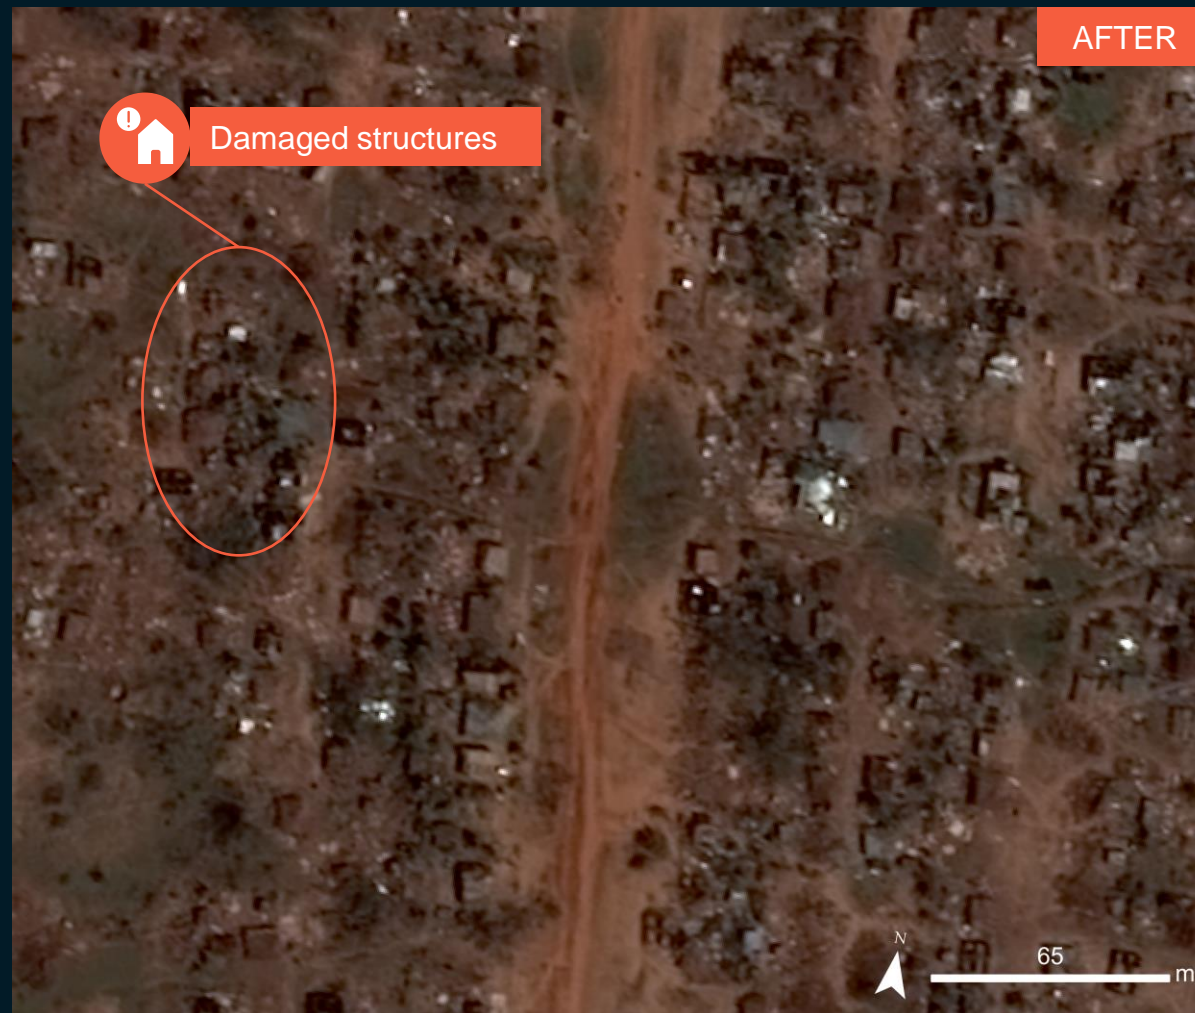
AOI 1 – 4: Sicura Town, Mecufi District, Cabo Delgado Province

Widespread damage & destroyed structures

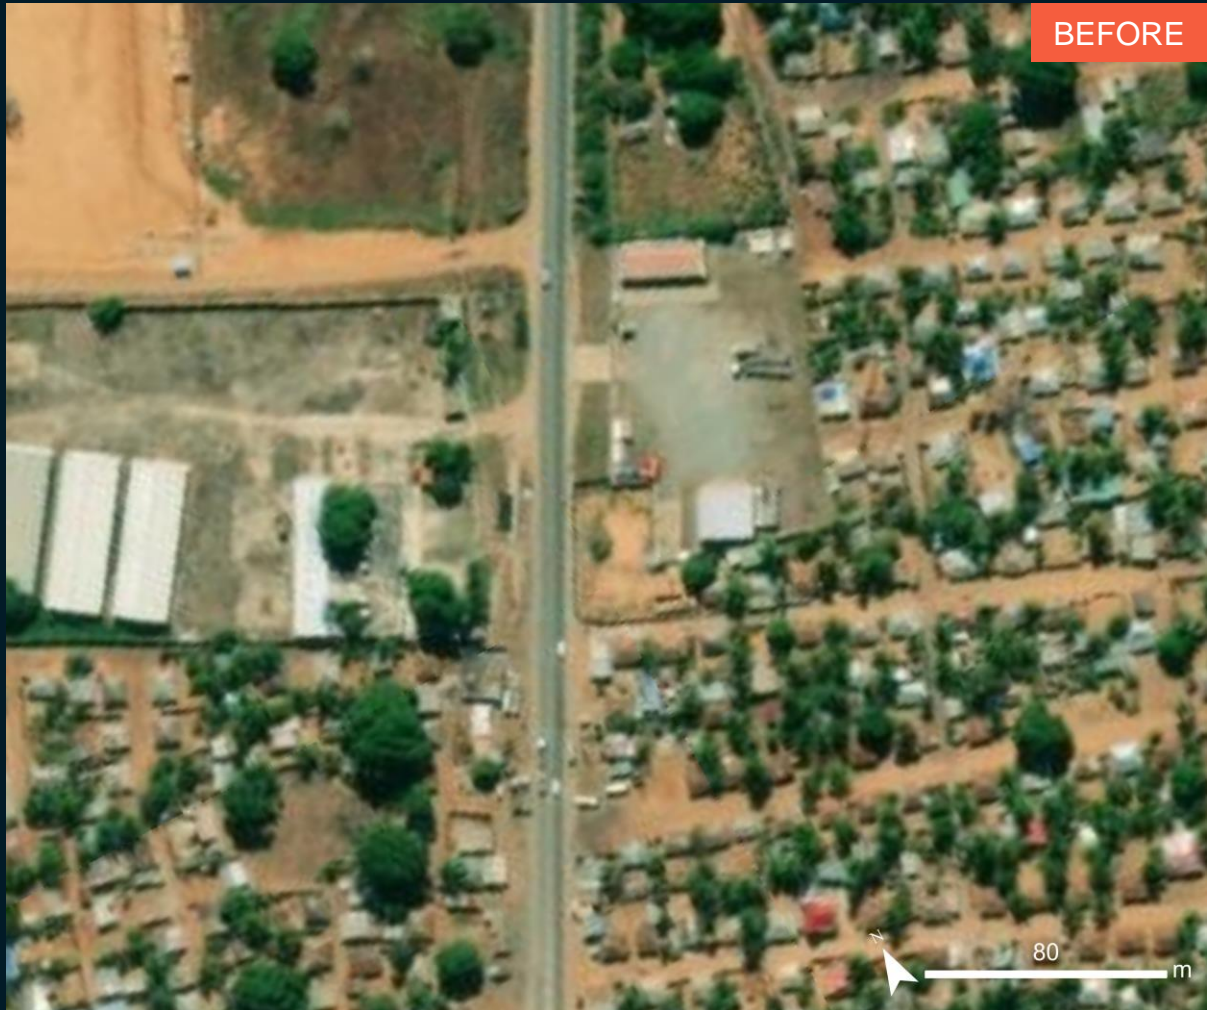
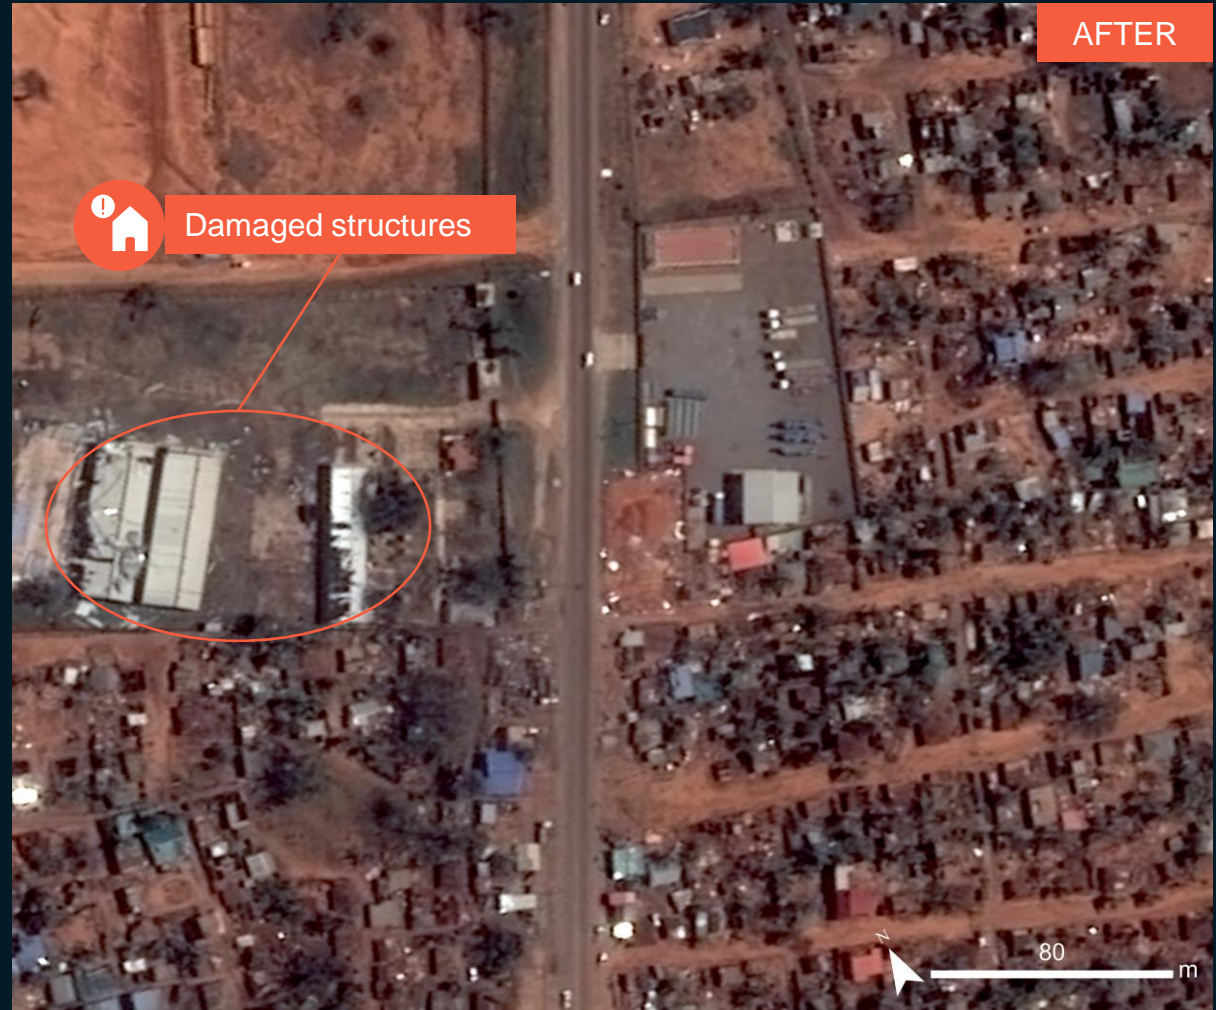
AOI 2 – 1: Muxara Suburb, Cidade de Pemba District, Cabo Delgado Province

Damaged structures

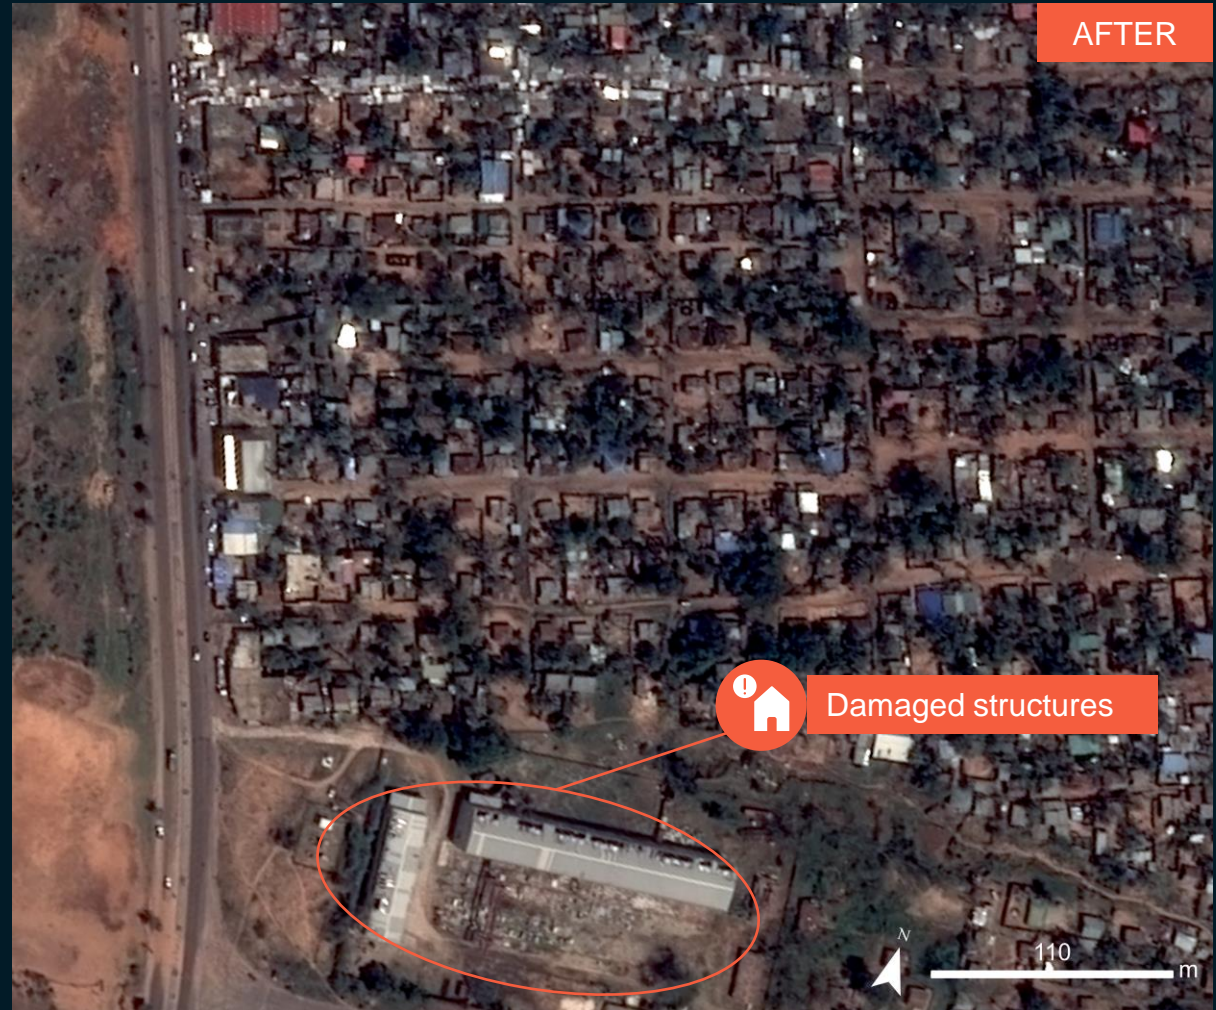
AOI 2 – 2: Bairro Alto Gingone Suburb, Cidade de Pemba District, Cabo Delgado Province

Damaged structures
